## **Annual Inspection**

Melton Parish Council

Beresford Drive Play Area

Beresford Drive, Woodbridge, Suffolk, IP12 1JJ

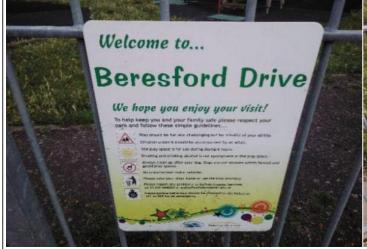
Finding: One sign is loose Action: Secure

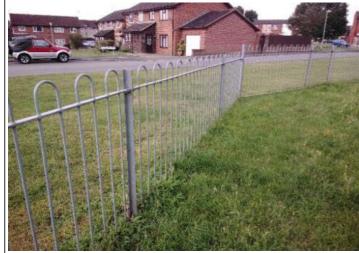
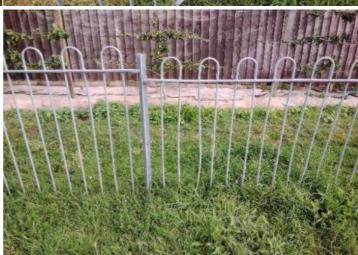
Finding: There is some damage to the fence sections

**Action:** Monitor for any further deterioration and repair as required

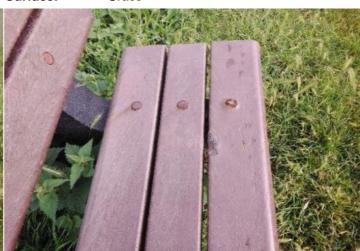
Finding: There is some evidence of fire damage to the item Action: Monitor for any further deterioration and repair as required

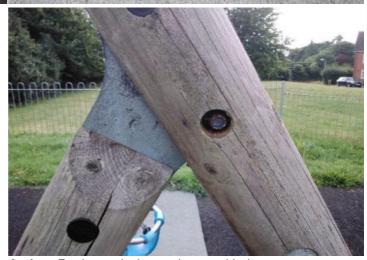
Finding: There is/are bolt cap covers missing or damaged Action: Replace missing or damaged bolt cap covers on the item

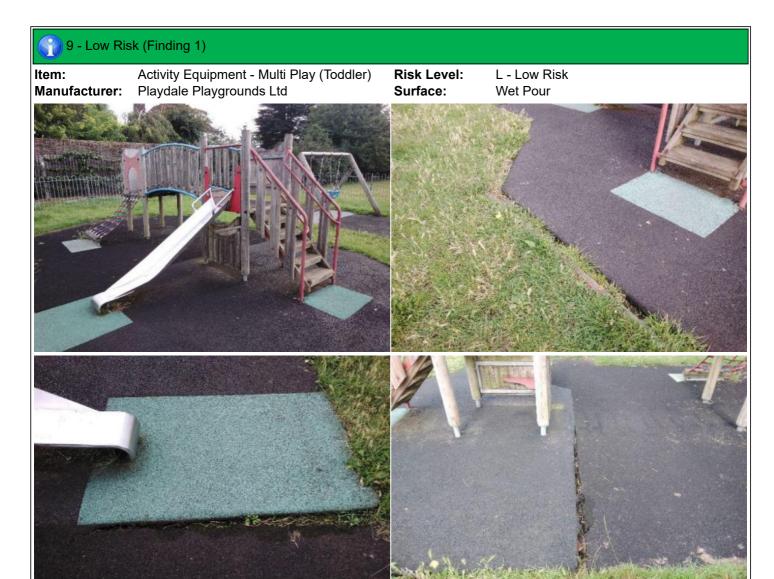
**Finding:** There are significant gaps (over 30mm) between the surface and the edging or between the joints in the surface; these are large enough for a small foot to enter

Action: Repair surfacing

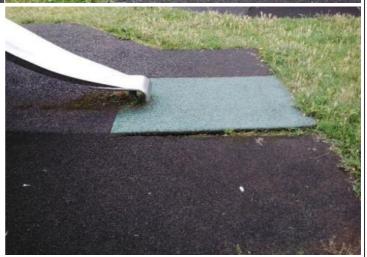
Finding: The surface is lifting at the edges and creating trip Action: Repair perimeter of surfacing to remove trip points points

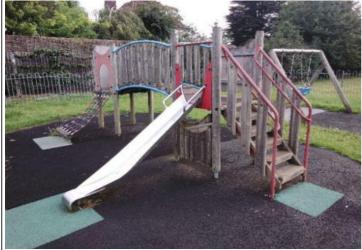
Finding: There are a number of dents in the slide surface

**Action:** Monitor for any further deterioration and repair as required

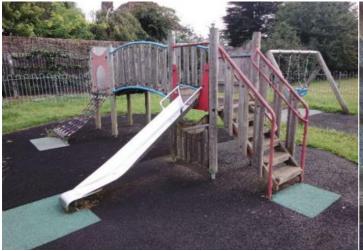
#### 8 - Low Risk (Finding 9)

**Finding:** There are areas or parts of the timber on the structure that have rotted

Action: Replace all affected timbers

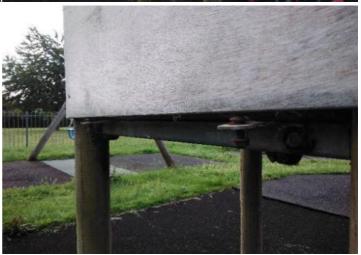
Finding: A barrier has been replaced and there protruding Action: Remove the protruding fixings fixings beneath

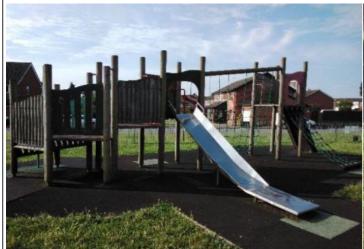
#### 4 - Very Low Risk (Finding 2)

Finding: There are a number of dents in the slide surface

**Action:** Monitor for any further deterioration and repair as required

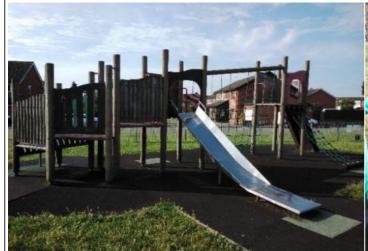
#### 6 - Low Risk (Finding 8)

Finding: The ropes/nets are worn/damaged in places

**Action:** Monitor for any further deterioration and repair or replace as required

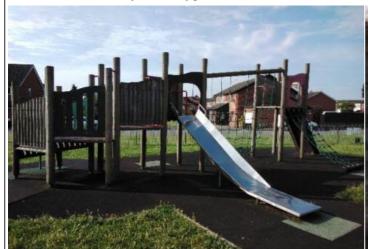
### 4 - Very Low Risk (Finding 10)

**Finding:** There is/are bolt cap covers missing or damaged on the item

Action: Replace missing or damaged bolt cap covers

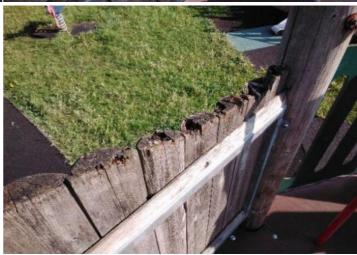
Finding: There is some evidence of rot in the timber

**Action:** Monitor for any further deterioration and replace as required

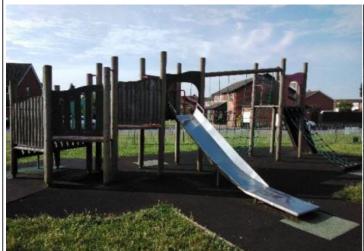
#### 8 - Low Risk (Finding 16)

**Finding:** The wet pour has been repaired with bitmac which **Action:** Replace with a appropriate safer surface forms a hard object within the impact area

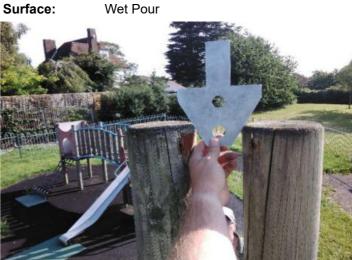
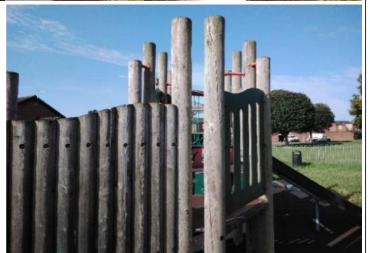
**Finding:** The item fails to meet the requirements of BS EN 1176 Part 1 4.2.7.2 head and neck entrapment in the uprights

**Action:** Replace the missing component to remove the entrapment

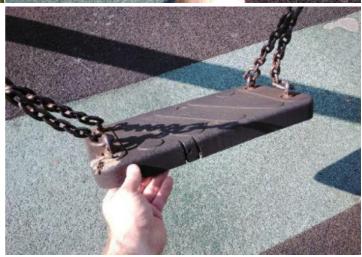
Finding: The seat has minor damage or wear

**Action:** Monitor for any further deterioration and replace as required
