# the play inspection company

## **Annual Inspection**

Melton Parish Council

Inspection Ref: 1437623 Site Ref: 18869

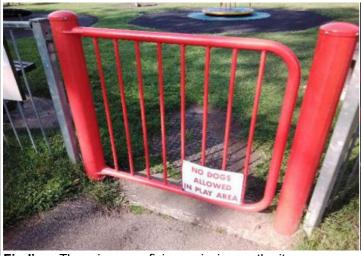
Item: Gates - Gate Manufacturer: Medway Gate Co. Risk Level: L - Low Risk Surface: N/A

There is or are fixings missing on the item - Replace all missing fixings

Action: Replace all missing fixings

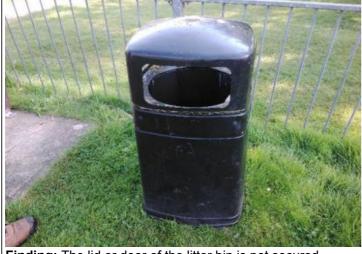
Finding: The lid or door of the litter bin is not secured

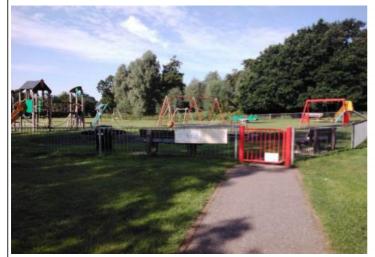
**Finding:** The site is accessible to the public during the COVID 19 pandemic. The government have released guidelines for safely re-opening these types of facilities which is available on the government website.

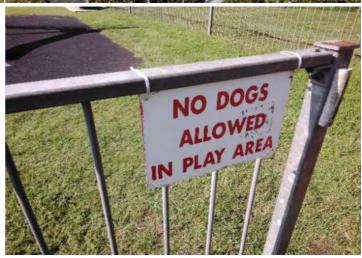
Finding: There are sharp protruding ties on the sign

**Action:** Remove the ties and consider an alternative fixing method

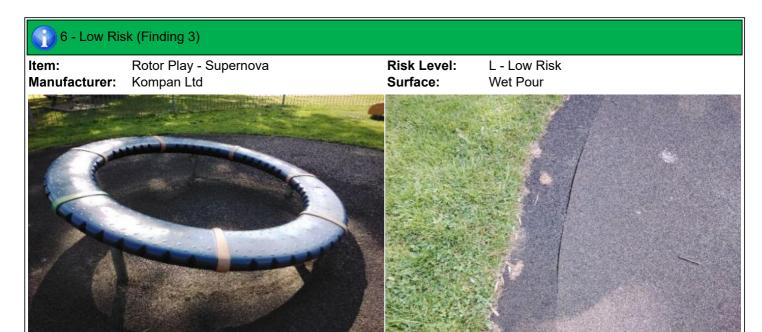
**Finding:** There are gaps opening between the surfacing and **Action:** Monitor for any further deterioration and repair as the edging surround or between the joints in the surfacing required

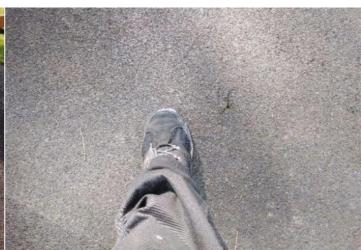
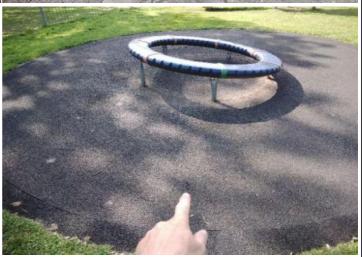
Finding: There is some minor damage to the surface

Action: Monitor for any further deterioration and repair as required

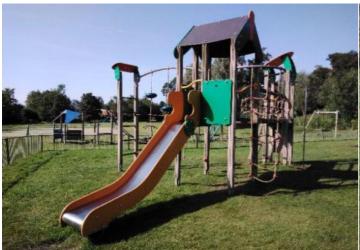
Activity Equipment - Multi Play (Junior) V - Very Low Risk Risk Level: Item: Kompan Ltd Surface: **Grass Matrix Tiles** Manufacturer:

Finding: There is/are finger entrapment/s in the frame and Action: Monitor - No remedial work recommended the item fails to meet the requirements of BS EN 1176 Part 1 4.2.7.6 Entrapment of fingers

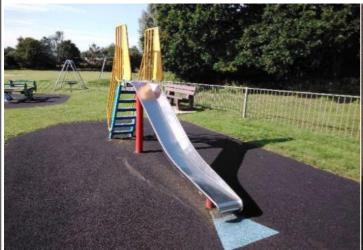
Item:Other - Free Standing SlideRisk Level:V - Very Low RiskManufacturer:Wicksteed PlaygroundsSurface:Wet Pour

There are a number of dents in the slide surface - Monitor for any further deterioration and repair as required

**Action:** Monitor for any further deterioration and repair as required

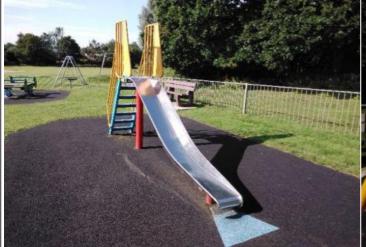
Item:Other - Free Standing SlideRisk Level:V - Very Low RiskManufacturer:Wicksteed PlaygroundsSurface:Wet Pour

**Finding:** The item fails to meet the requirements of BS 1176 Part 1 4.2.7.2 head and neck entrapment in the barriers and/or steps

Finding: The item fails to meet the requirements of BS EN Action: Monitor - No remedial work recommended

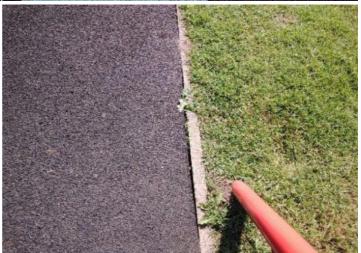
**Finding:** There are gaps opening between the surfacing and **Action:** Monitor for any further deterioration and repair as the edging surround or between the joints in the surfacing required

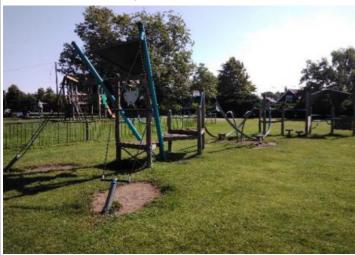
Item:Activity Equipment - Multi Play (Senior)Risk Level:L - Low RiskManufacturer:Kompan LtdSurface:Grass Matrix Tiles

**Finding:** The grass mats are silted up, the soil is compacted **Action:** Reinstate as required and the area will become very slippery when the soil is wet.

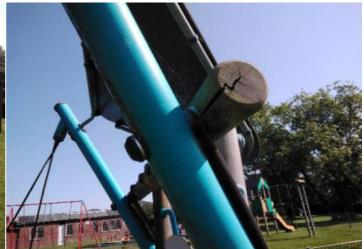
Item:Activity Equipment - Multi Play (Senior)Risk Level:L - Low RiskManufacturer:Kompan LtdSurface:Grass Matrix Tiles

**Finding:** The timber has a number of splits/shakes or air Action: Monitor to ensure the splits do not cross through cracks and this may affect the stability or allow water ingress fixing points of the structure and/or cause any instability which will accelerate the rotting process

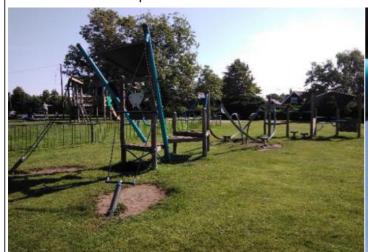
Item:Activity Equipment - Multi Play (Senior)Risk Level:L - Low RiskManufacturer:Kompan LtdSurface:Grass Matrix Tiles

Finding: The ropes/nets are worn/damaged in places

**Action:** Monitor for any further deterioration and repair or replace as required

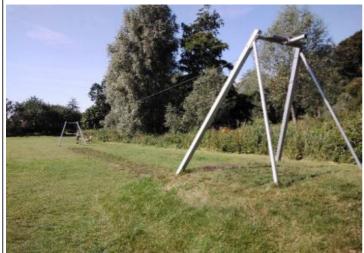
Item: Other - Cable Runway

**Finding:** We have completed a visual inspection of the cable and fixing points from ground level, however it is not possible to fully inspect the cable and fixings without either hiring equipment to gain access or removing the cable and inspecting at ground level. We recommend that the main cable and fixing security is thoroughly inspected at least in accordance with the manufacturers recommendations to check for damage, security or internal rusting, this will help to ensure the continued safe use of the equipment

**Action:** Inspect in accordance with the manufacturers recommendations
