Annual Inspection

Melton Parish Council

Beresford Drive Play Area

Beresford Drive, Woodbridge, Suffolk, IP12 1JJ

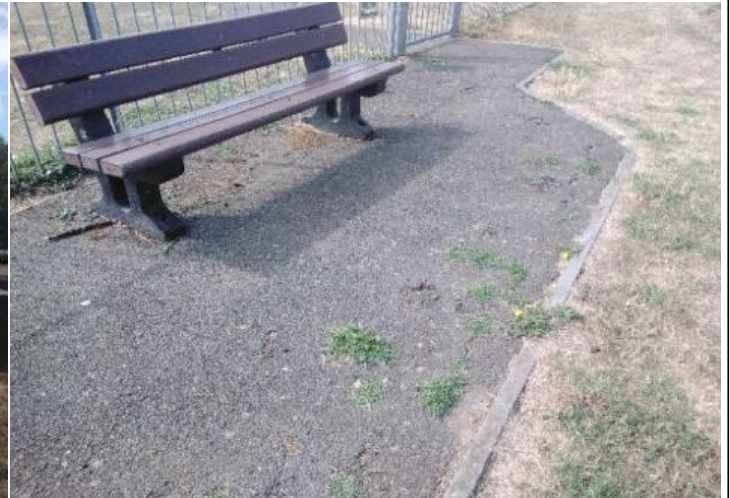
Finding: There is some minor damage to the surface

Action: Monitor for any further deterioration and repair as required

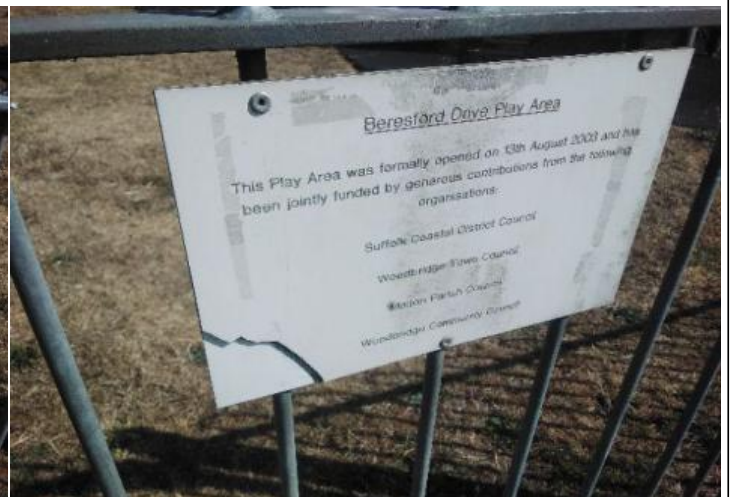
Finding: A sign is damaged

Action: Replace

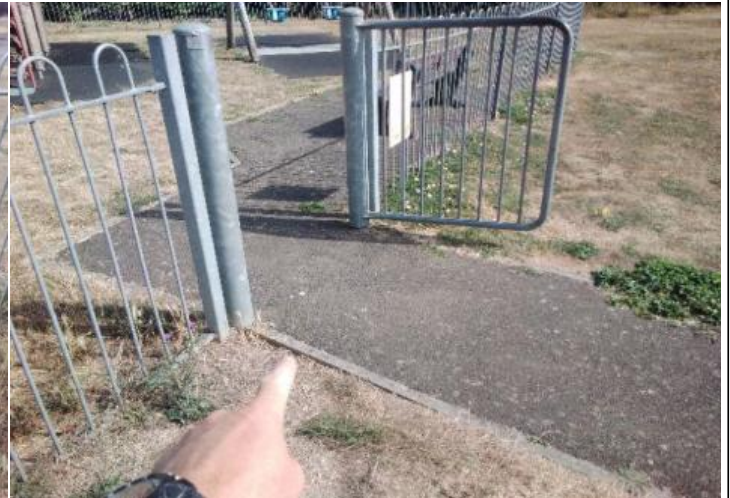
Finding: There are trip hazards at the edges of the surface

Action: Reinstate surrounding surface levels to remove the trip points

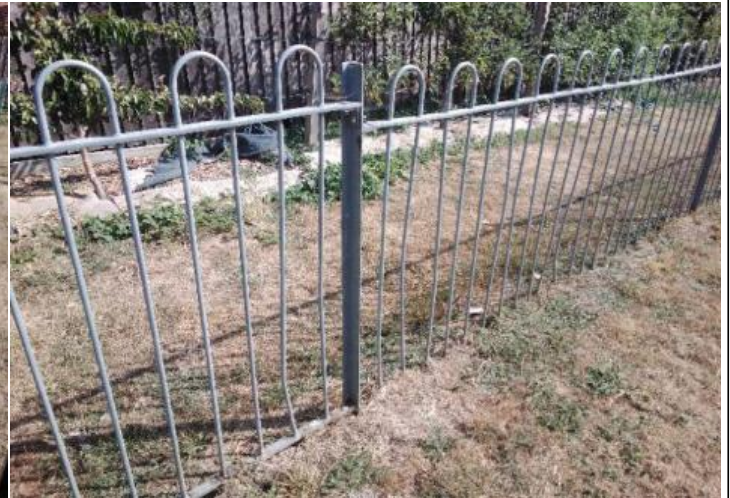
Finding: There is some damage to the fence sections

Action: Monitor for any further deterioration and repair as required

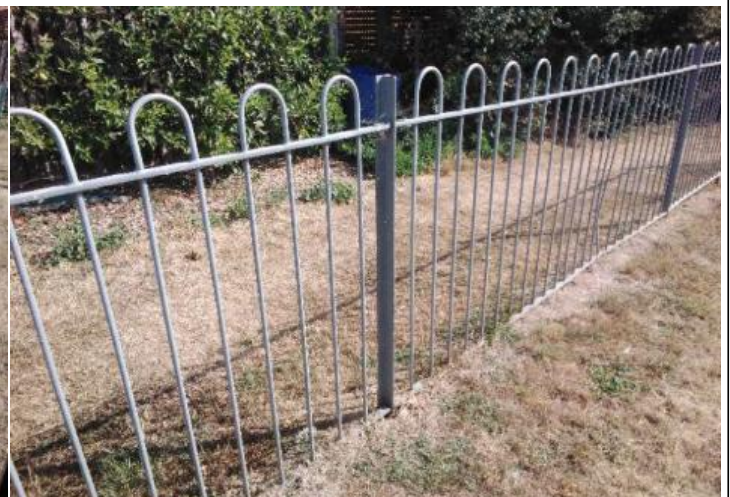
Finding: There are a number of loose posts around the fence

Action: Monitor for any further deterioration and reset as required

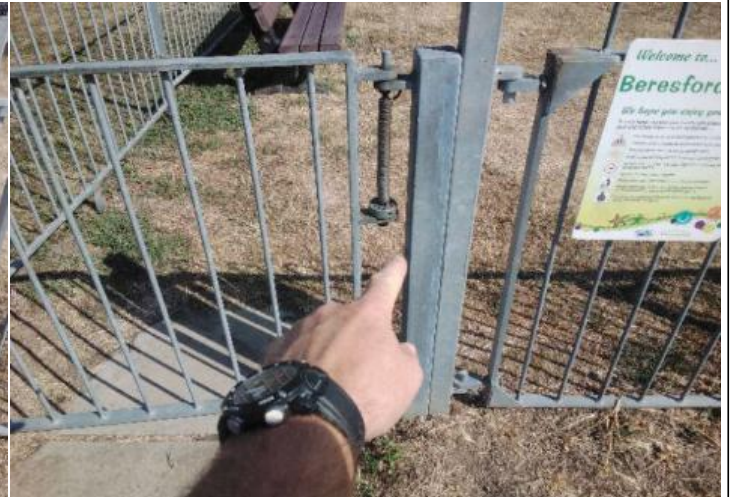
Finding: A number of fixing(s) have worked loose

Action: Secure all loose fixings

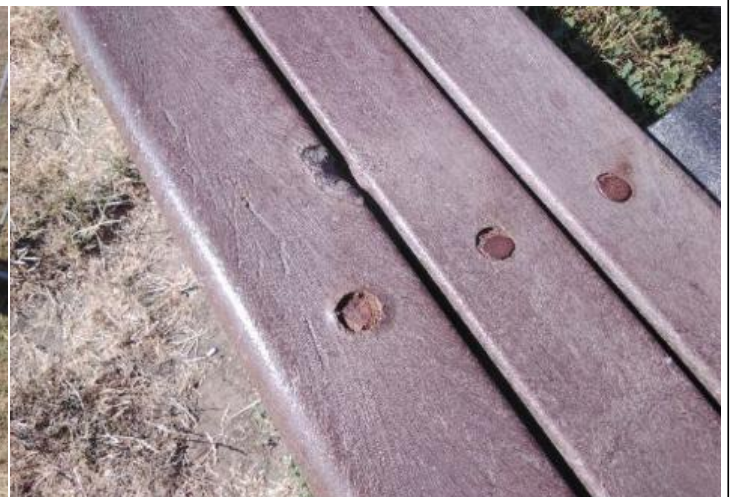
Finding: There is some evidence of fire damage to the item

Action: Monitor for any further deterioration and repair as required

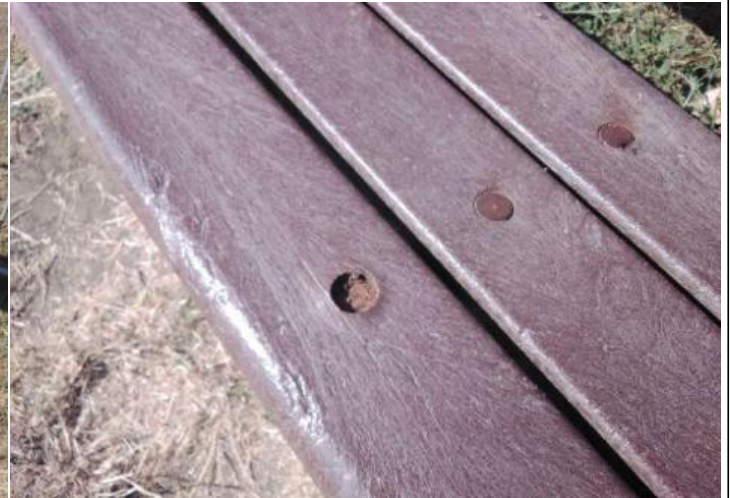
Finding: The fixings have corroded excessively

Action: Replace all corroded fixings

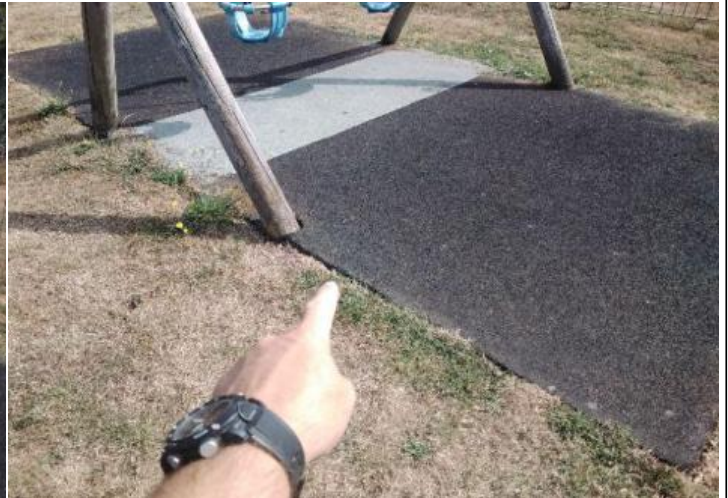
Finding: There are trip hazards at the edges of the surface

Action: Reinstate surrounding surface levels to remove the trip points

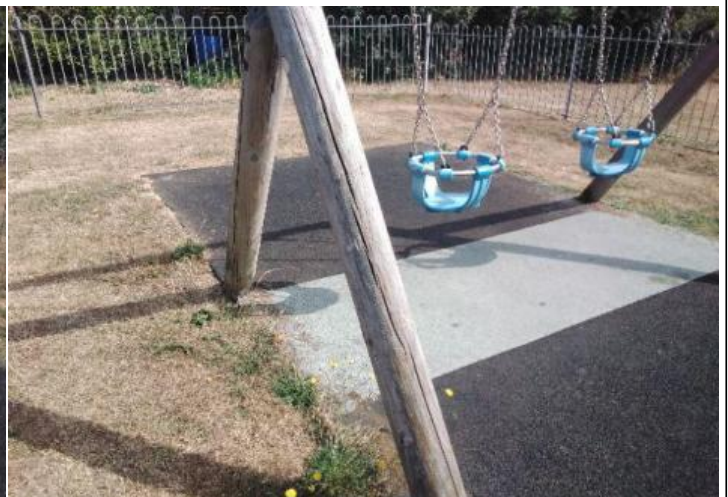
Finding: The timber has a number of splits/shakes or air cracks and this may affect the stability or allow water ingress which will accelerate the rotting process

Action: Monitor to ensure the splits do not cross through fixing points of the structure and/or cause any instability

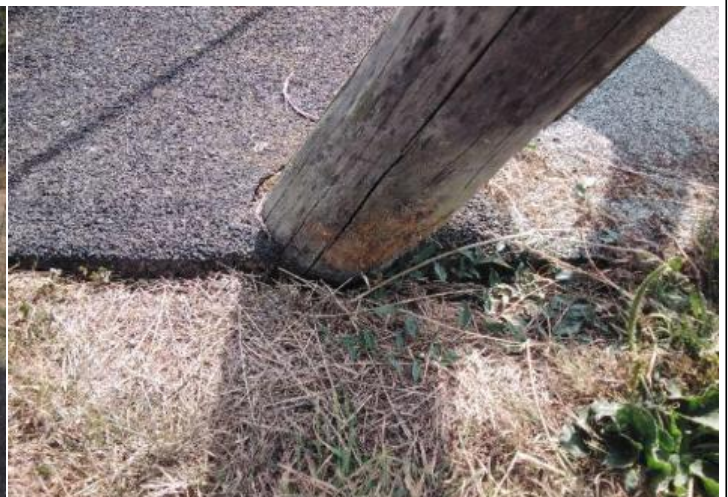
Finding: There is some strimmer / machinery damage apparent on the posts, this can penetrate the preservative applied to the timber and accelerate the rotting process

Action: Monitor for any deterioration (rot) and replace as required

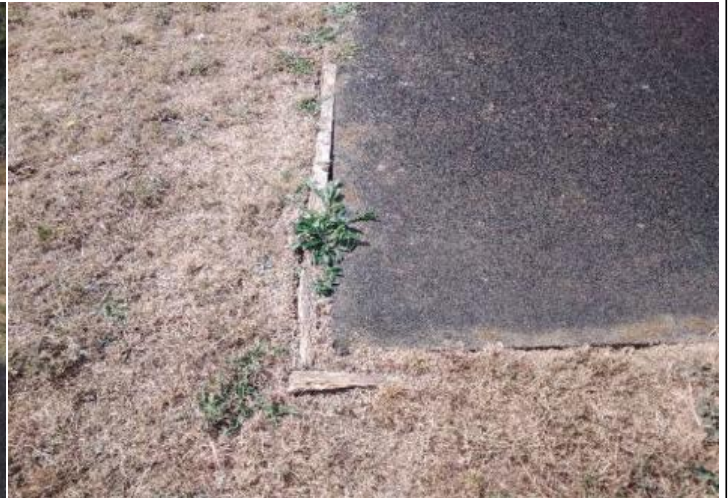
Finding: There are gaps opening between the surfacing and the edging surround or between the joints in the surfacing **Action:** Monitor for any further deterioration and repair as required

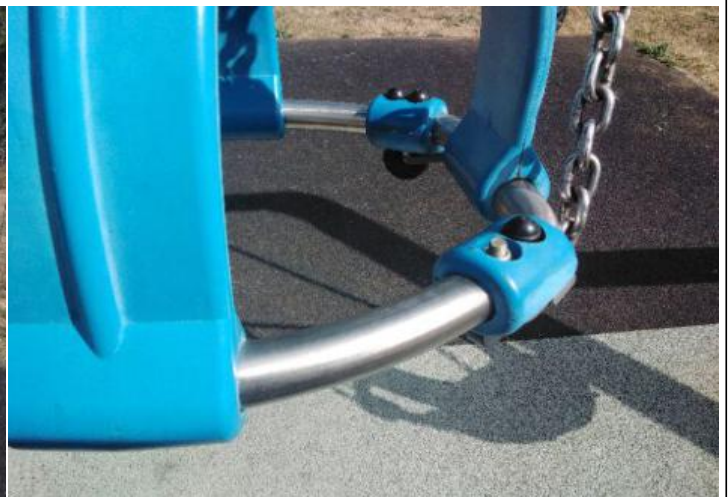
Finding: There are caps missing from the underside of the seats **Action:** Replace missing caps under the seats

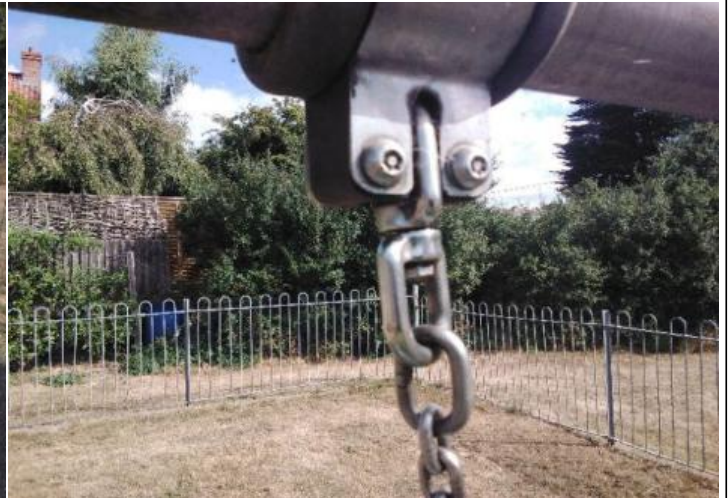
Finding: The swivel joint is becoming worn

Action: Monitor for any further deterioration and replace

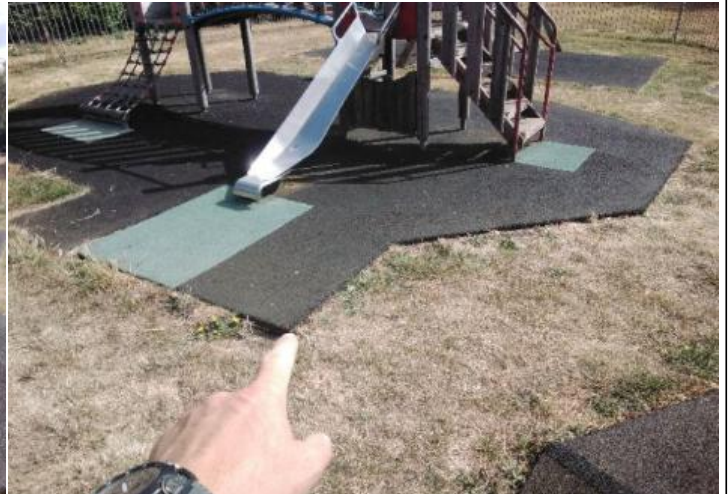
Finding: There are trip hazards at the edges of the surface

Action: Reinstate surrounding surface levels to remove the trip points

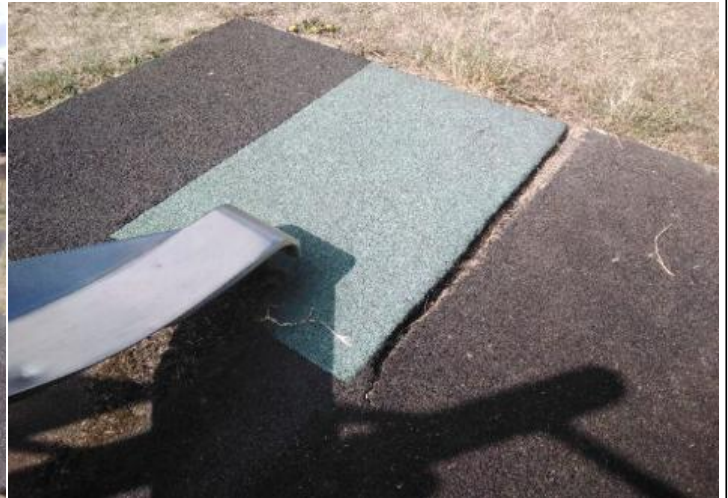
Finding: There are significant gaps (over 30mm) between the surface and the edging or between the joints in the surface; these are large enough for a small foot to enter

Action: Repair surfacing

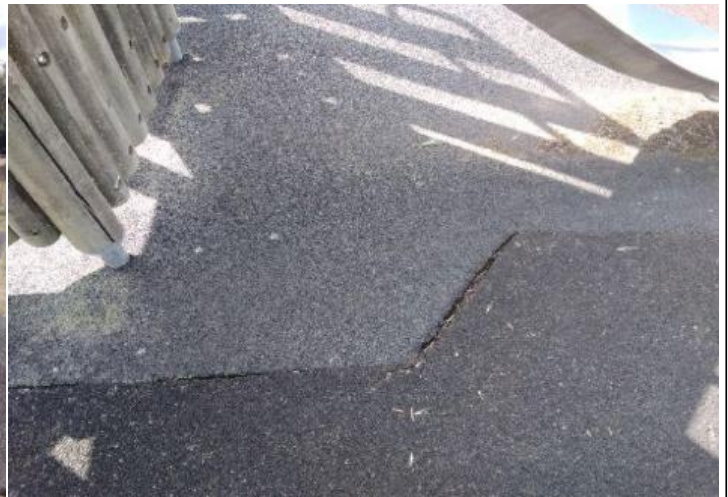
Finding: There are gaps opening between the surfacing and the edging surround or between the joints in the surfacing

Action: Monitor for any further deterioration and repair as required

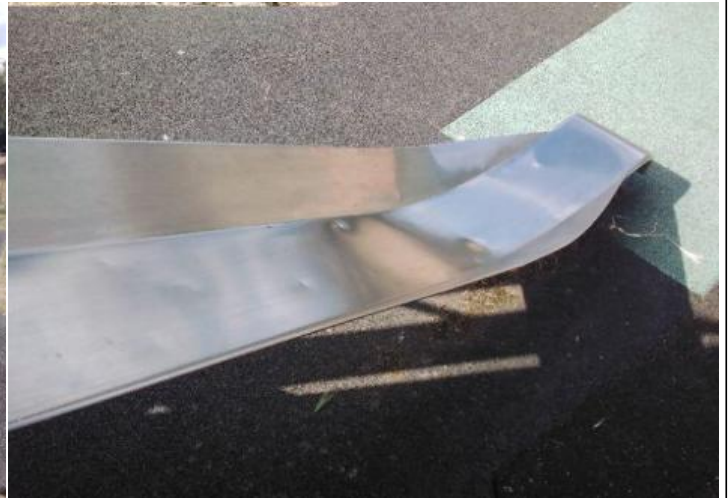
Finding: There are a number of dents in the slide surface

Action: Monitor for any further deterioration and repair as required

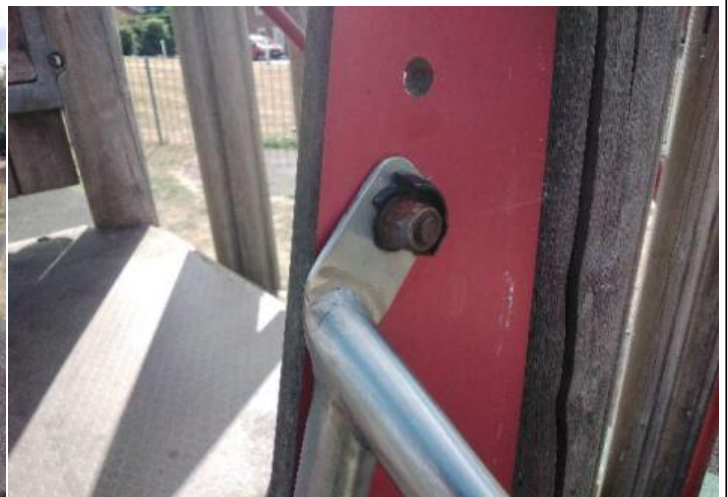
Finding: There is/are bolt cap covers missing or damaged on the item

Action: Replace missing or damaged bolt cap covers

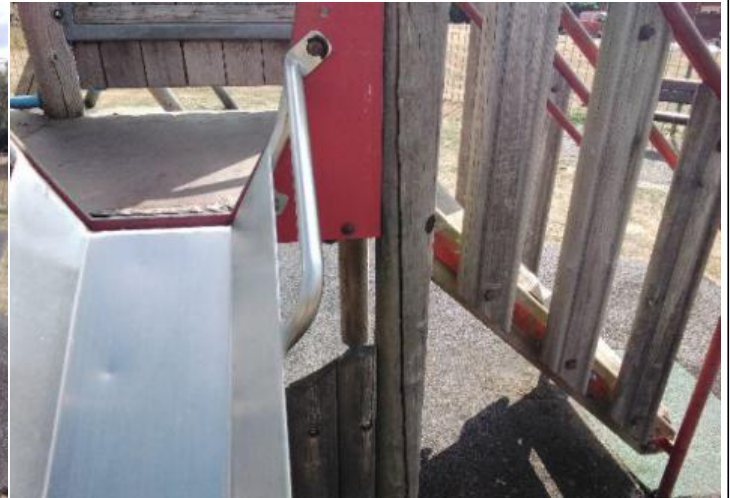
Finding: There are splits in the timber running through fixing points and creating some instability in the structure
Action: Replace all affected timber parts

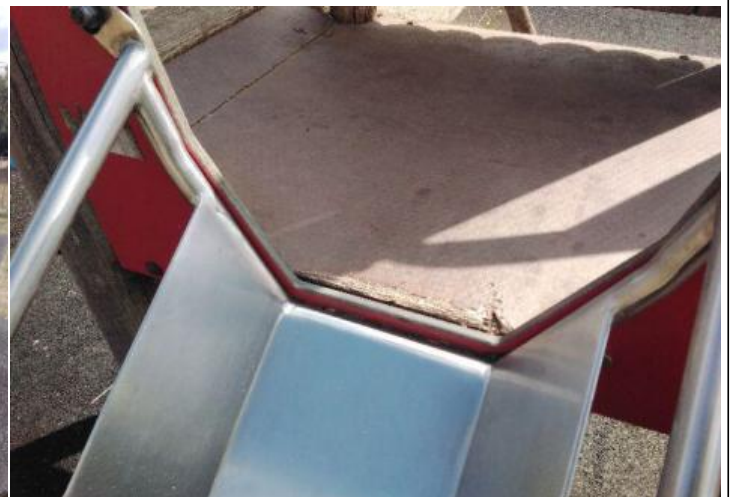
Finding: There is some evidence of rot in the timber

Action: Monitor for any further deterioration and replace as required

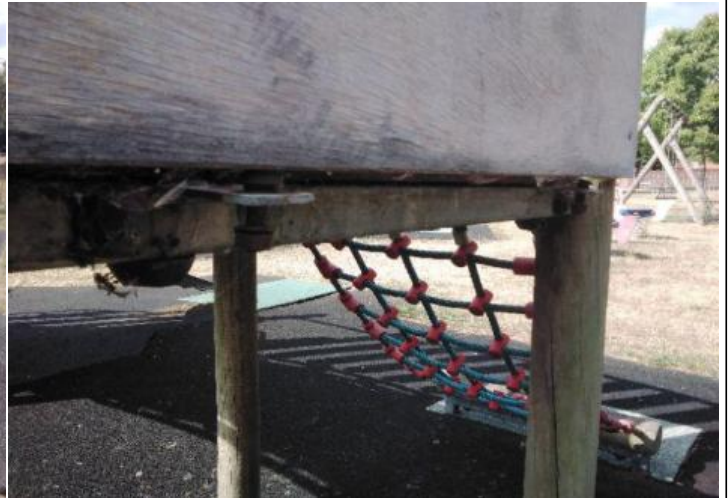
Finding: A barrier has been replaced and there protruding fixings beneath

Action: Remove the protruding fixings

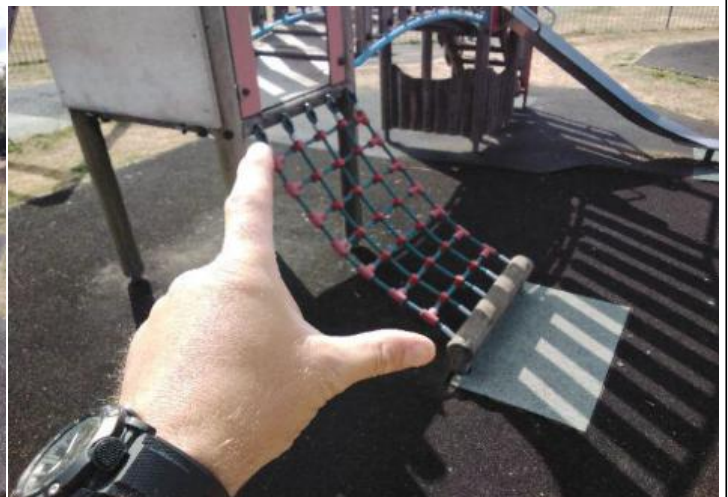
Finding: There are falls in excess of 600mm between adjacent components on the structure, in contravention of the recommendations set out in BS EN 1176 Part 1; 4.2.8.4

Action: Monitor - No remedial work recommended

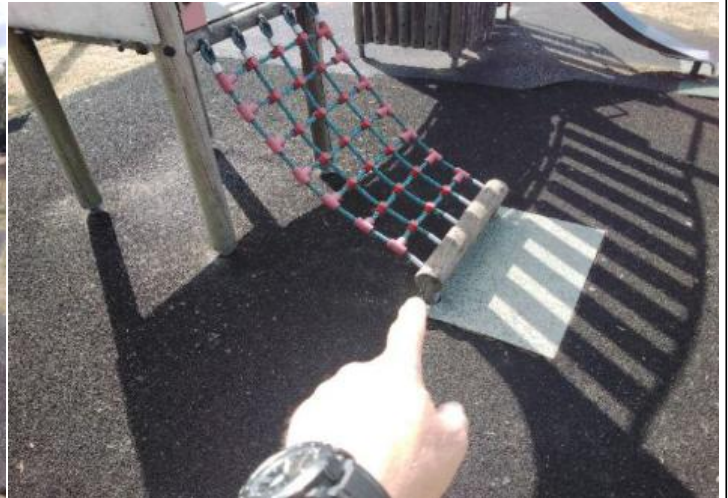
Finding: A number of fixing(s) have worked loose

Action: Secure all loose fixings

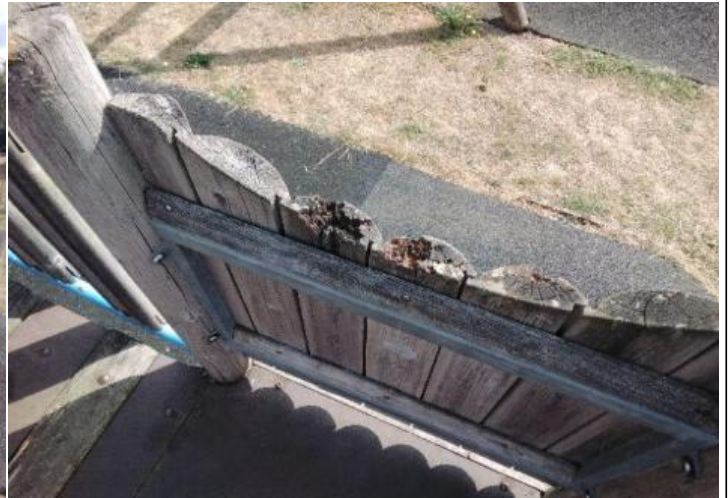
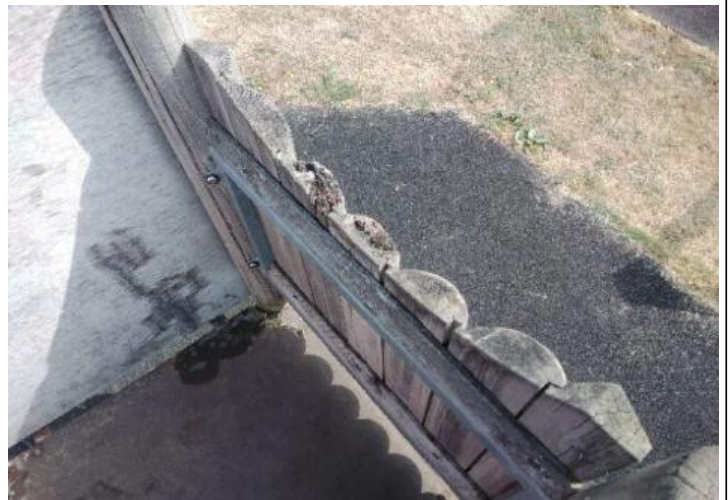
Finding: There is some evidence of rot in the timber

Action: Monitor for any further deterioration and replace as required

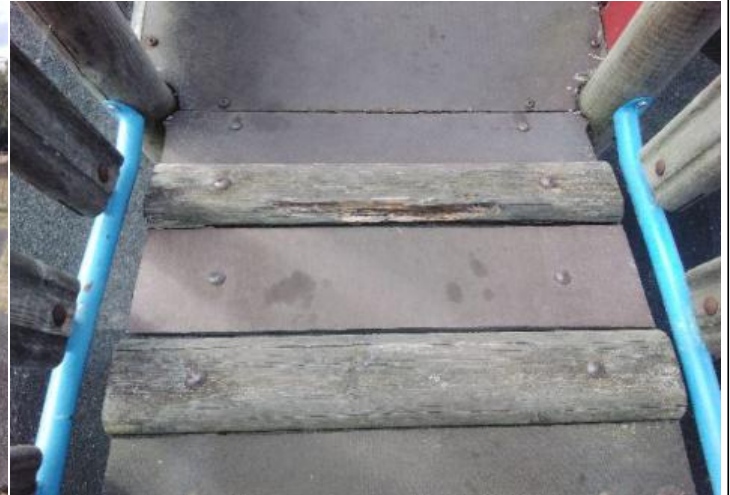
Finding: There are areas or parts of the timber on the structure that have rotted

Action: Replace all affected timbers

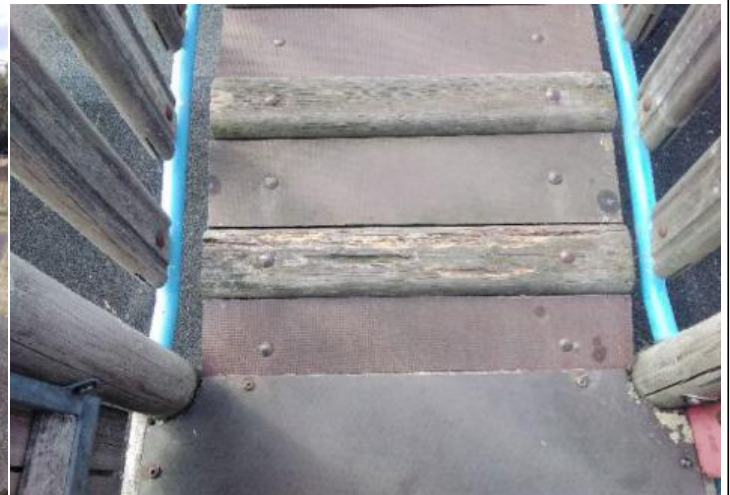
Finding: There is some evidence of rot in the timber

Action: Monitor for any further deterioration and replace as required

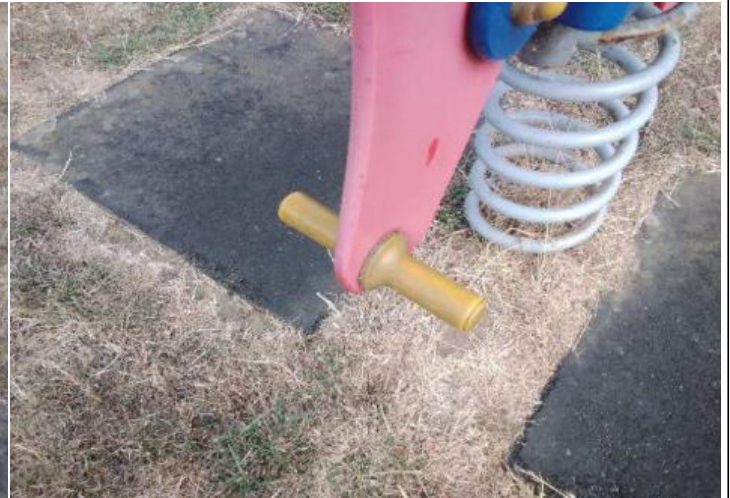
Finding: The end of handgrips and/or footrests have a cross section of less than 15cm² and fail to meet the requirements of BS EN 1176 Part 6
Action: Monitor - No remedial work recommended

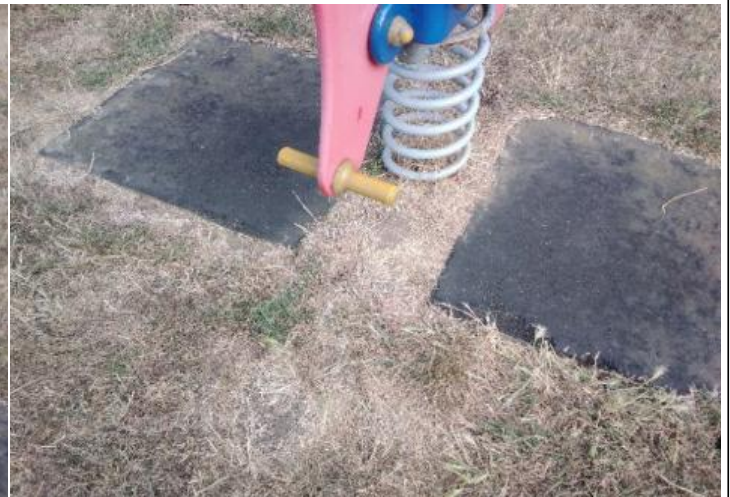
Finding: There is some minor damage to the surface

Action: Monitor for any further deterioration and repair as required

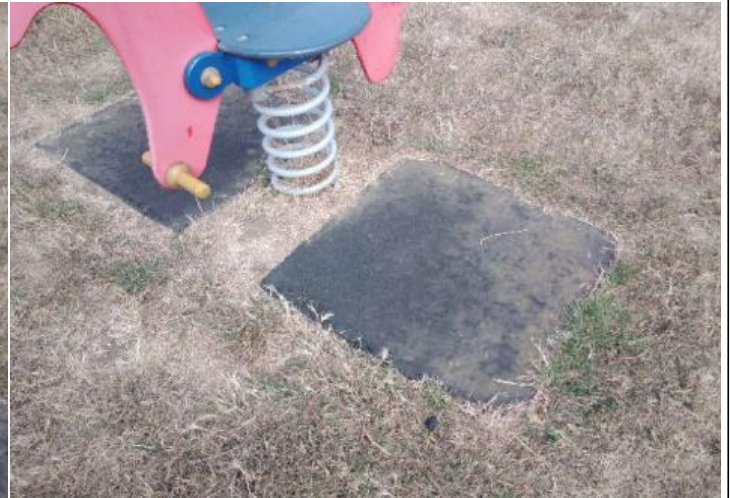
Finding: There is algae, silt or moss growth on the surface resulting in slippery conditions

Action: Clean and treat appropriately

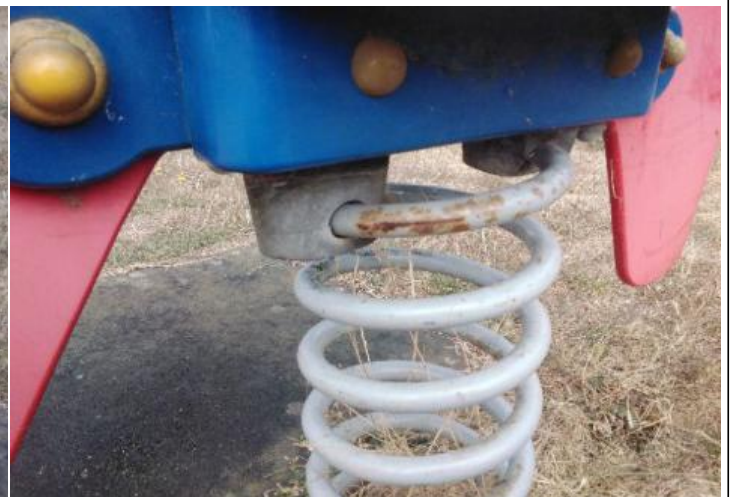
Finding: The paintwork on this item has been damaged or worn exposing the metal underneath which is rusting

Action: Treat any rusting components and repaint

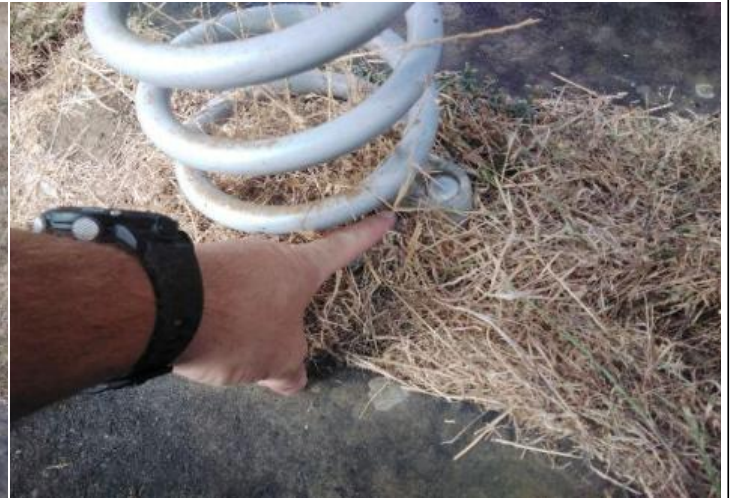
Finding: The U bolts clamping the spring are worn

Action: Monitor for any further deterioration and replace as required

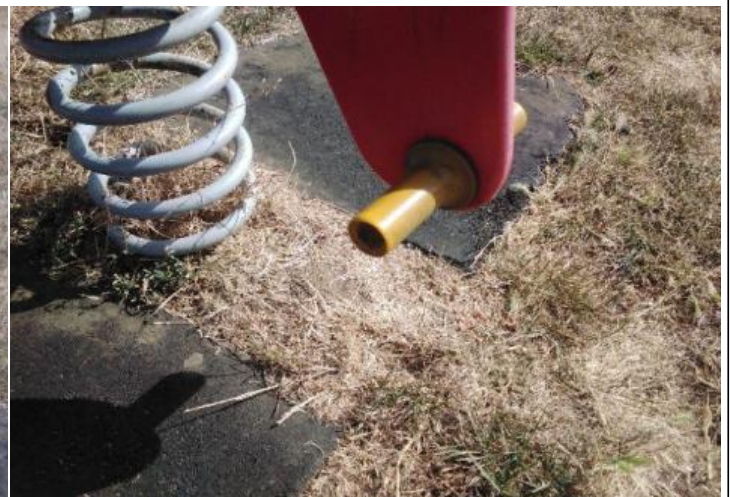
Finding: There is/are bolt cap covers missing or damaged on the item

Action: Replace missing or damaged bolt cap covers

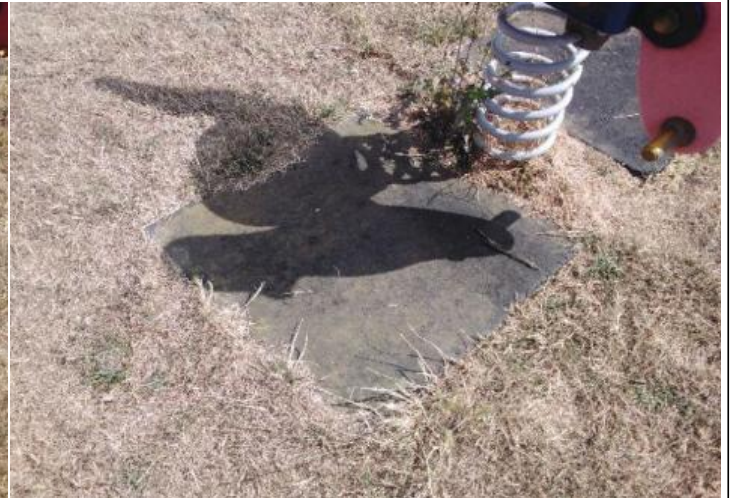
Finding: There is algae, silt or moss growth on the surface resulting in slippery conditions

Action: Clean and treat appropriately

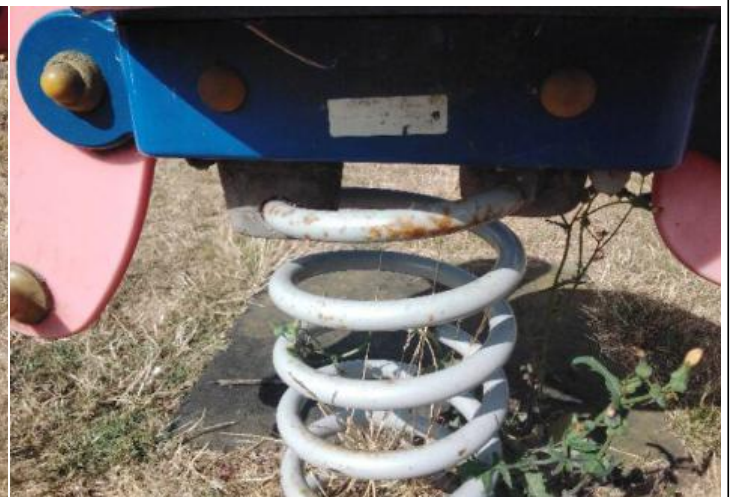
Finding: The paintwork on this item has been damaged or worn exposing the metal underneath which is rusting

Action: Treat any rusting components and repaint

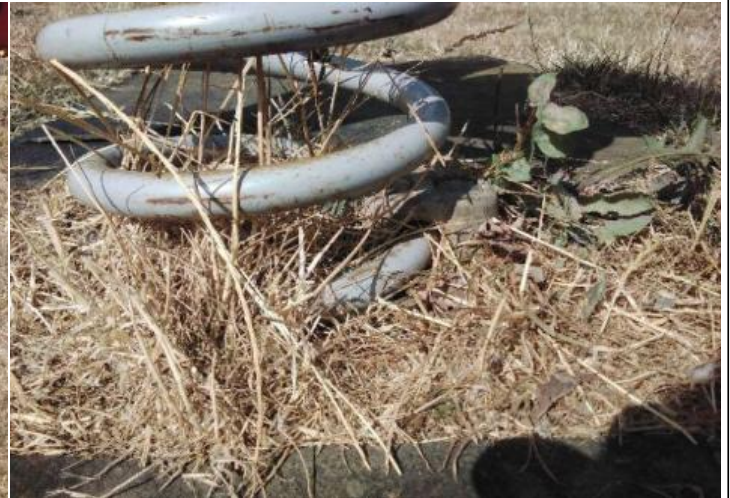
Finding: The U bolts clamping the spring are worn

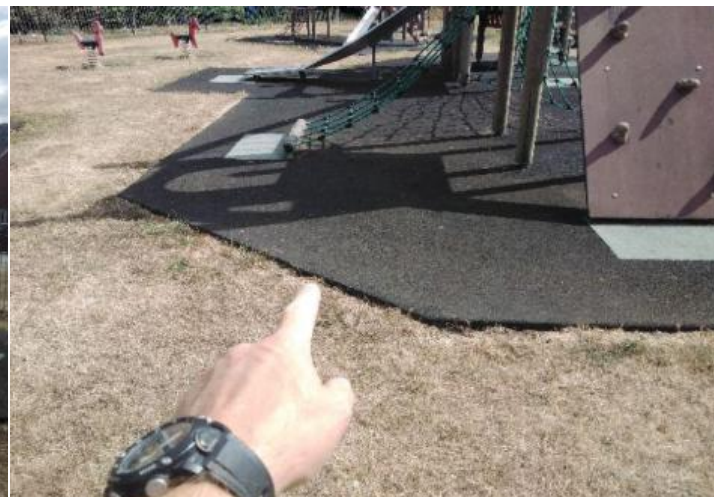
Finding: There are trip hazards at the edges of the surface

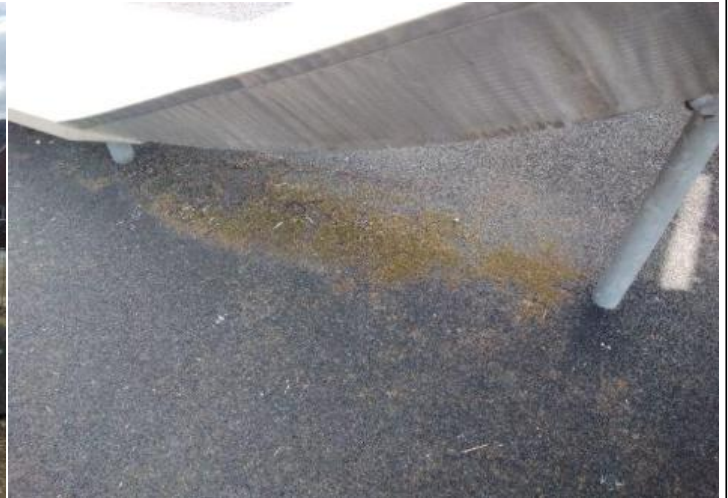
Finding: There is algae, silt or moss growth on the surface resulting in slippery conditions

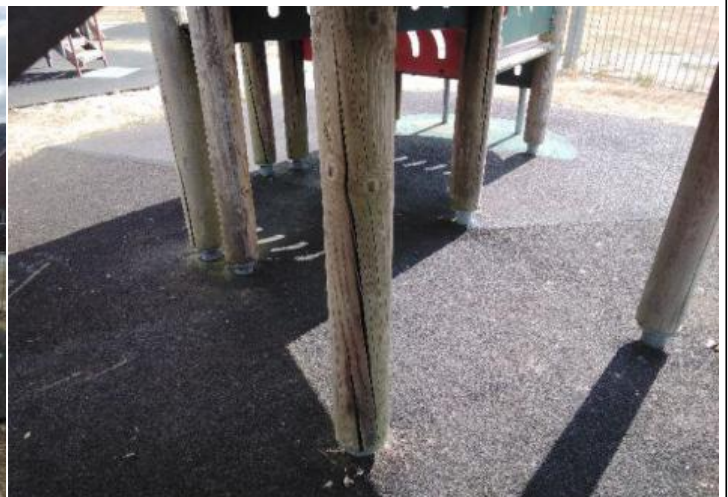
Finding: The timber has a number of splits/shakes or air cracks and this may affect the stability or allow water ingress which will accelerate the rotting process

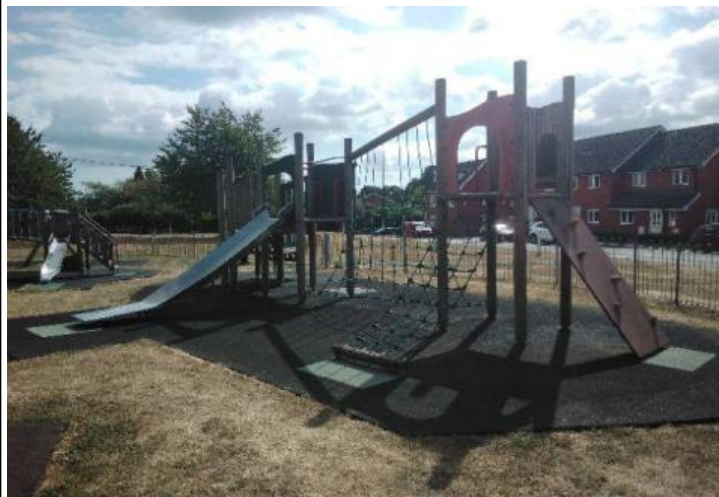
Finding: The ropes/nets are worn/damaged in places

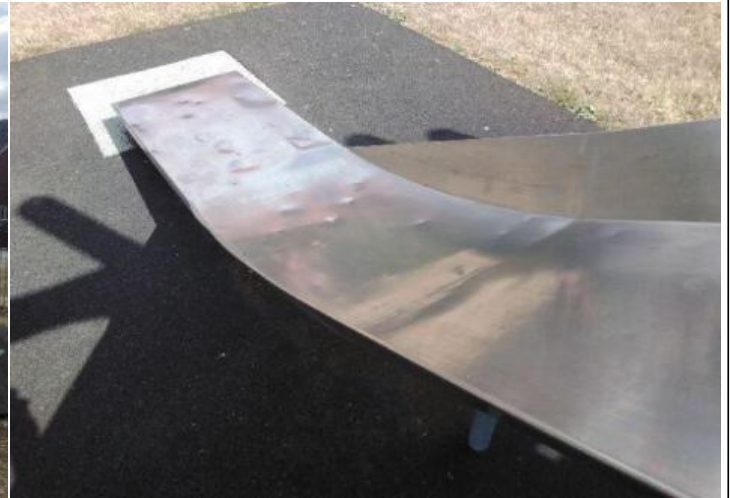
Finding: There are a number of dents in the slide surface

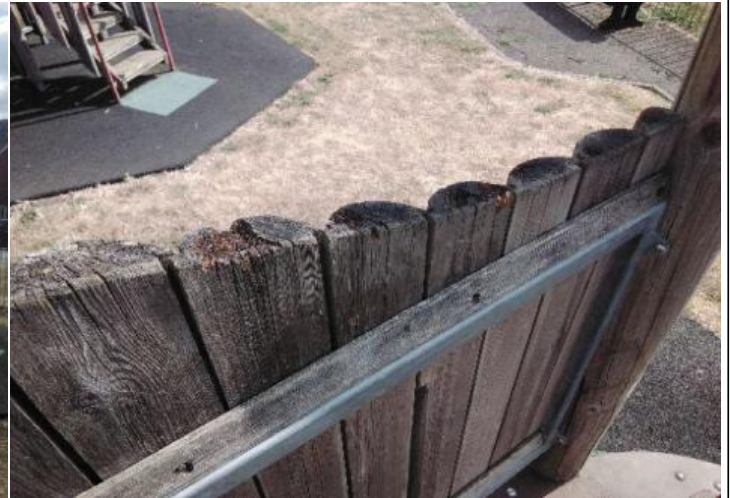
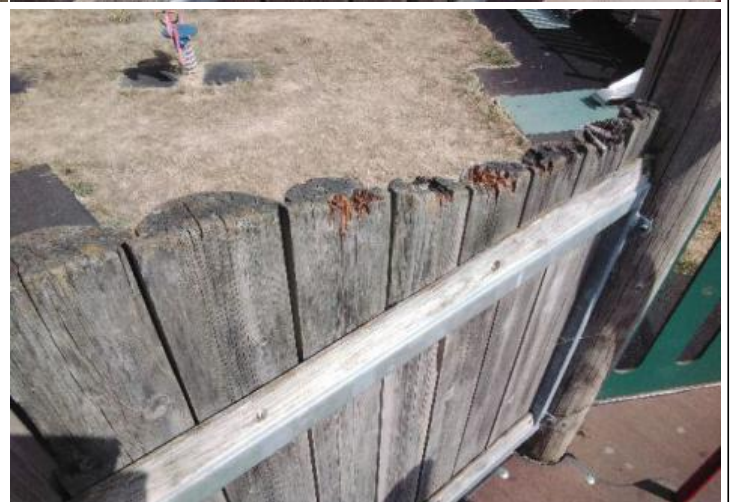
Finding: There is some evidence of rot in the timber

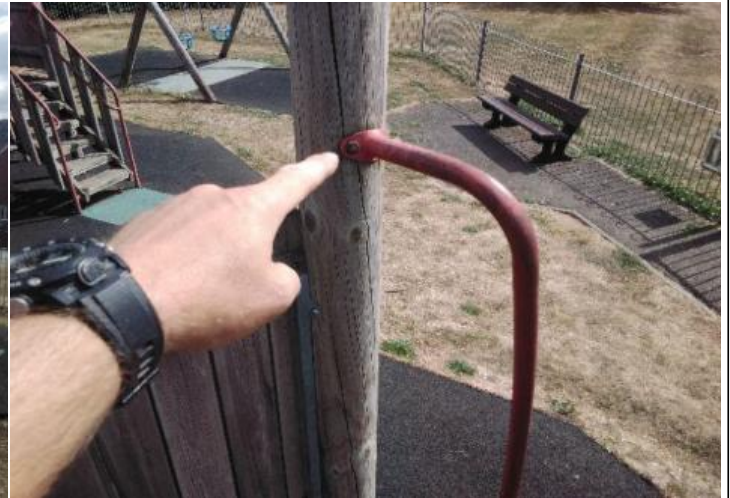
Finding: A number of fixing(s) have worked loose

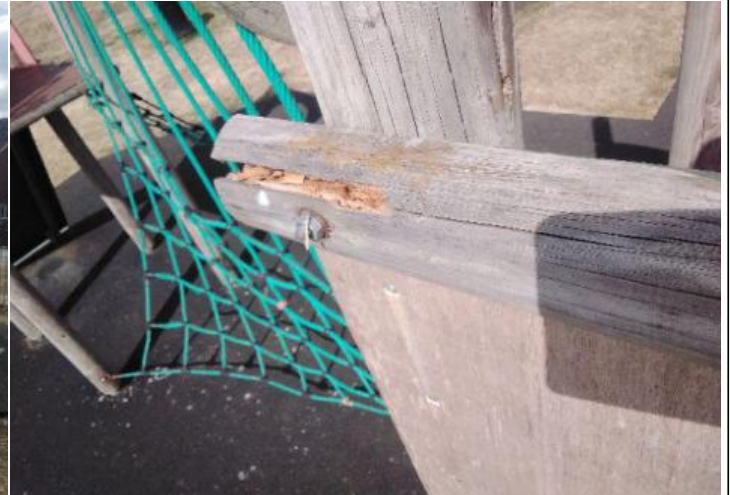
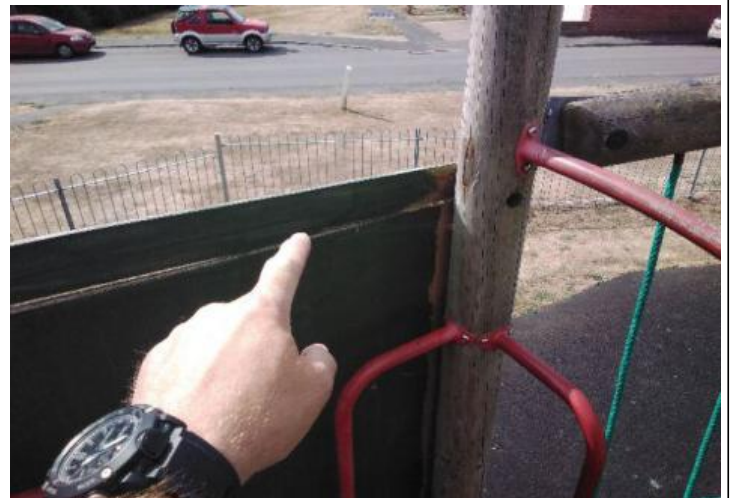
Finding: There are areas or parts of the timber on the structure that have rotted

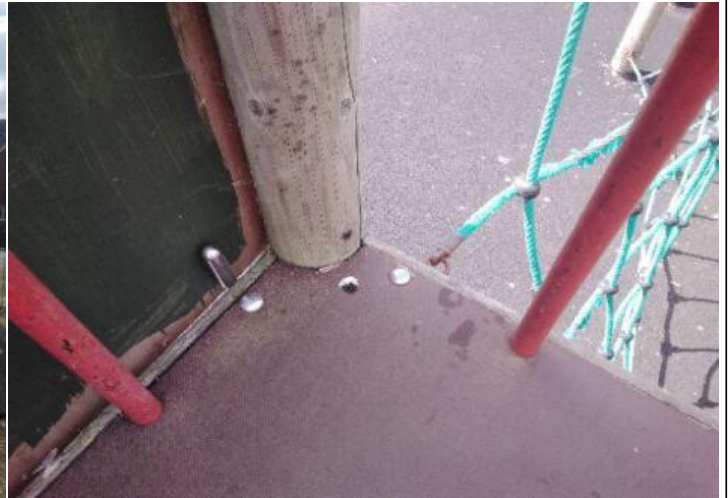
Finding: There is/are finger entrapment/s in the platform and the item fails to meet the requirements of BS EN 1176 Part 1 4.2.7.6 Entrapment of fingers

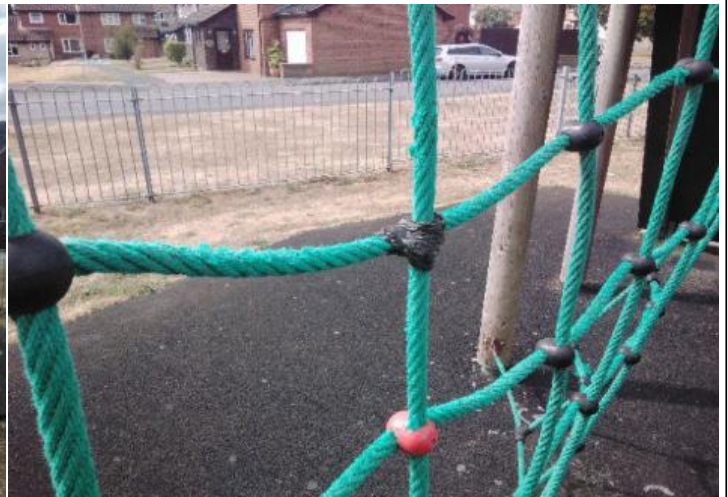
Finding: The item has missing component(s)

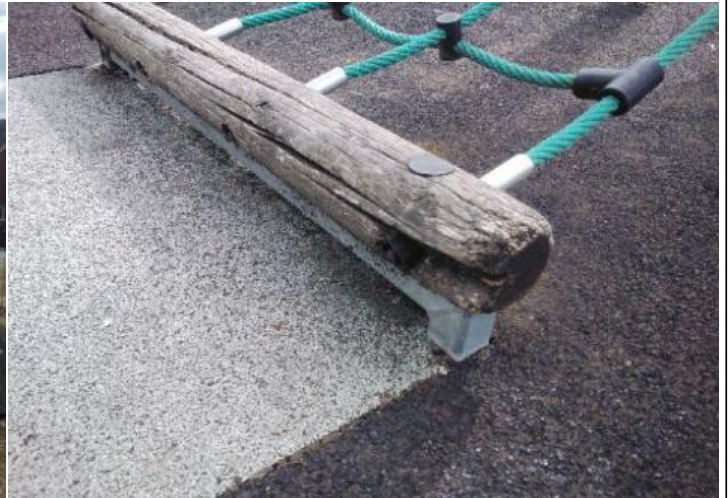
Finding: There is some damage to the item

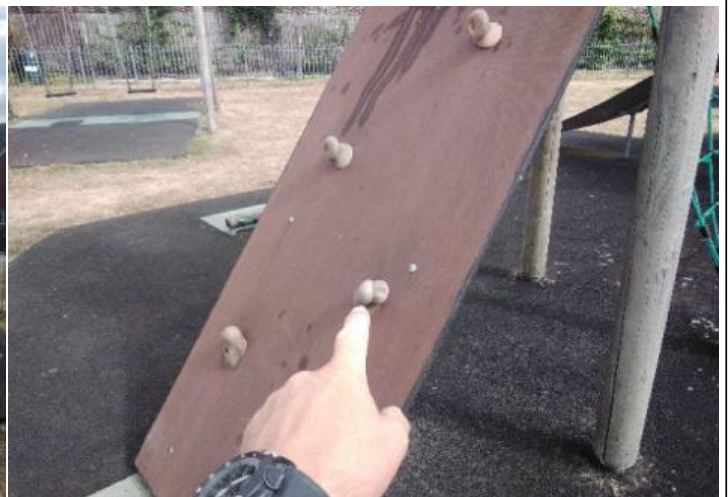
Finding: A number of fixing(s) have worked loose

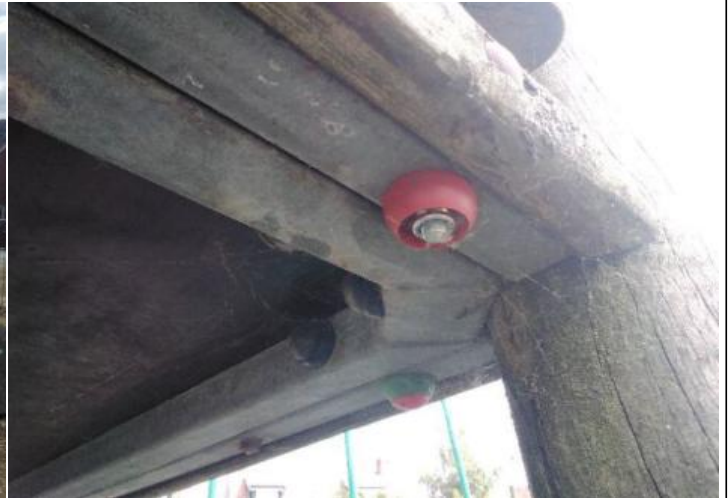
Finding: There is/are bolt cap covers missing or damaged on the item

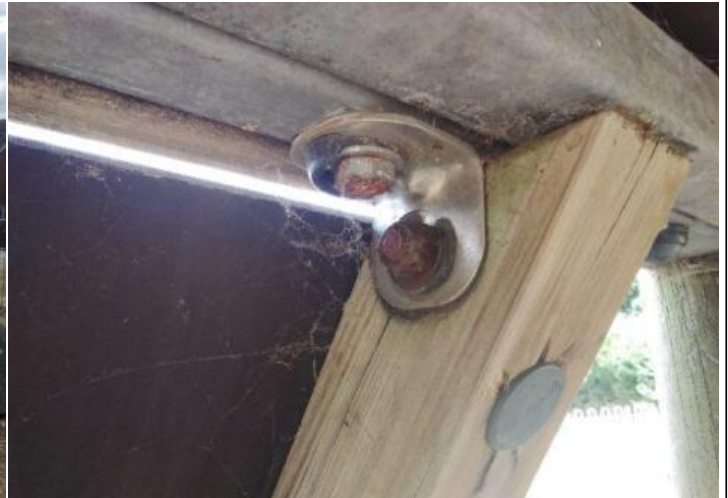
Finding: The fixings have corroded excessively

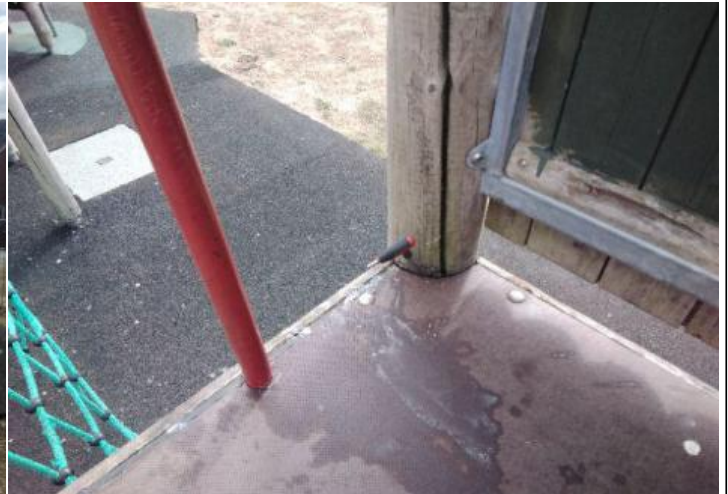
Finding: There is some evidence of rot in the timber

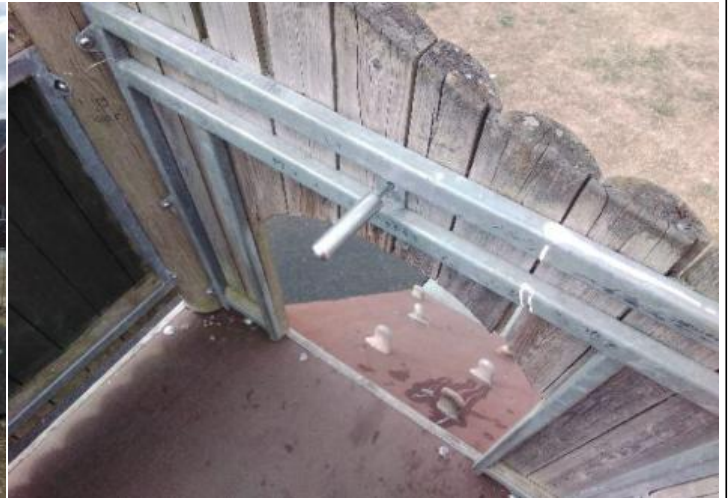
Finding: There is/are finger entrapment/s in the barrier and the item fails to meet the requirements of BS EN 1176 Part 1 4.2.7.6 Entrapment of fingers
Action: Remove the entrapment

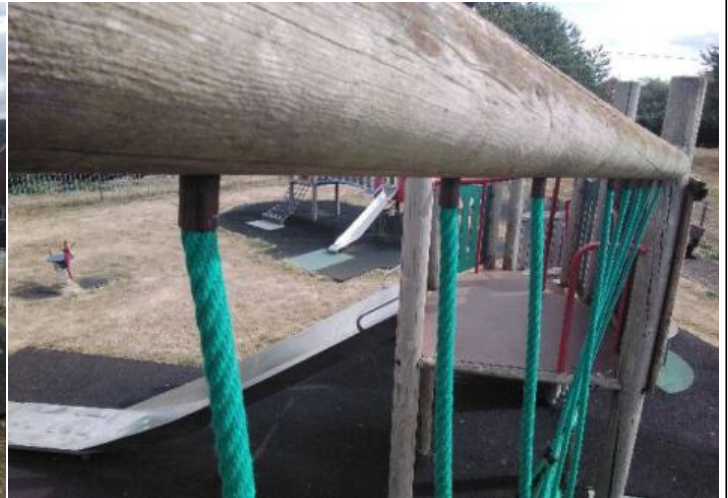
Finding: The net connections are corroding

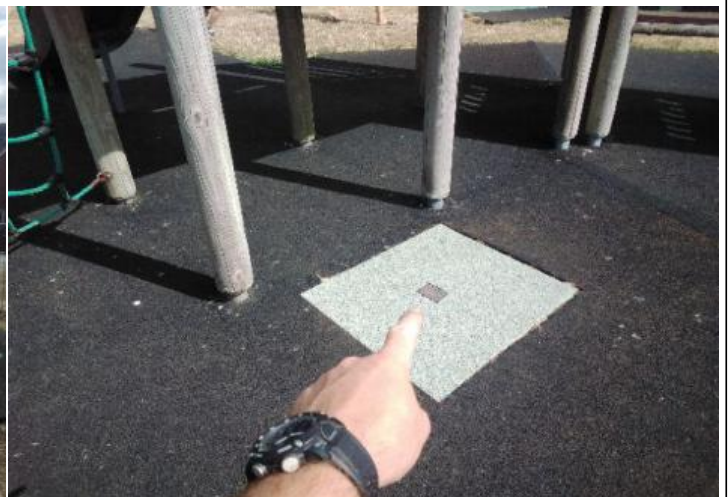
Finding: The wet pour has been repaired with bitmac which forms a hard object within the impact area

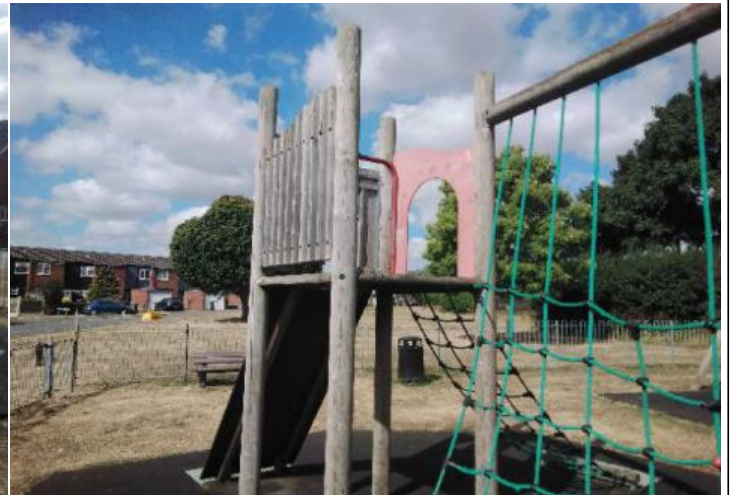
Finding: The tower is becoming unstable

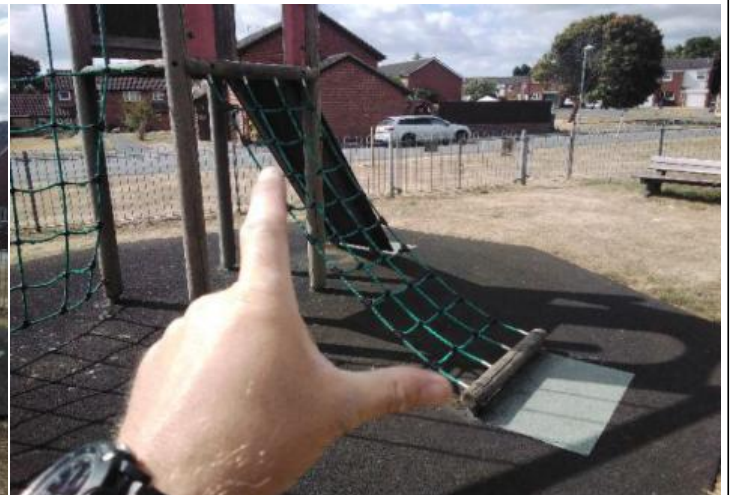
Finding: There are falls in excess of 600mm between adjacent components on the structure, in contravention of the recommendations set out in BS EN 1176 Part 1; 4.2.8.4
