Annual Inspection

Melton Parish Council

Beresford Drive Play Area

Beresford Drive, Woodbridge, Suffolk, IP12 1JJ

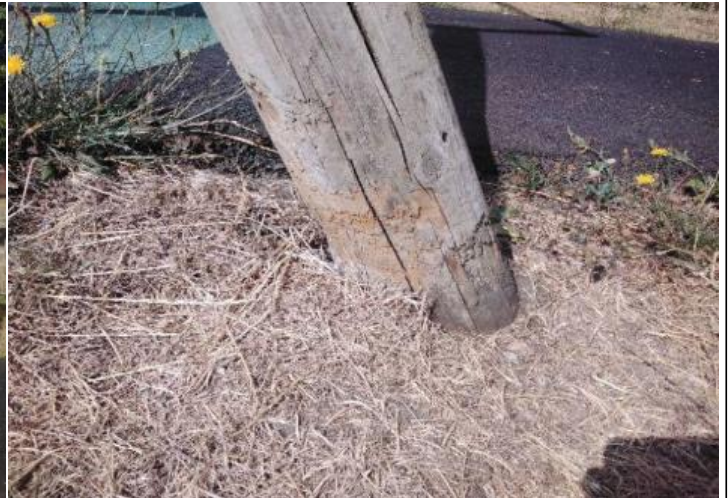
Finding: There is some strimmer / machinery damage apparent on the posts, this can penetrate the preservative applied to the timber and accelerate the rotting process

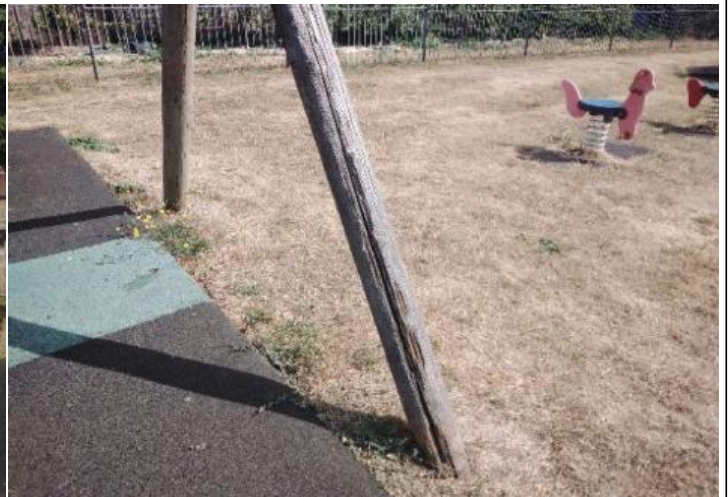
Finding: The timber has a number of splits/shakes or air cracks and this may affect the stability or allow water ingress which will accelerate the rotting process

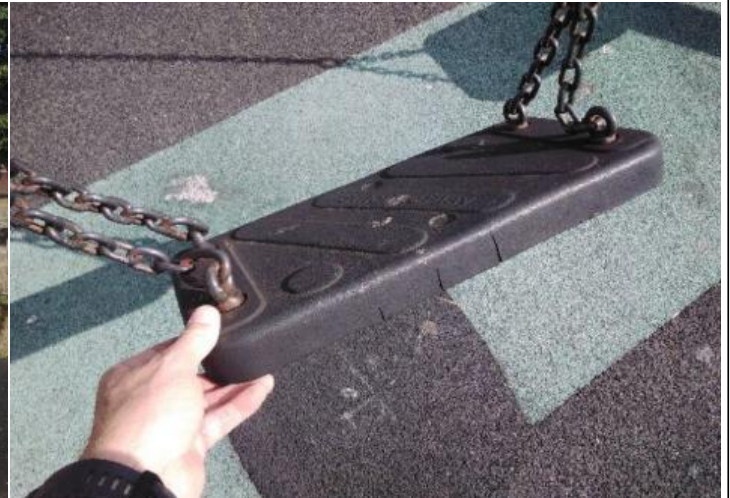
Finding: The seat has minor damage or wear

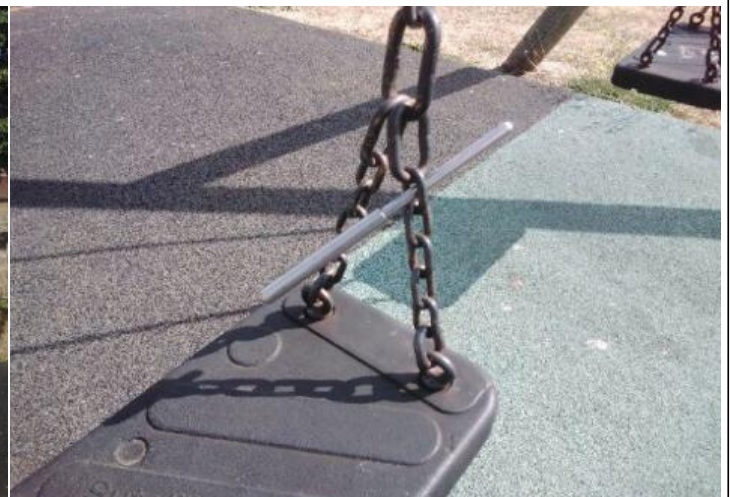
Finding: The chain openings are in excess of the 8.6mm as recommended by BS EN 1176

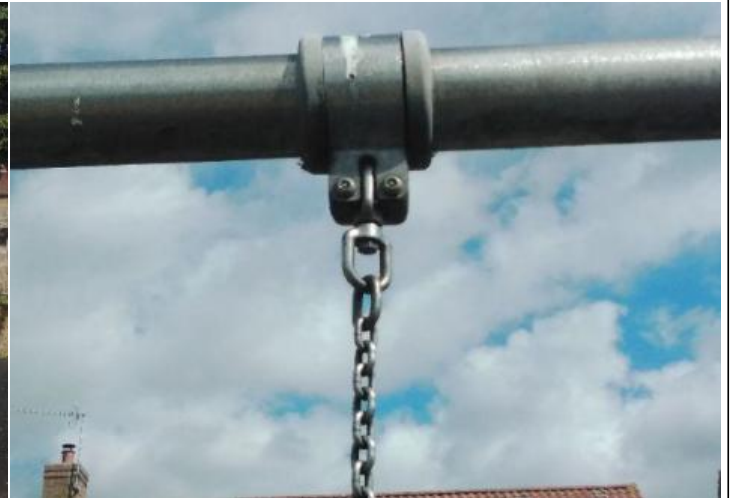
Finding: The swivel joint is becoming worn

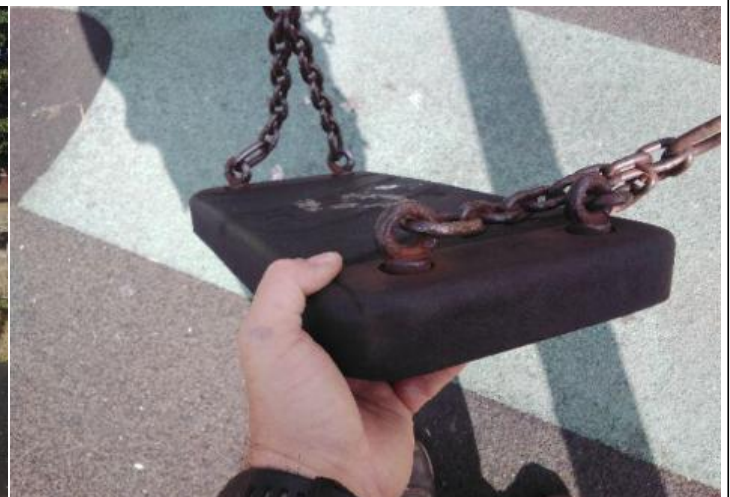
Finding: The swing seat connectors have some wear present

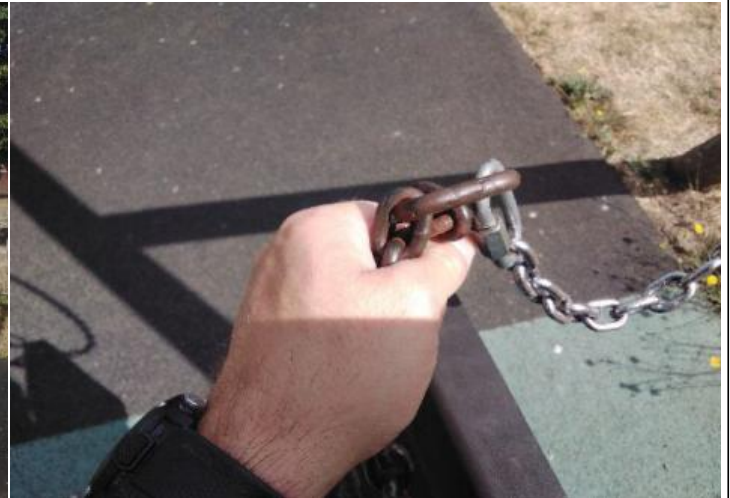
Finding: There is some notable evidence of chain wear

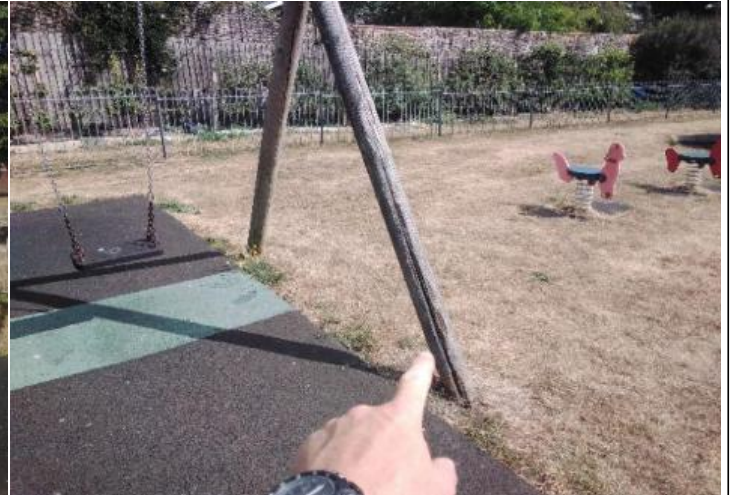
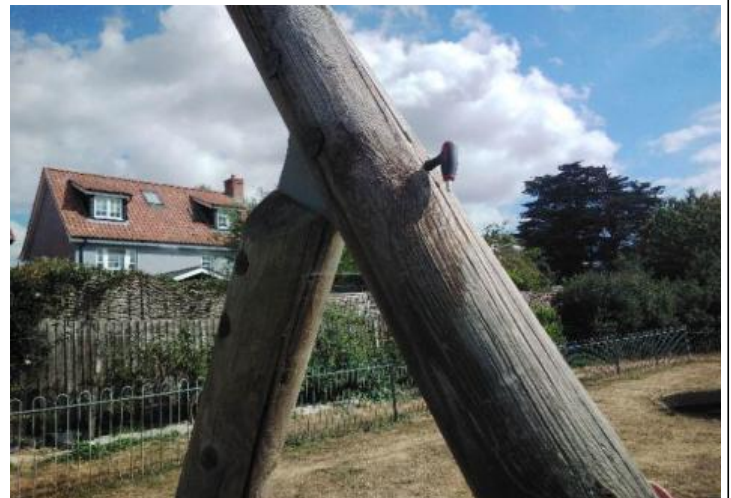
Finding: There are areas or parts of the timber on the structure that have rotted

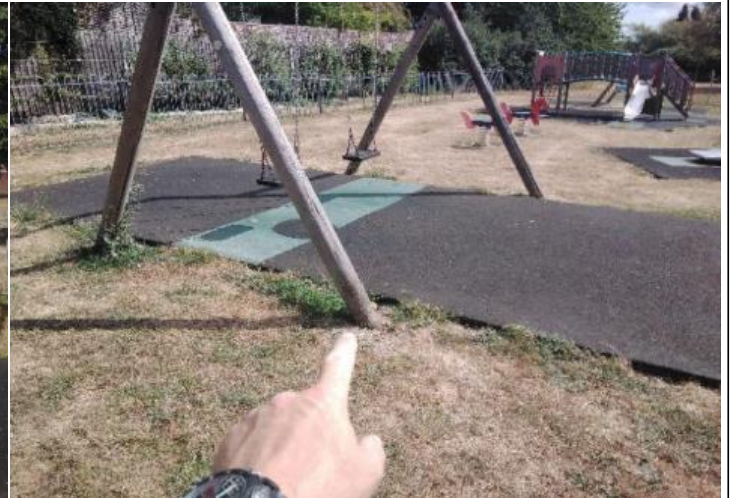
Finding: There are areas or parts of the timber on the structure that have rotted
