the play inspection company

Annual Inspection

Melton Parish Council

Melton Road

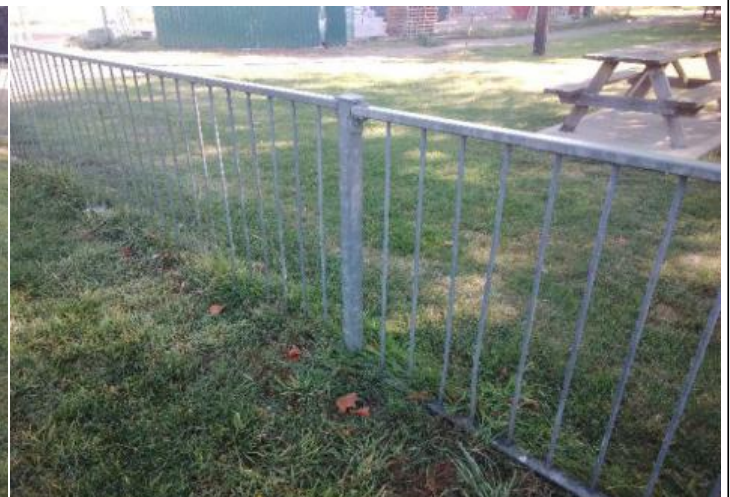
Finding: There are a number of loose posts around the fence

Action: Monitor for any further deterioration and reset as required

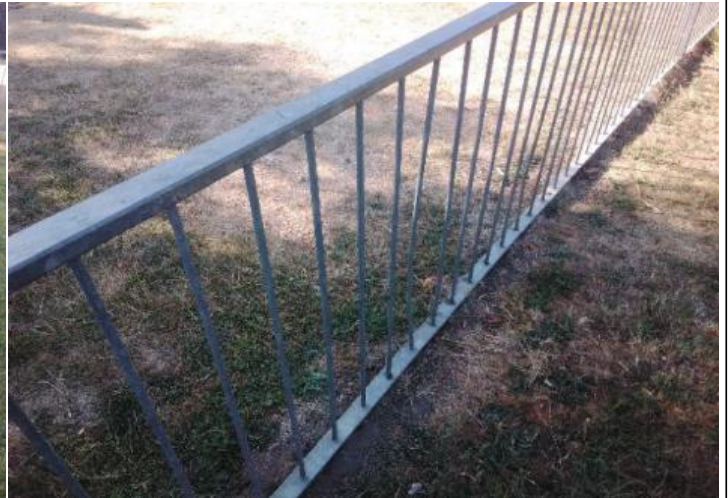
Finding: There is some damage to the fence sections

Action: Monitor for any further deterioration and repair as required

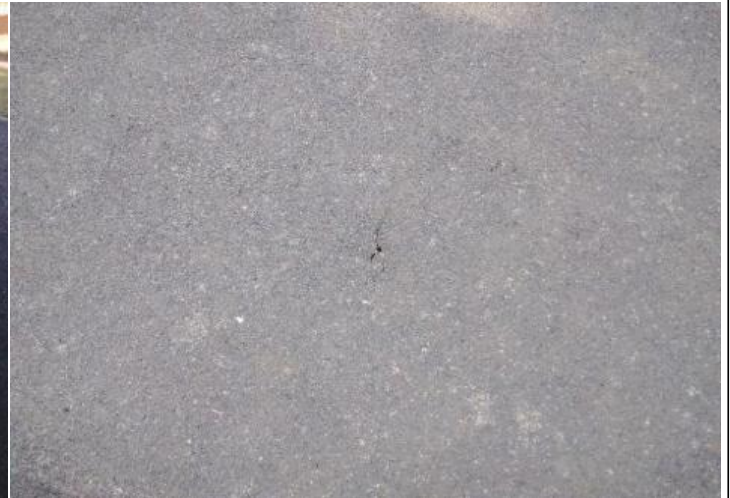
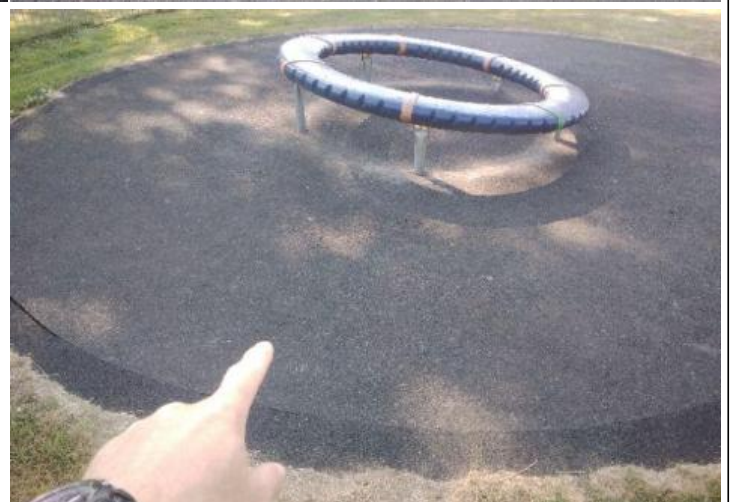
Finding: There is some minor damage to the surface

Action: Monitor for any further deterioration and repair as required

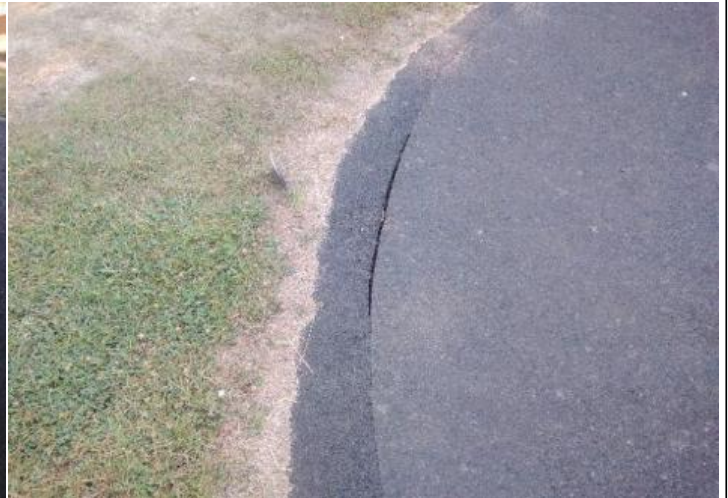
Finding: There are gaps opening between the surfacing and the edging surround or between the joints in the surfacing
Action: Monitor for any further deterioration and repair as required

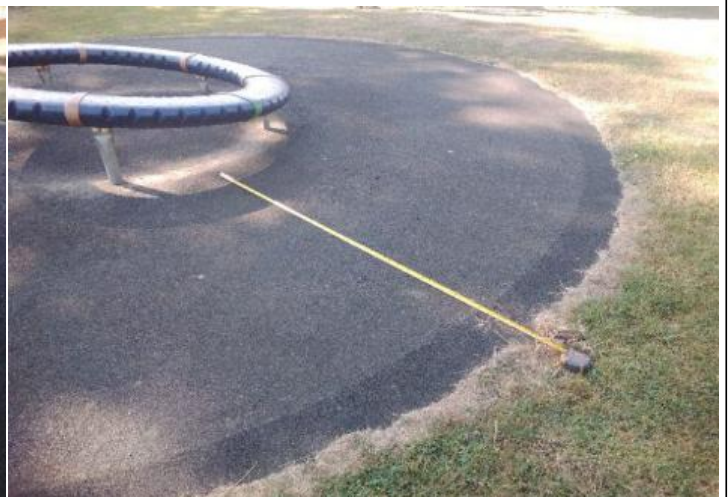
Finding: The surfacing dimensions are short and do not meet with the requirements of the current applicable standard

Action: Monitor - no remedial action recommended

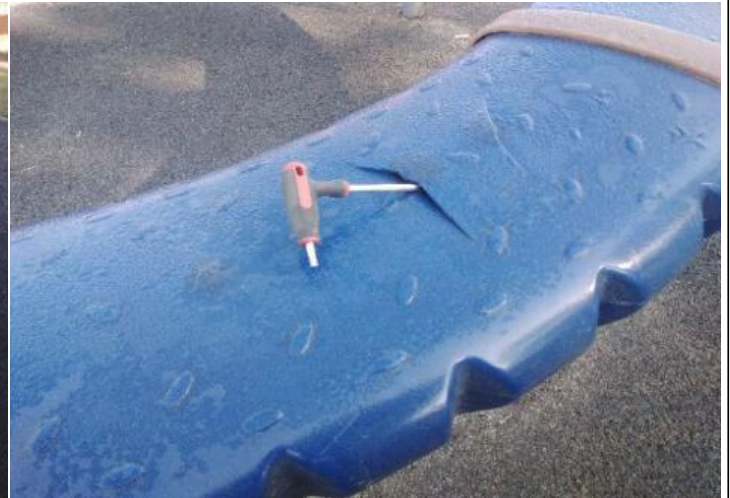
Finding: The ring is damaged

Action: Replace

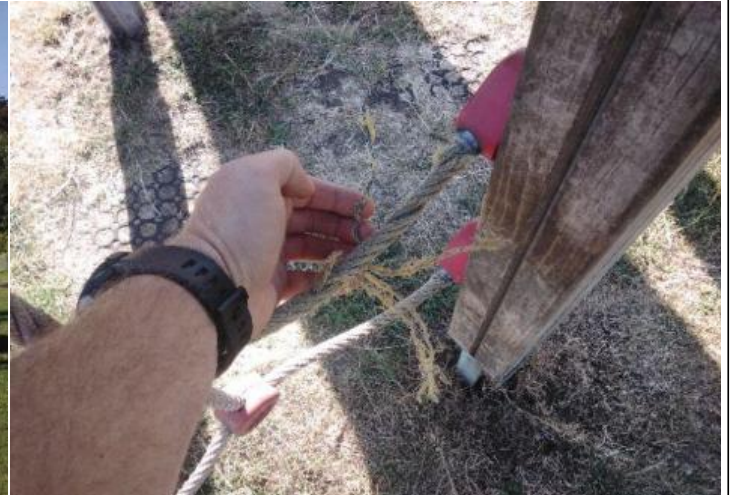
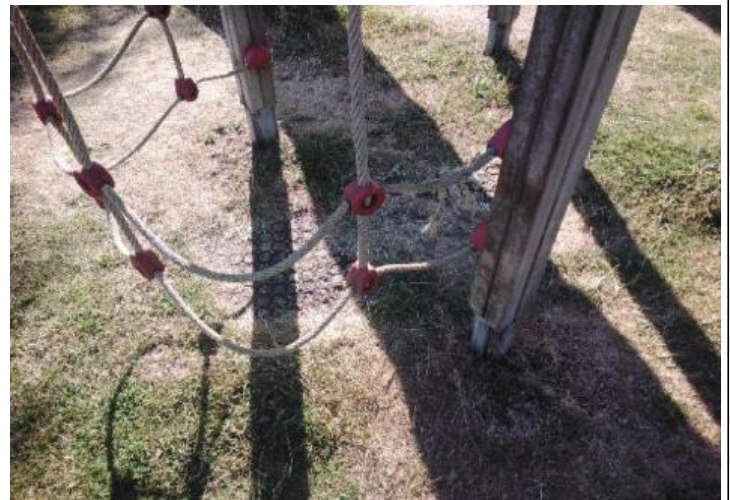
Finding: The rope has worn and there are sharp wire strands protruding

Action: Replace rope or net

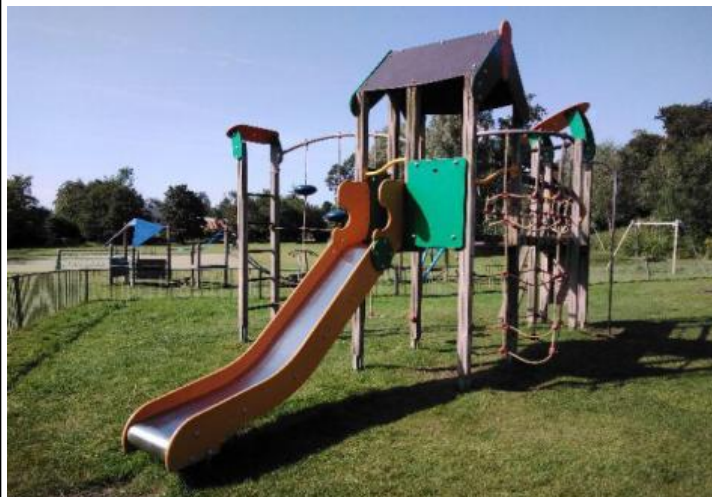
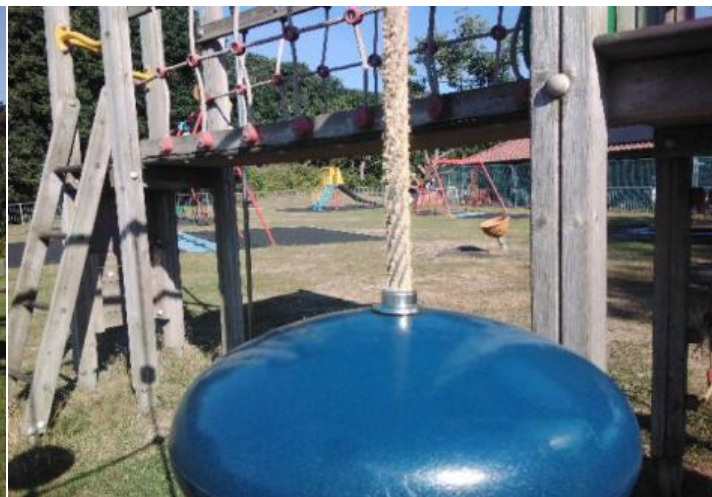
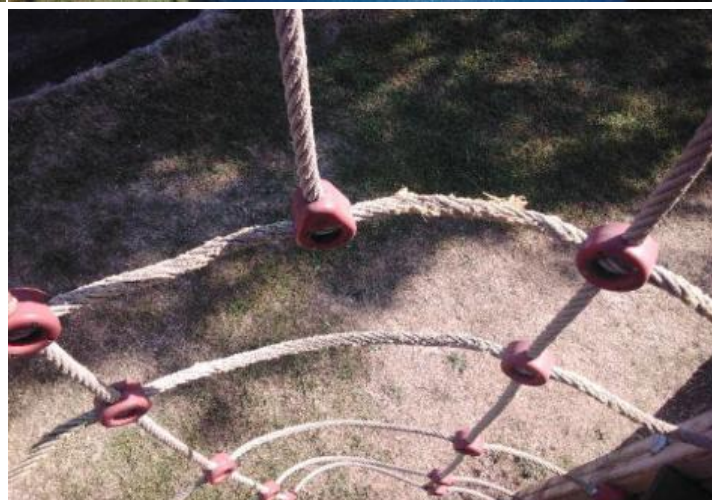
Finding: The ropes/nets are worn/damaged in places

Action: Monitor for any further deterioration and repair or replace as required

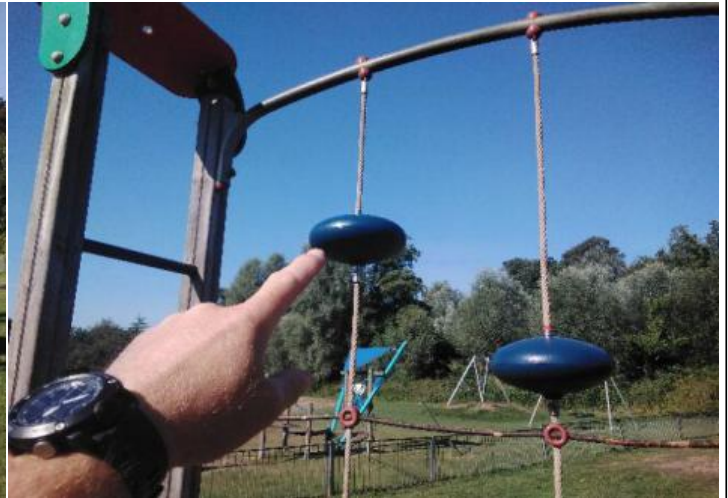
Finding: A number of fixing(s) have worked loose

Action: Secure all loose fixings

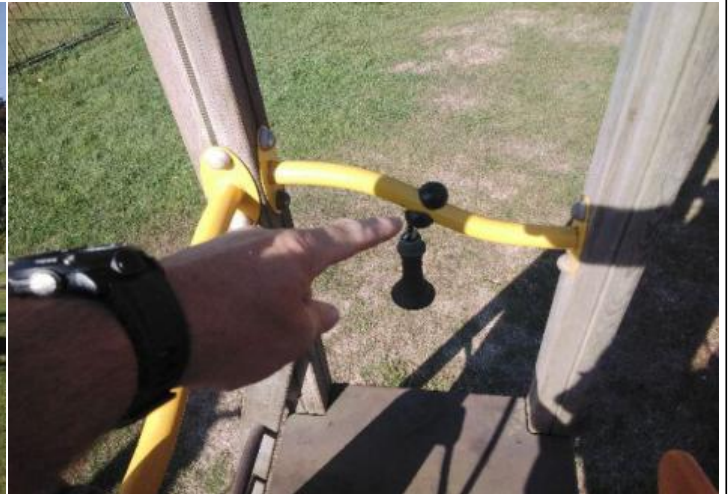
Finding: A number of fixing(s) have worked loose

Action: Secure all loose fixings

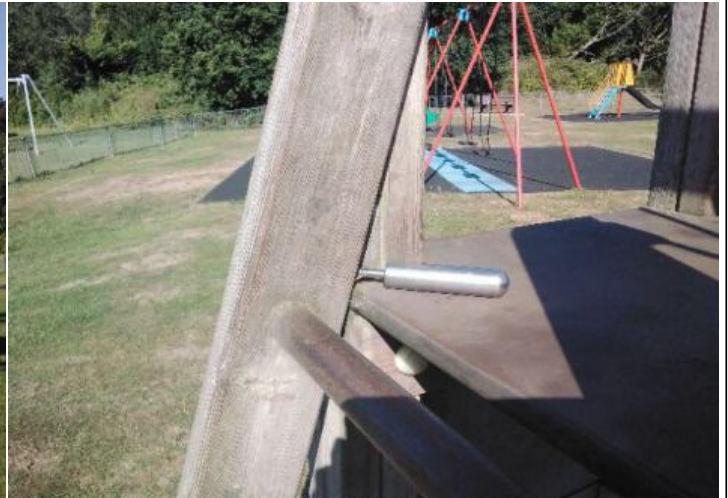
Finding: There is/are finger entrapment/s in the framework and the item fails to meet the requirements of BS EN 1176 Part 1 4.2.7.6 Entrapment of fingers

Action: Monitor - No remedial work recommended

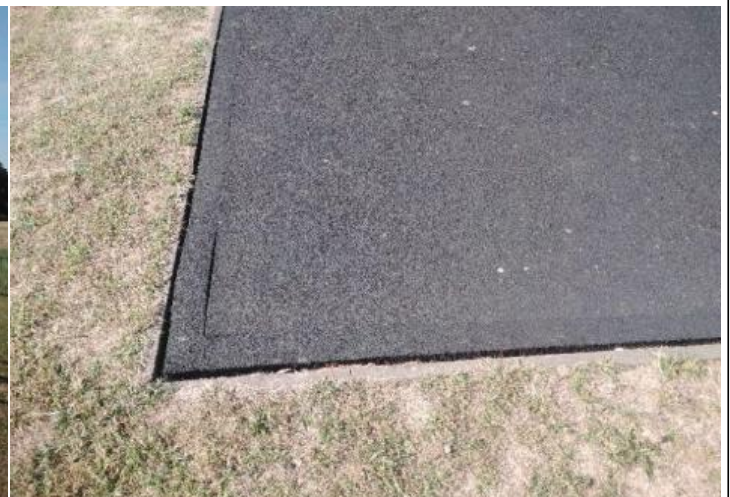
Finding: There are significant gaps (over 30mm) between the surface and the edging or between the joints in the surface; these are large enough for a small foot to enter. **Action:** Repair surfacing

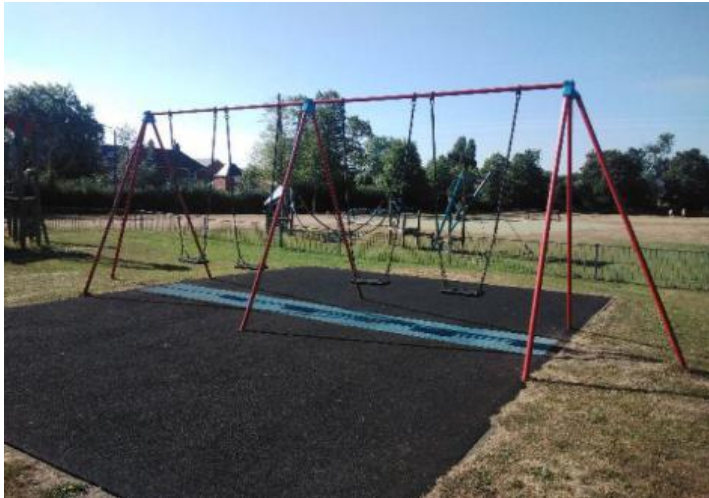
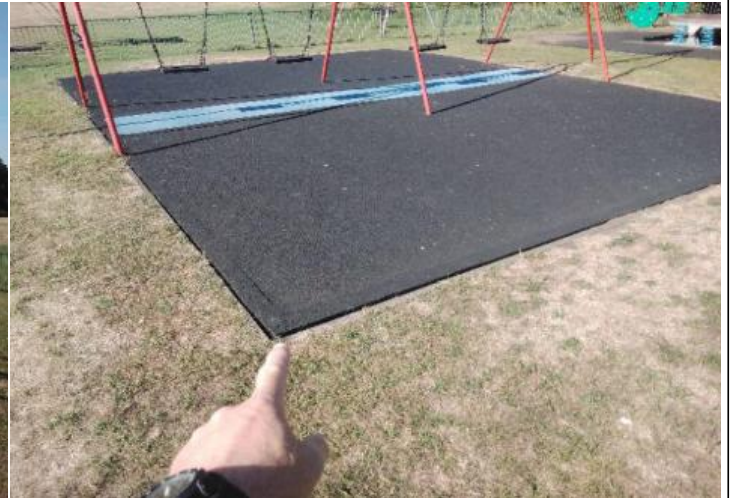
Finding: The surface is lifting at the edges and creating trip points

Action: Repair perimeter of surfacing to remove trip points

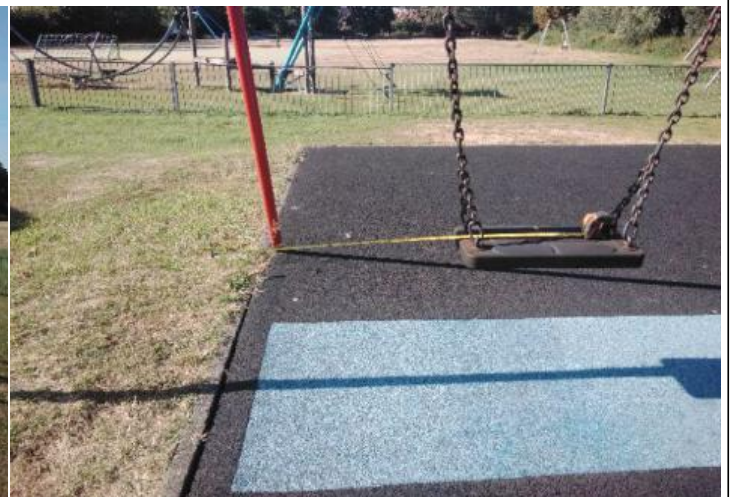
Finding: The seats are too close to the frame as defined in BS EN 1176 Part 2; this is a low risk failure and no remedial action is required

Action: Monitor - No remedial work recommended

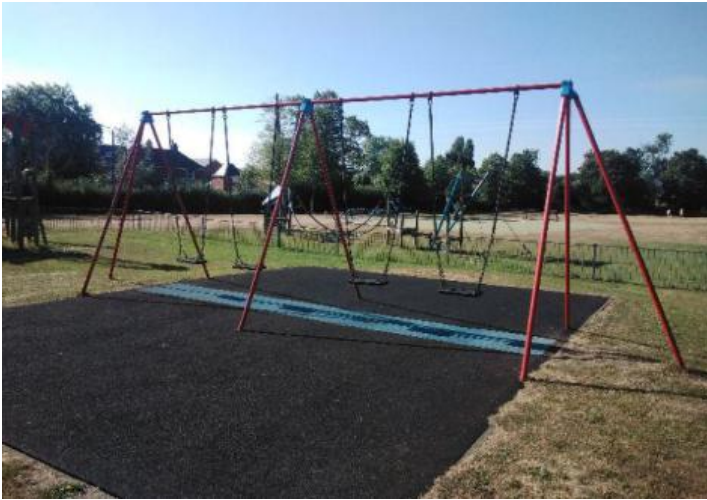
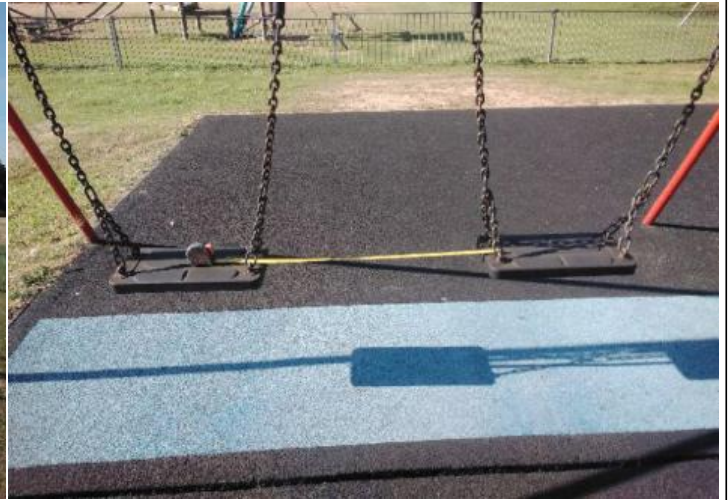
Finding: The seats are too close to each other as defined in BS EN 1176 Part 2; this is a low risk failure and no remedial action is required

Action: Monitor - No remedial work recommended

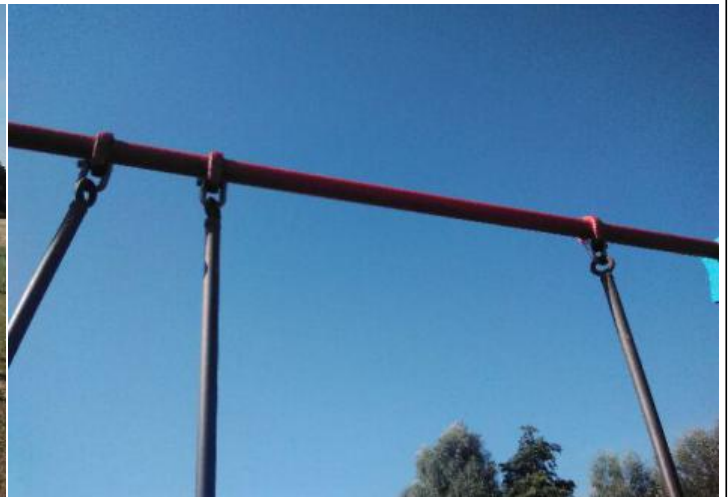
Finding: The bushes are showing signs of wear

Action: Monitor for any further deterioration and replace as required

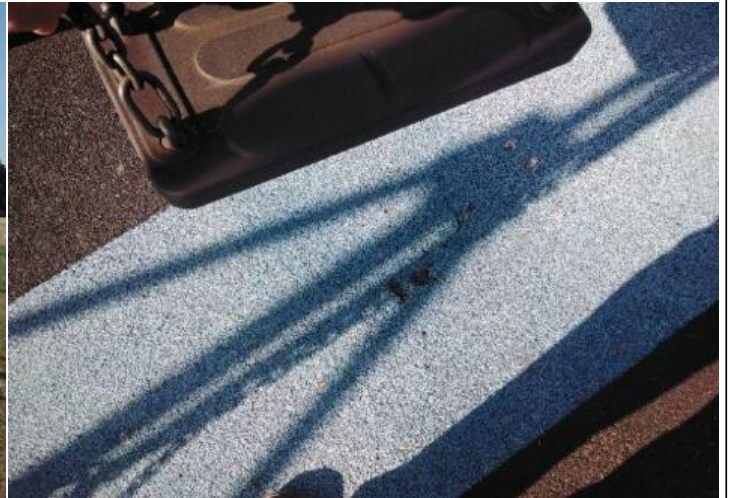
Finding: There is some minor damage to the surface

Action: Monitor for any further deterioration and repair as required

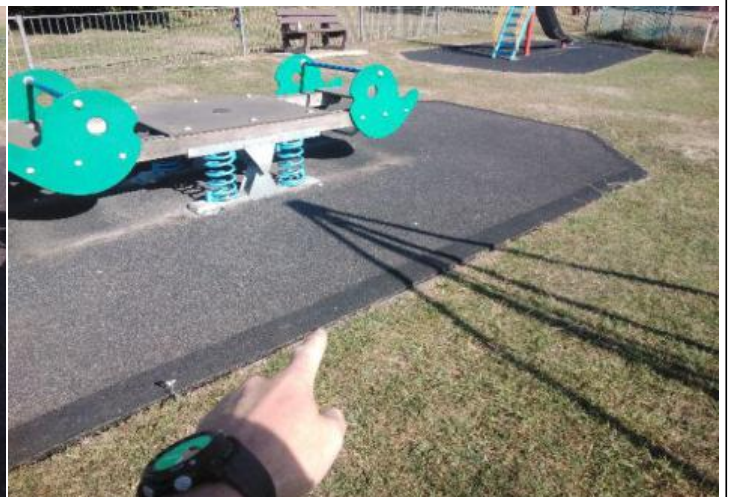
Finding: The surface is lifting at the edges and creating trip points

Action: Repair perimeter of surfacing to remove trip points

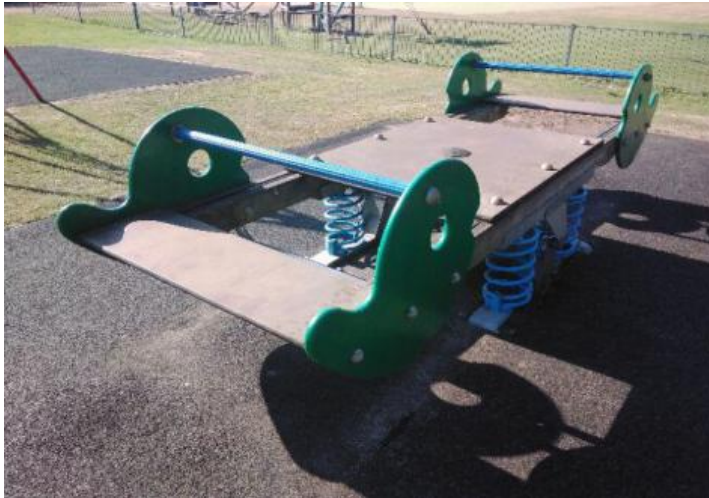
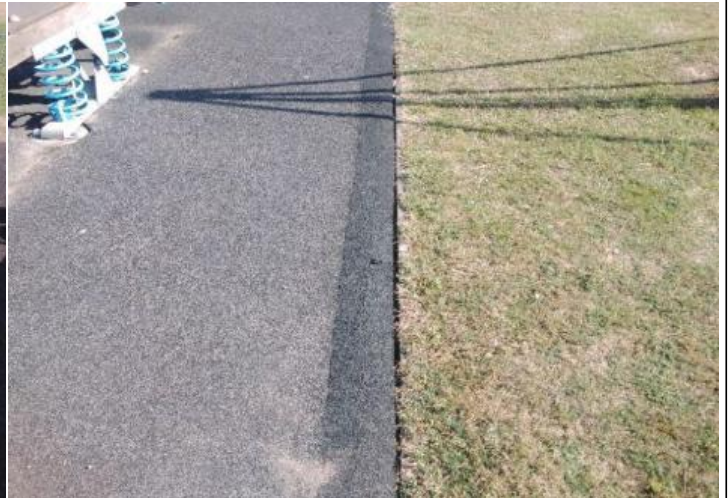
Finding: There are gaps opening between the surfacing and the edging surround or between the joints in the surfacing
Action: Monitor for any further deterioration and repair as required

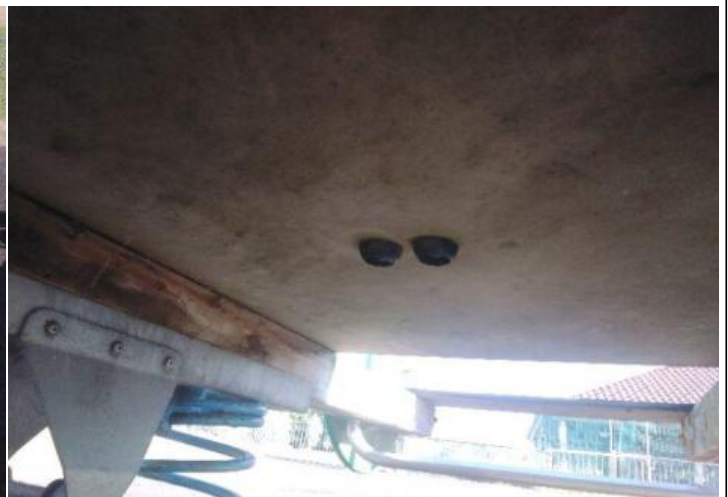
Finding: There is/are bolt cap covers missing or damaged on the item
Action: Replace missing or damaged bolt cap covers

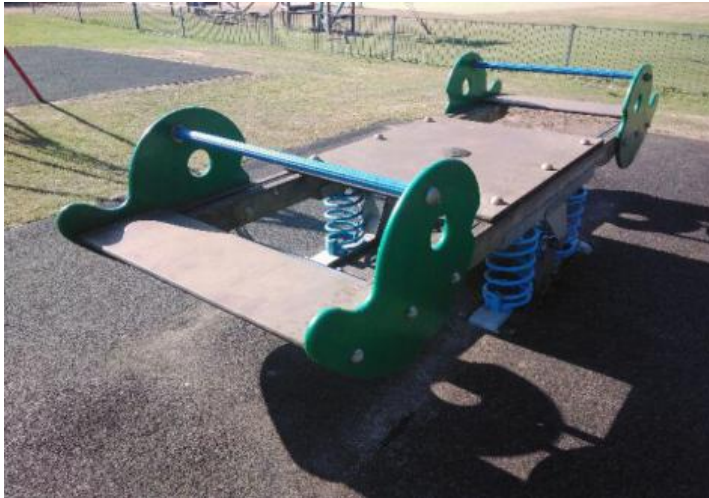
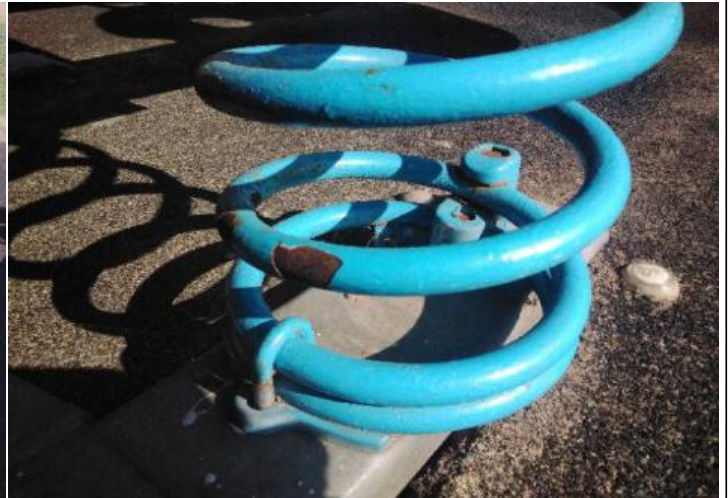
Finding: The paintwork on this item has been damaged or worn exposing the metal underneath which is rusting

Action: Treat any rusting components and repaint

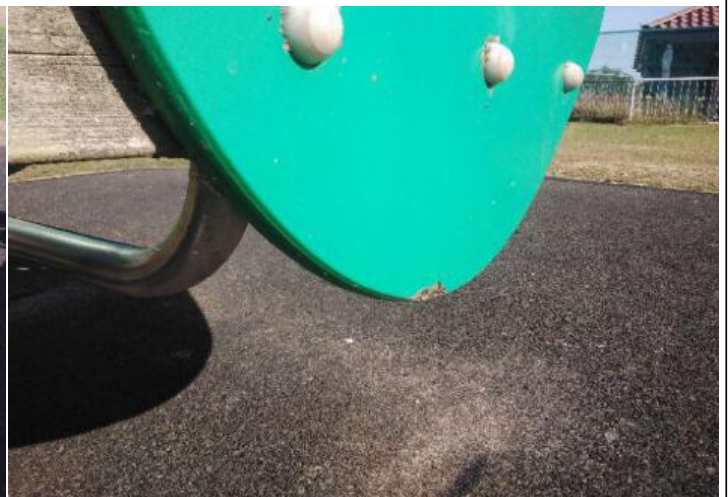
Finding: There is some damage to the item

Action: Monitor for any further deterioration and repair as required

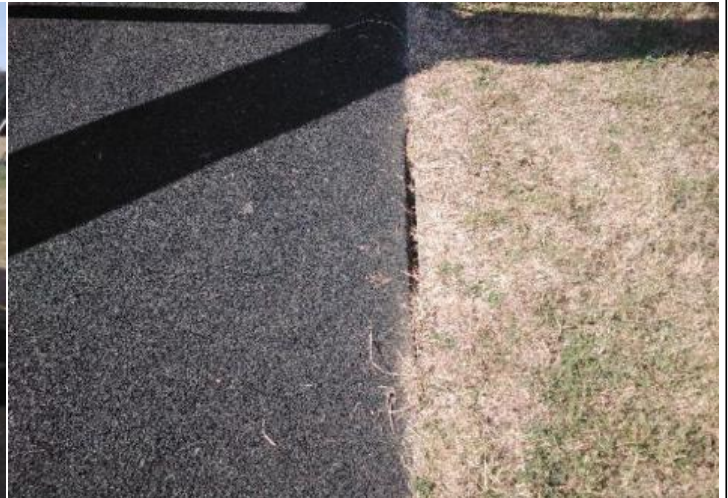
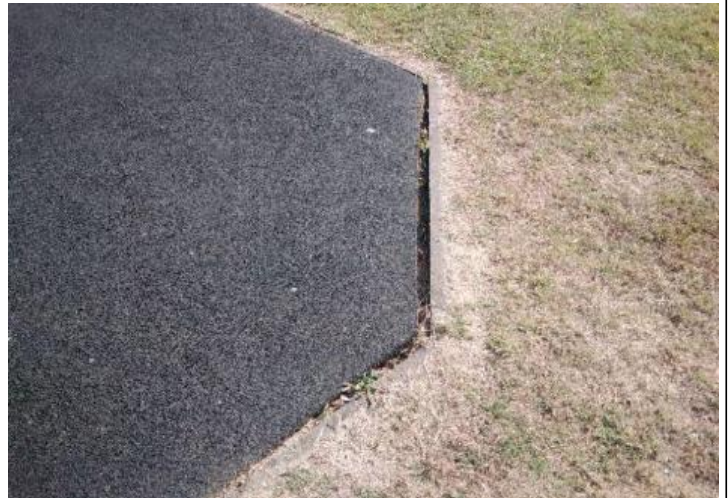
Finding: There are significant gaps (over 30mm) between the surface and the edging or between the joints in the surface; these are large enough for a small foot to enter

Action: Repair surfacing

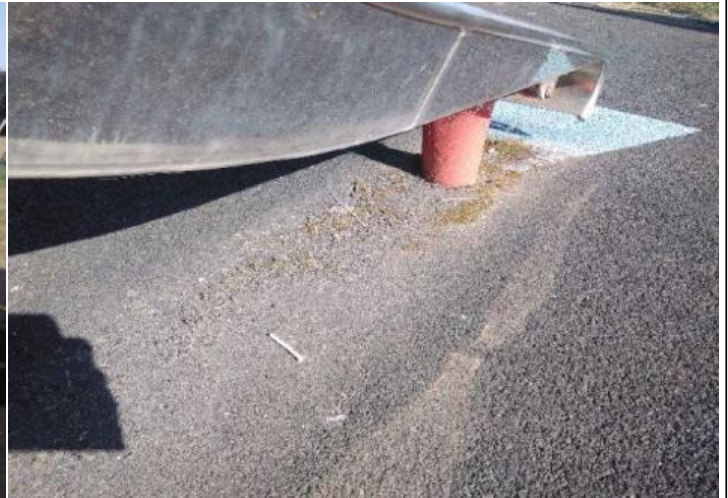
Finding: There is algae, silt or moss growth on the surface resulting in slippery conditions

Action: Clean and treat appropriately

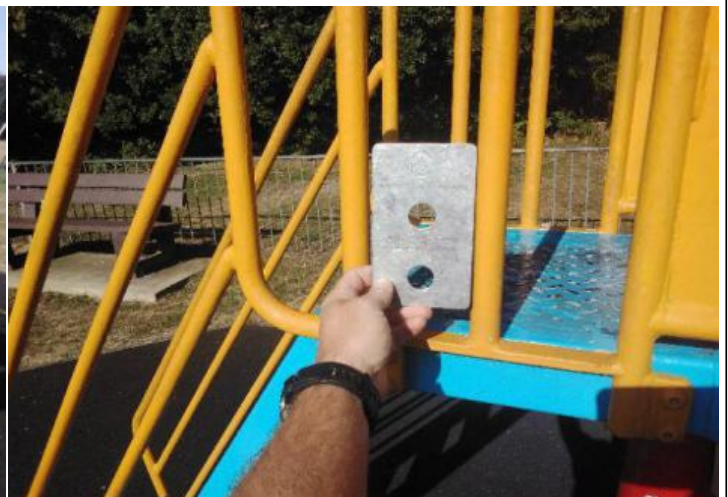
Finding: The item fails to meet the requirements of BS EN 1176 Part 1 4.2.7.2 head and neck entrapment in the barriers and/or steps

Action: Monitor - No remedial work recommended

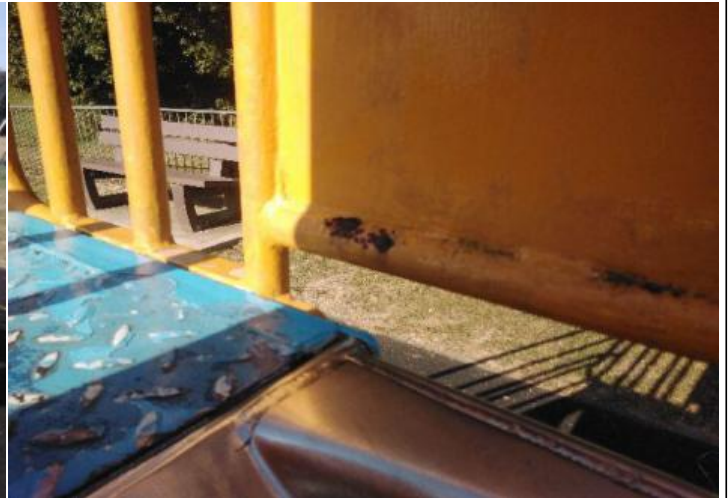
Finding: The paintwork on this item has been damaged or worn exposing the metal underneath which is rusting

Action: Treat any rusting components and repaint

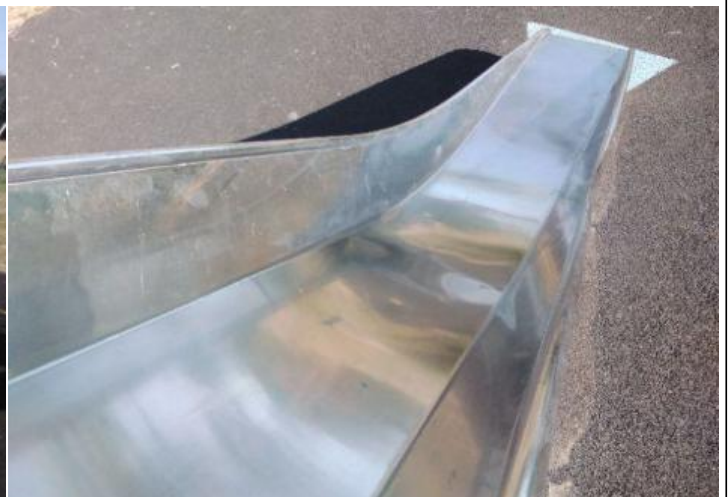
Finding: There are a number of dents in the slide surface

Action: Monitor for any further deterioration and repair as required

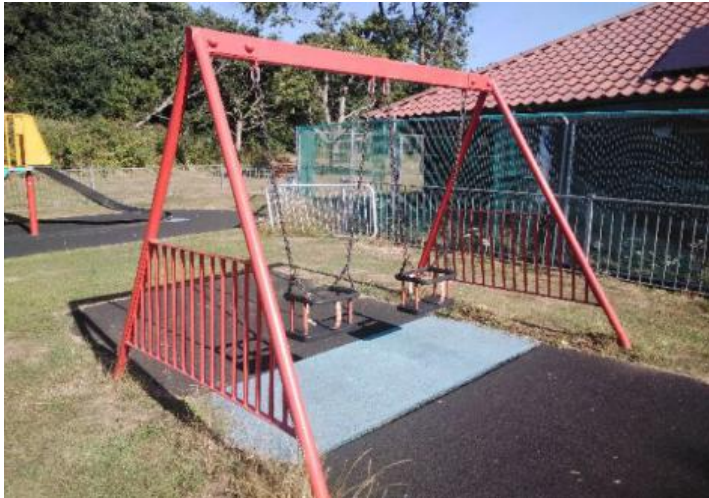
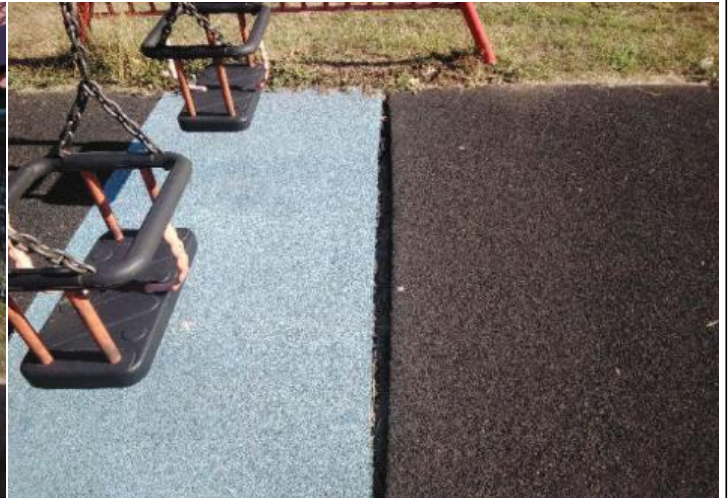
Finding: There are significant gaps (over 30mm) between the surface and the edging or between the joints in the surface; these are large enough for a small foot to enter

Action: Repair surfacing

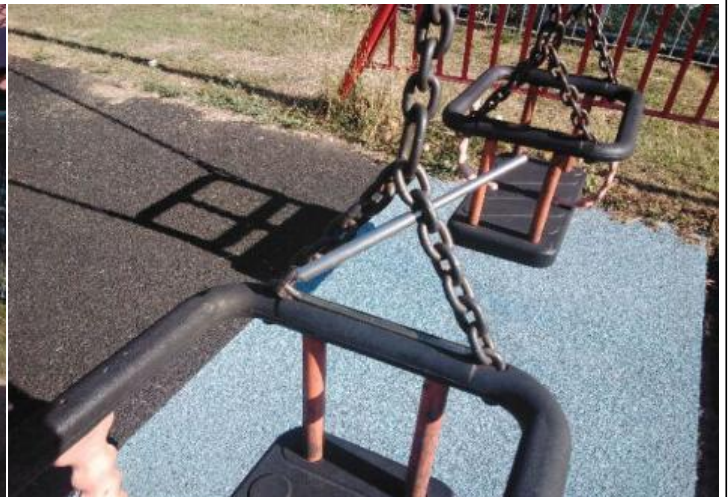
Finding: The chain openings are in excess of the 8.6mm as recommended by BS EN 1176

Action: Monitor - No remedial work recommended

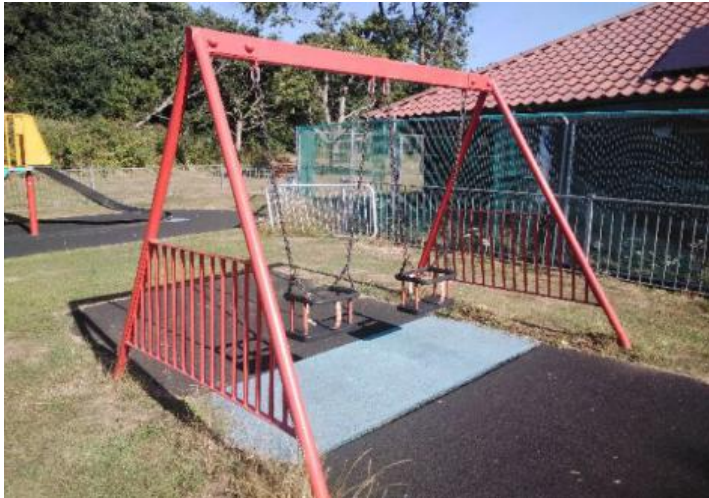
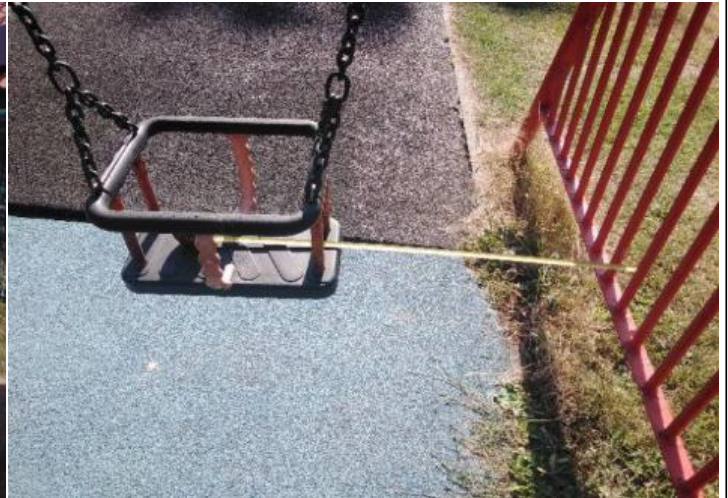
Finding: The surfacing width under the seat/s is / are less than 875mm when measured from the centre of the seat outwards, and fails the requirements of BS EN 1176 Part 2

Action: Monitor - No remedial work recommended

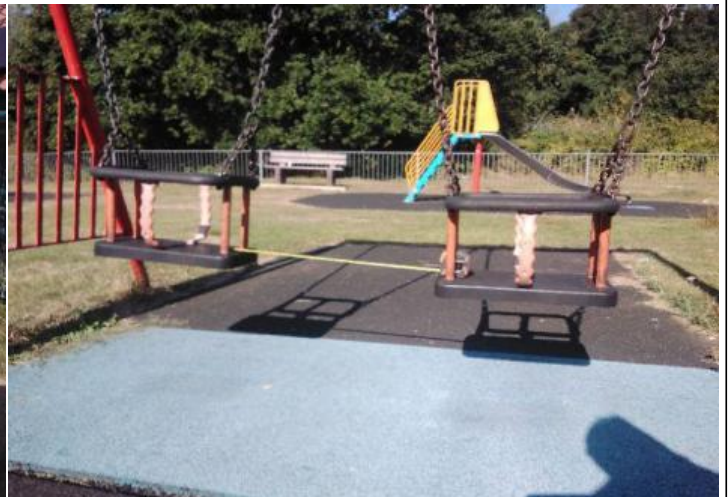
Finding: The seats are too close to each other as defined in BS EN 1176 Part 2; this is a low risk failure and no remedial action is required

Action: Monitor - No remedial work recommended

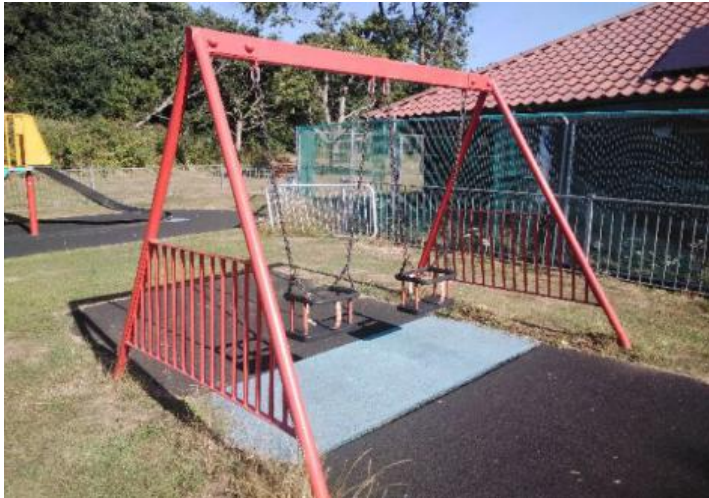
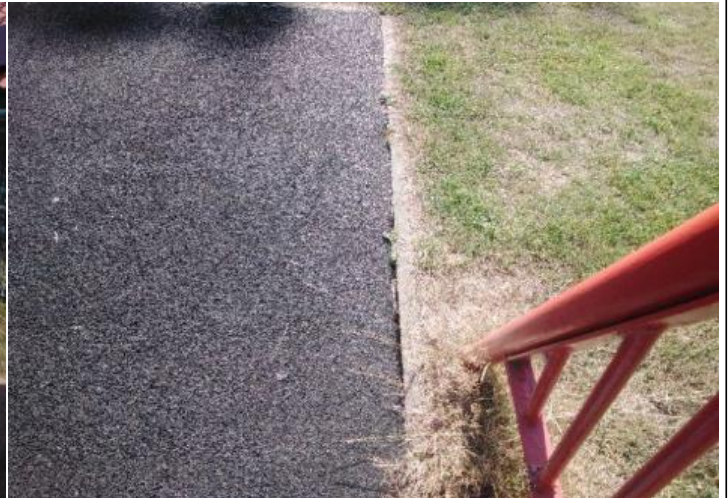
Finding: There are gaps opening between the surfacing and the edging surround or between the joints in the surfacing
Action: Monitor for any further deterioration and repair as required

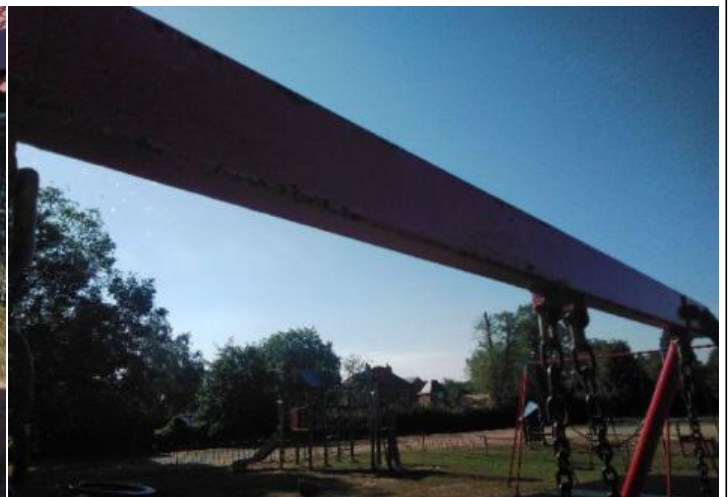
Finding: The paintwork on this item has been damaged or worn exposing the metal underneath which is rusting
Action: Treat any rusting components and repaint

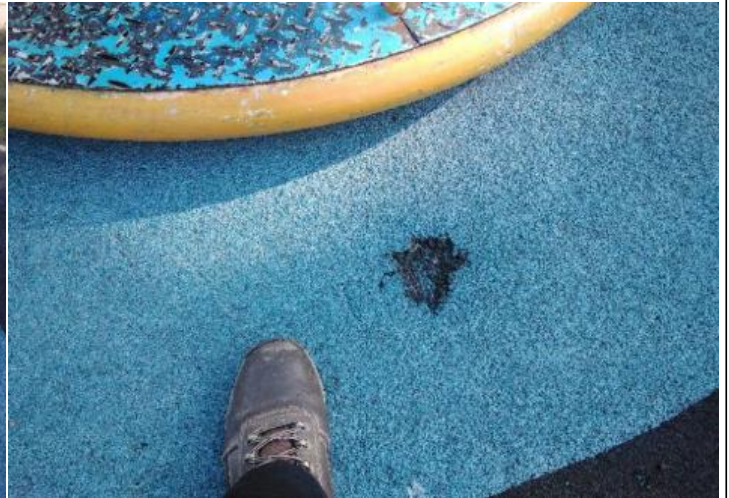
Finding: There is some minor damage to the surface

Action: Repair

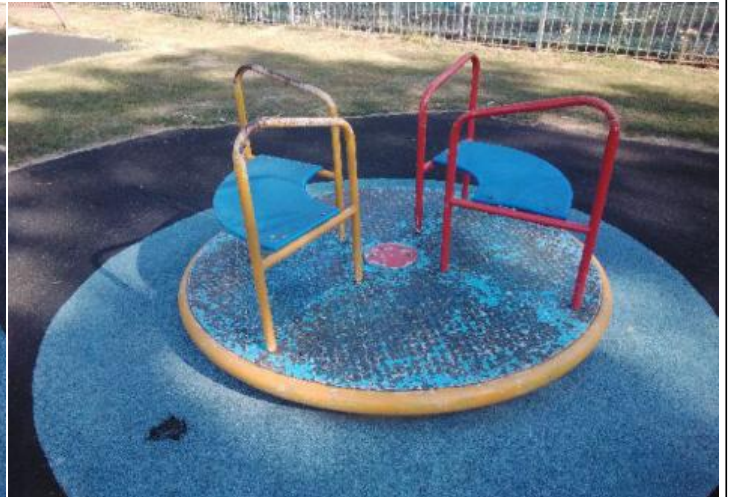
Finding: The bearing is worn / damaged and the item is not operating correctly

Action: Repair / replace

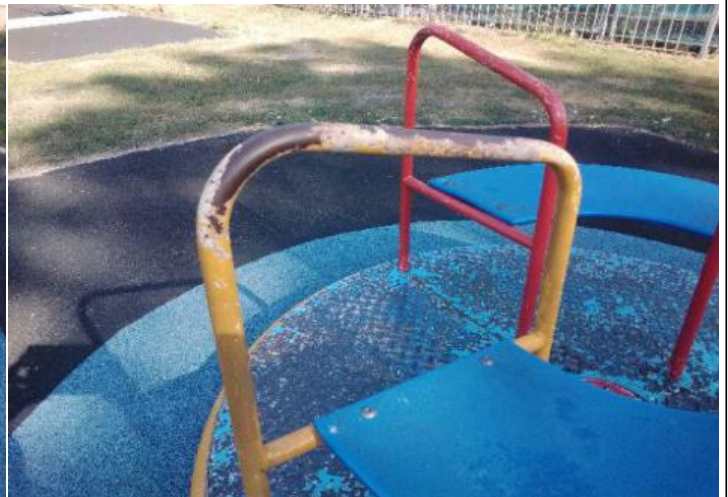
Finding: The paintwork on this item has been damaged or worn exposing the metal underneath which is rusting

Action: Treat any rusting components and repaint

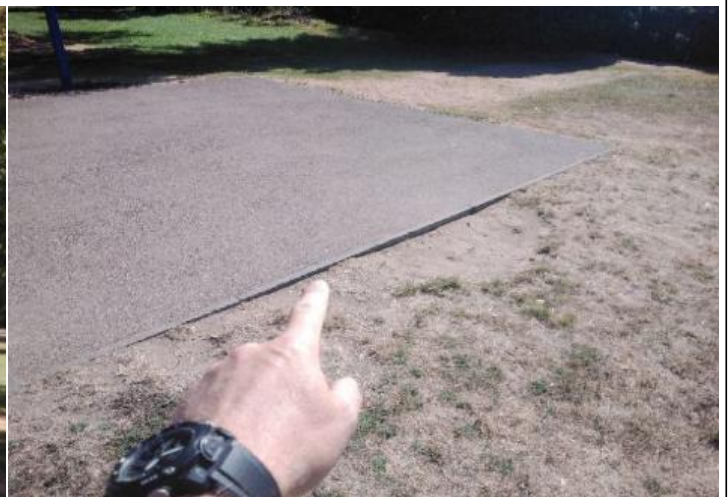
Finding: There are trip hazards at the edges of the surface

Action: Reinstate surrounding surface levels to remove the trip points

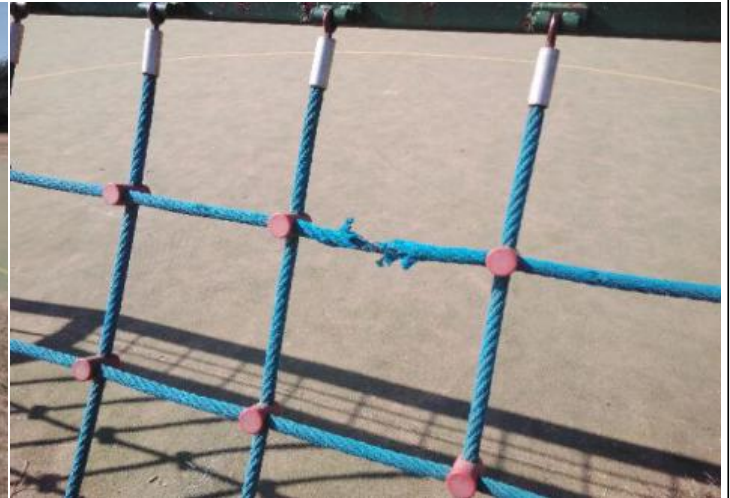
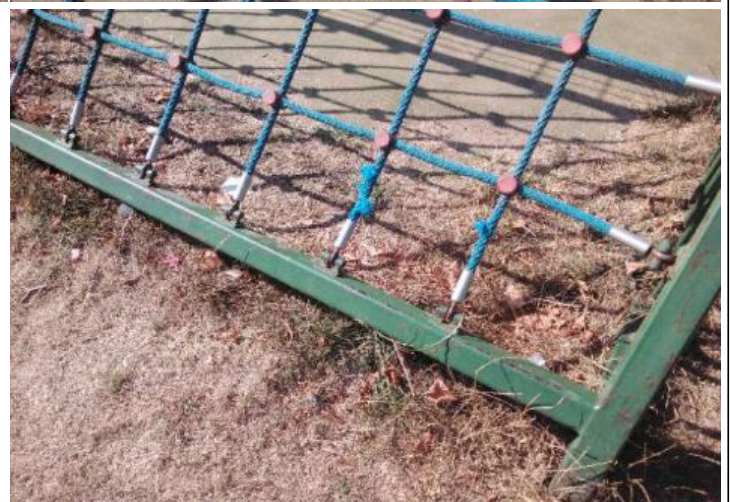
Finding: The ropes/nets are worn/damaged in places

Action: Monitor for any further deterioration and repair or replace as required

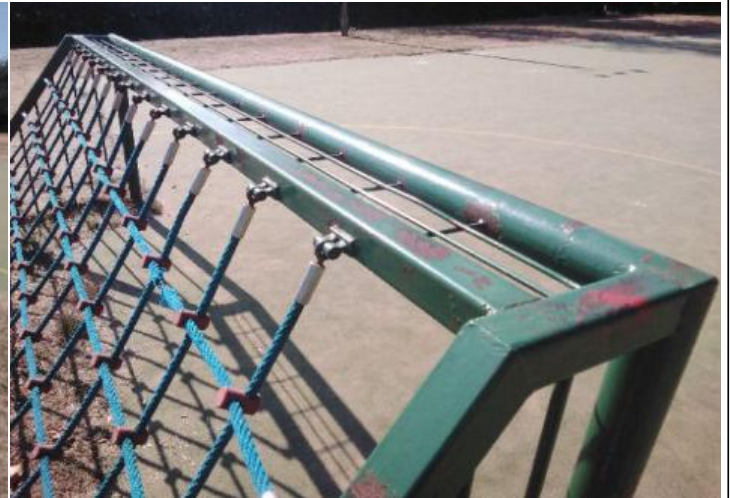
Finding: The paintwork on this item has been damaged or worn exposing the metal underneath which is rusting

Action: Treat any rusting components and repaint

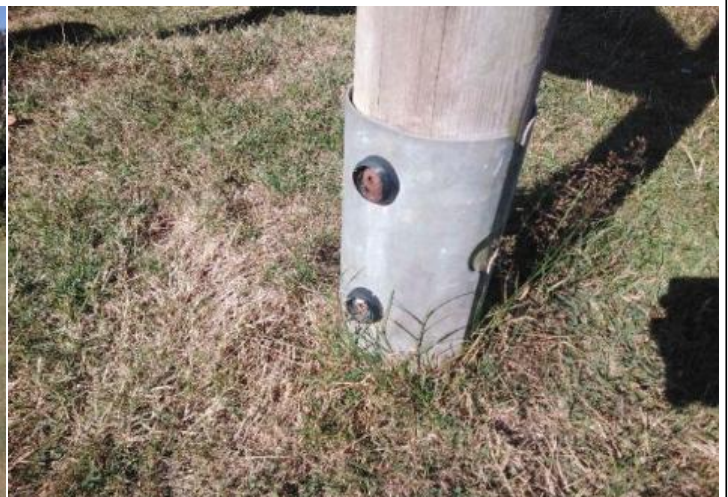
Finding: There is/are bolt cap covers missing or damaged on the item

Action: Replace missing or damaged bolt cap covers

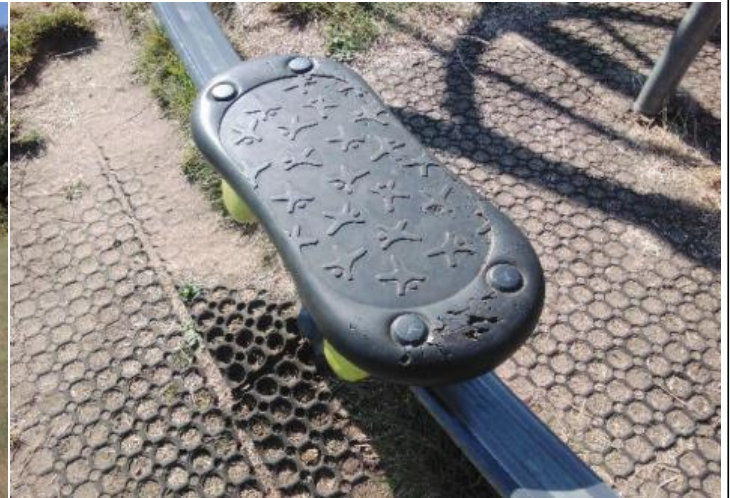
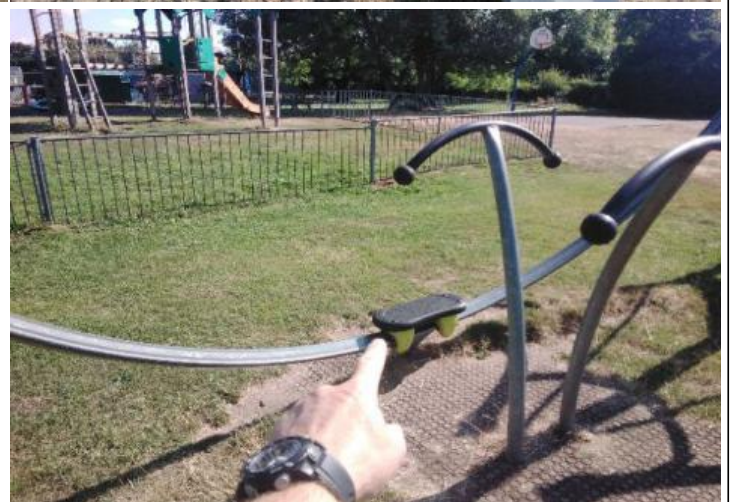
Finding: There is some damage to the traveller

Action: Monitor for any further deterioration and repair as required

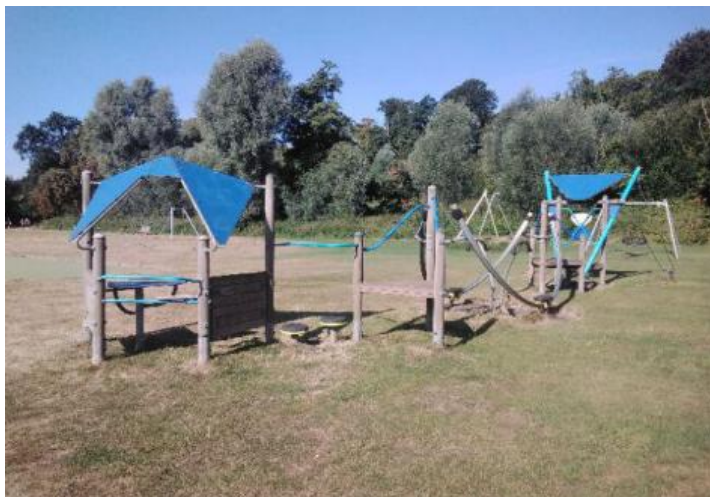
Finding: There is some damage to the item

Action: Monitor for any further deterioration and repair as required

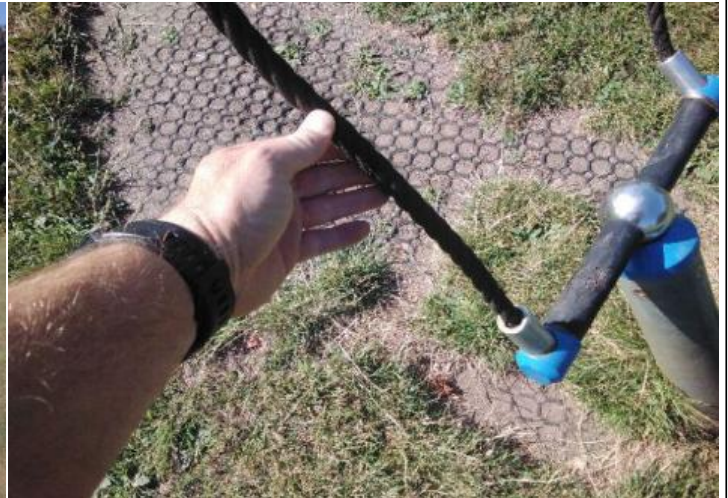
Finding: The ropes/nets are worn/damaged in places

Action: Monitor for any further deterioration and repair or replace as required

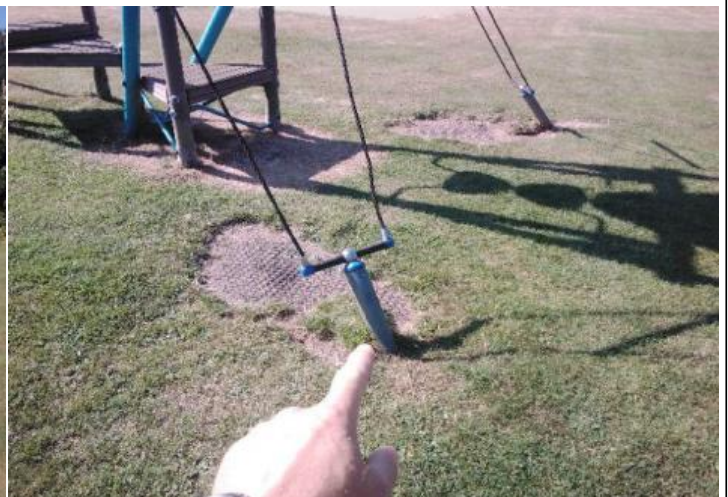
Finding: The spinning post is loose in the socket

Action: Monitor for any further deterioration and repair as required
