the play inspection company

Annual Inspection

Melton Parish Council

Melton Road

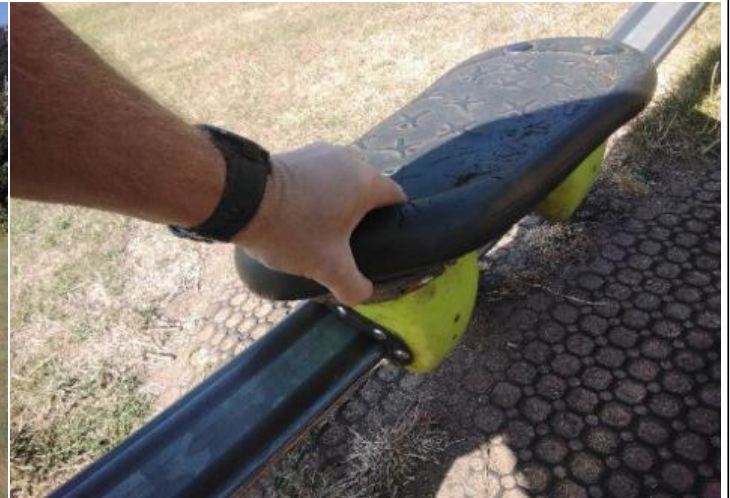
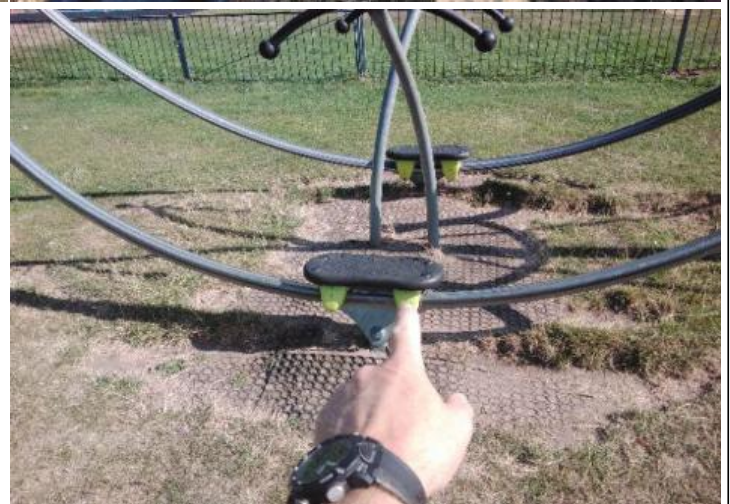
Finding: The traveller is damaged

Action: Replace

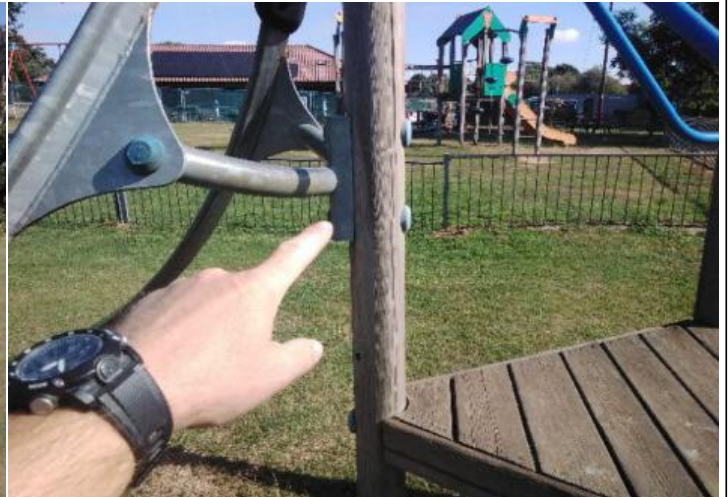
Finding: A number of fixing(s) have worked loose

Action: Secure all loose fixings

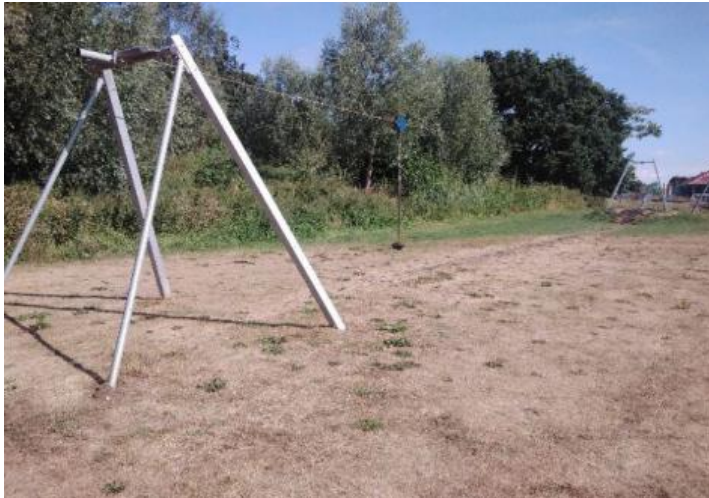
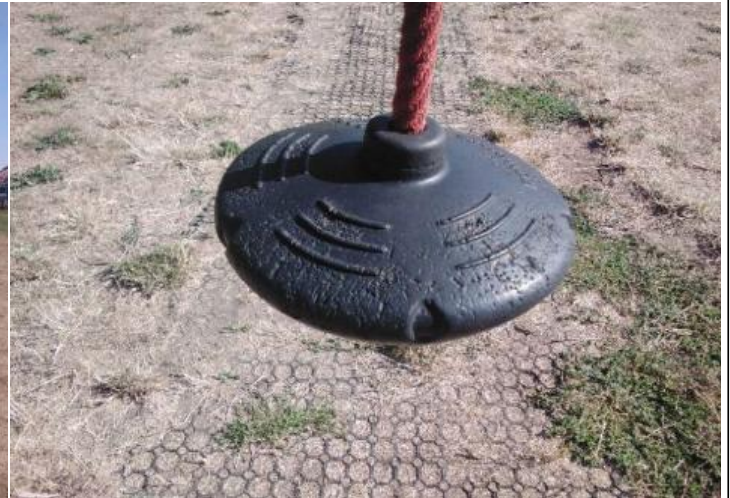
Finding: The cableway seat has been damaged

Action: Monitor for any further deterioration and replace as required

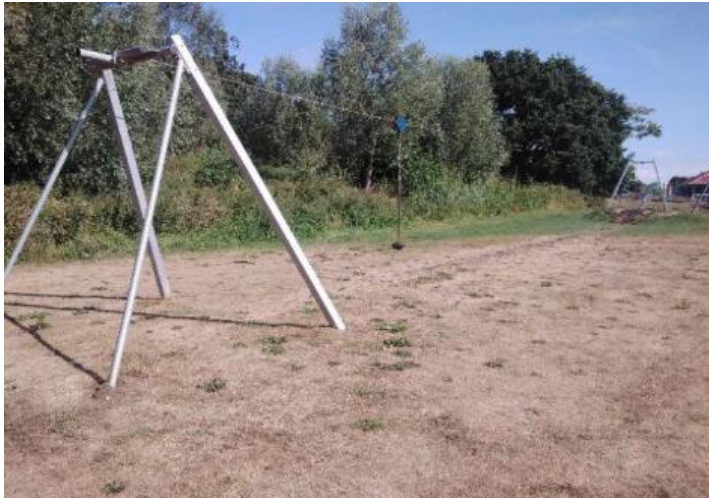
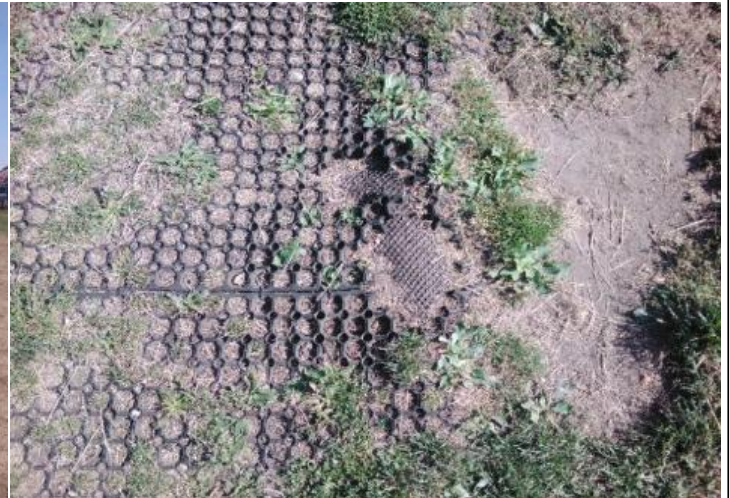
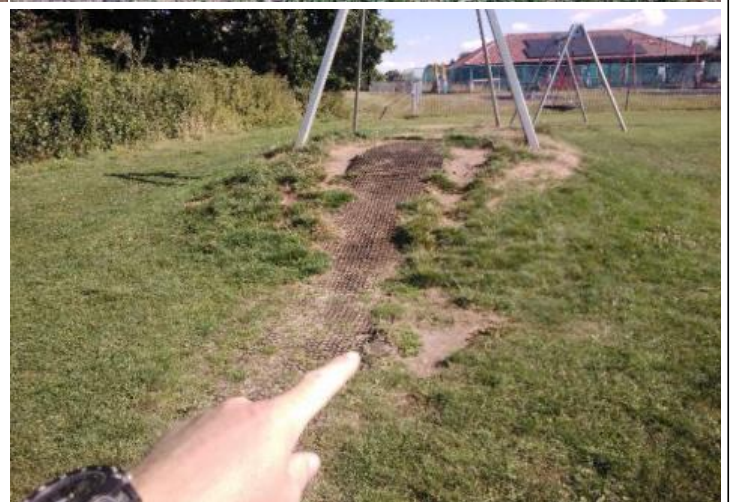
Finding: There is moderate damage to the surface

Action: Repair the damaged areas of surfacing

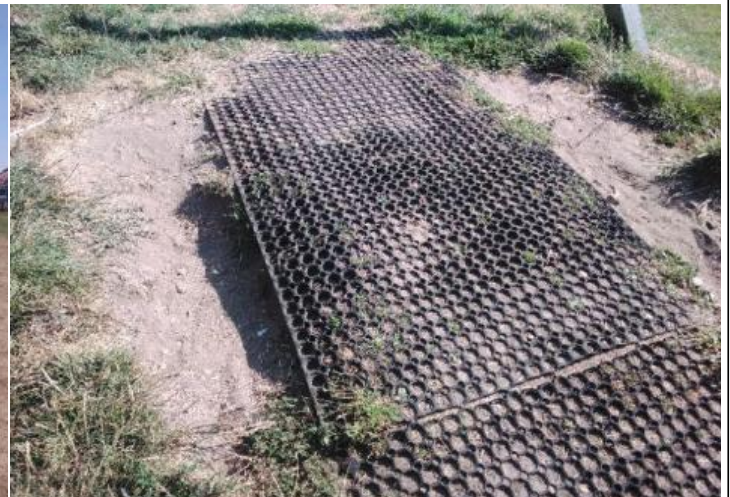
Finding: The edges of the grass mat surface have not been installed in accordance with the API Code of Practice
Action: Tuck in edges of grass mat to remove trip hazards

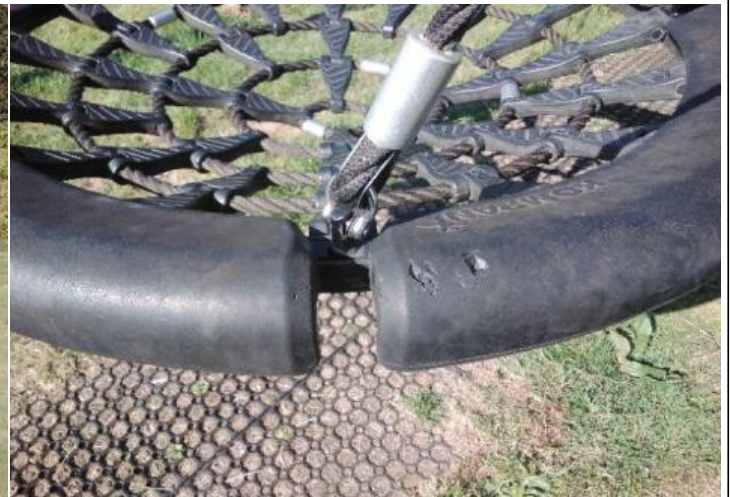
Finding: The seat has minor damage or wear

Action: Monitor for any further deterioration and replace as required

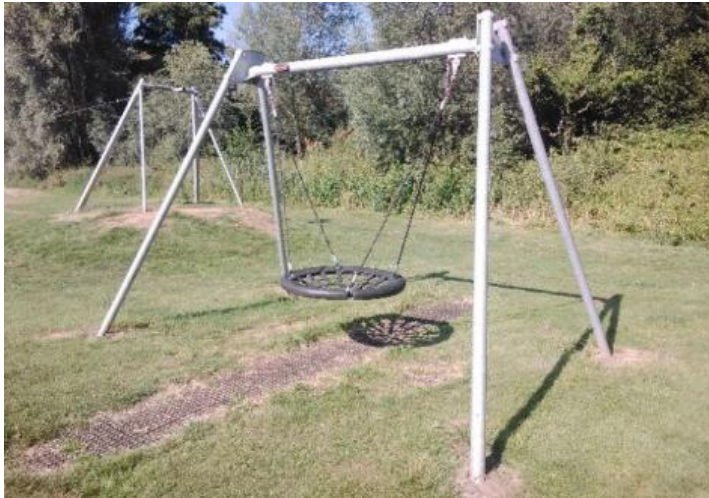
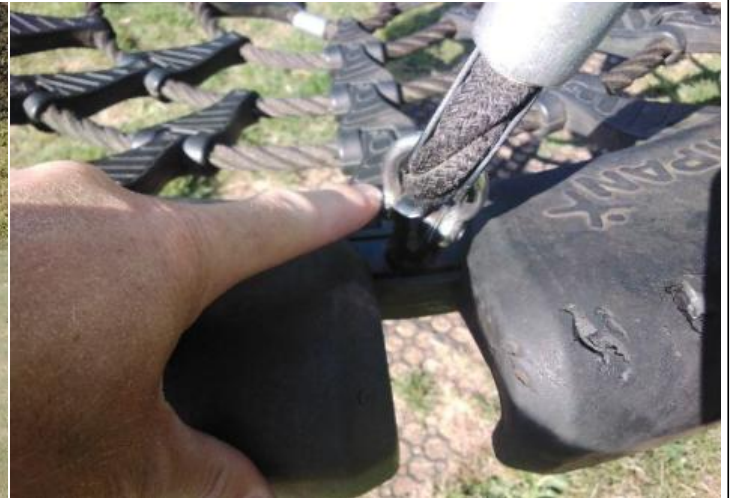
Finding: The bushes are worn or missing

Action: Replace worn or missing bushes
