Melton PC: 2021 Divested sites:
Tree Safety Report.

Melton Parish Council

Date of Report: October 11th, 2022.

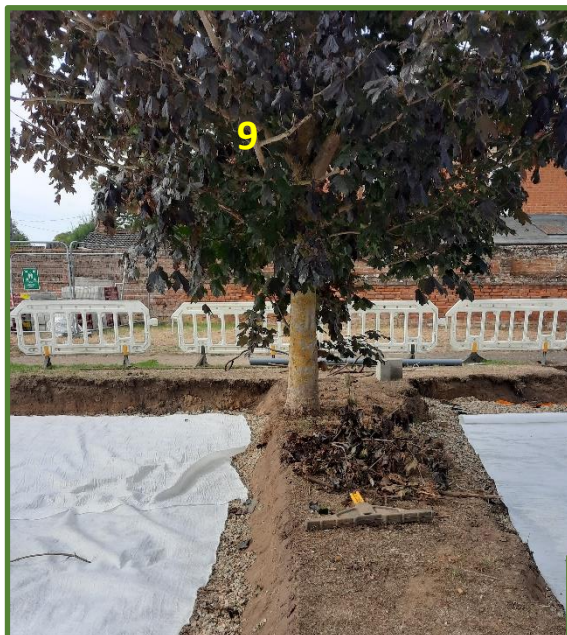
Tree related comments: Only one tree of the six originally assessment now remains in a 'Good' condition. Two trees (9 and 10) formally given an overall condition of 'Fair' at the last assessment are located in an area where persistent car parking and compacting the ground and tree rooting area was highlighted in the last inspection. At the time of the latest inspection, formal hard standing parking bays were being constructed around their bases.

Figure 3: Location of tree 9, an Acer platanoides 'Purpurea' a purple acer in relation to the position of the new parking bay (Authors own image. Sept 2022).

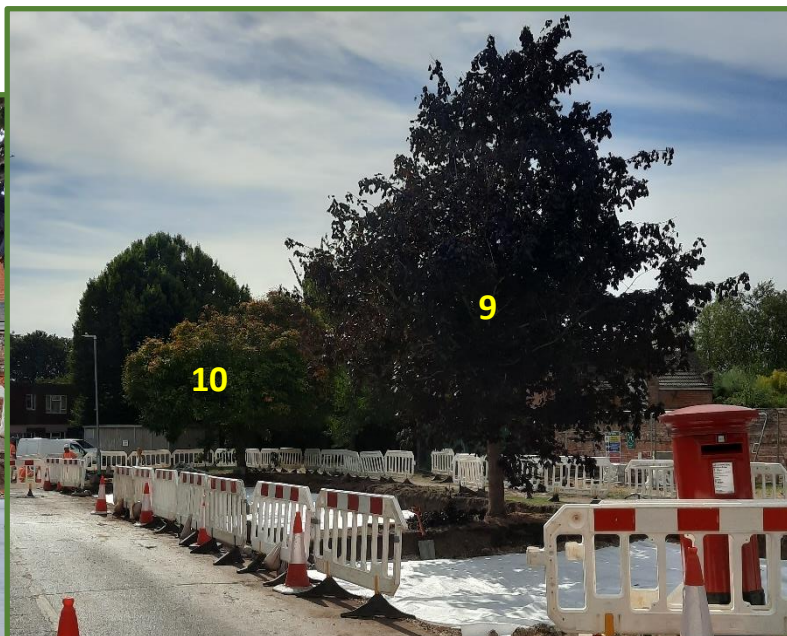
Findings and significance: Although no specific safety issues were identified tree 9 or 10, a Swedish whitebeam it lost a considerable amount of its feeding roots during the process of parking bay construction. Although not a safety issue, its health is very likely to suffer over the coming years because of the feeding root loss. Tree 9, a young purple maple has been left so close to the edge of a new parking bay, its retention may not be tenable for long. (See Appendix E: Supporting photographs).

Figure 2: Location of trees' 9 and 10, Land adj. The Street (Authors own image, September 2022)

Recommendations: No recommendations have been made for tree work on safety grounds. However, this may be a good site to consider further tree planting, as all the trees have a relatively short life expectancy.

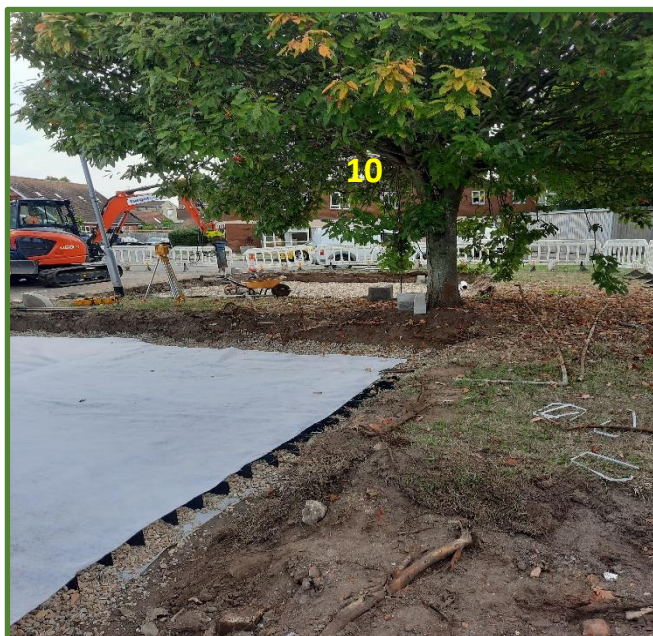
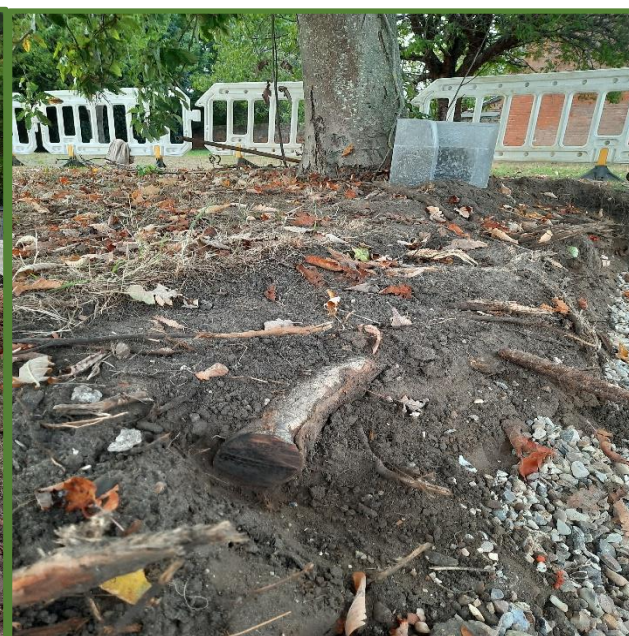
Figure 4: Excavations for bays approx. 300 to 400mm depth with feeding root damage to tree 10, a Sorbus x intermedia to within 60mm metres of the trunk (Authors own image, September 2022).
