## Annual Inspection

Melton Parish Council

Beresford Drive Play Area

Beresford Drive, Woodbridge, Suffolk, IP12 1JJ

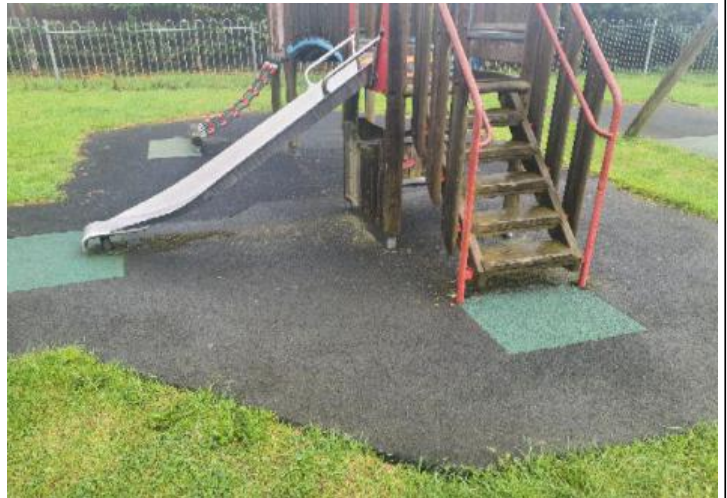
**Finding:** There is algae, silt or moss growth on the surface resulting in slippery conditions

There is algae, silt or moss growth on the surface resulting in slippery conditions - Clean and treat appropriately

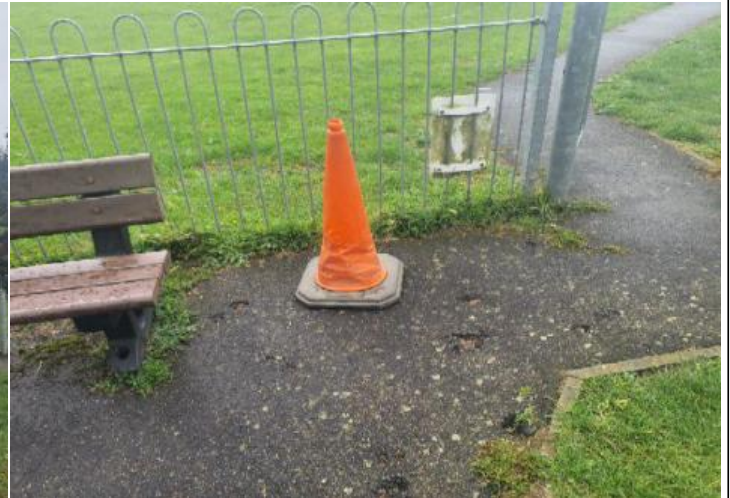
**Finding:** There is a loose cone on site

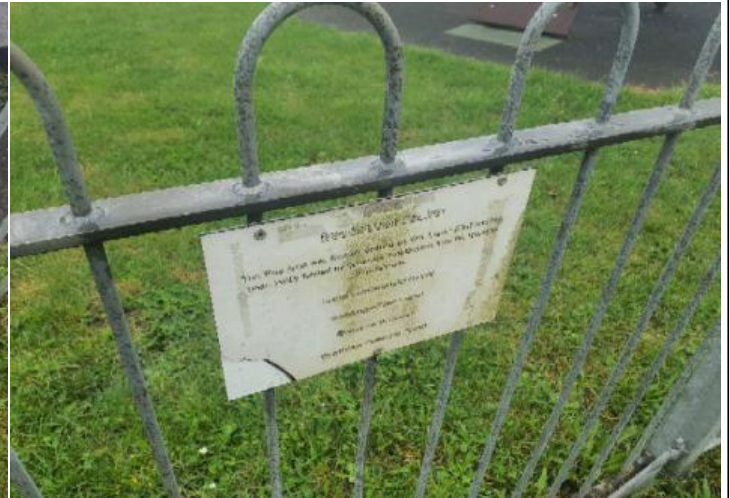
**Finding:** A sign is damaged

**Action:** Replace

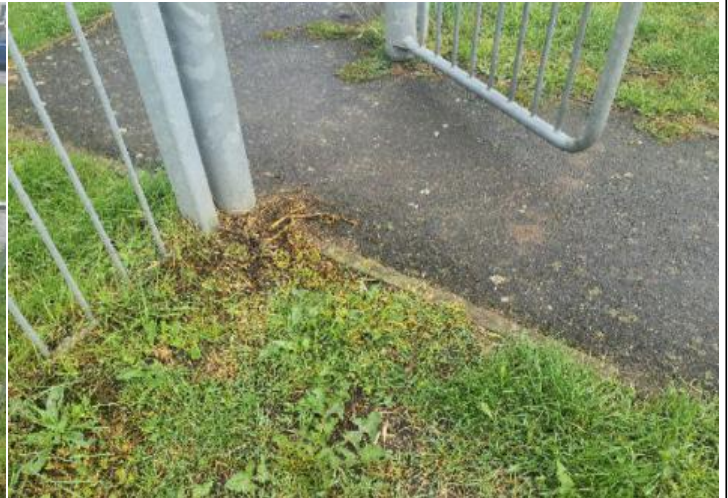
**Finding:** There are trip hazards at the edges of the surface

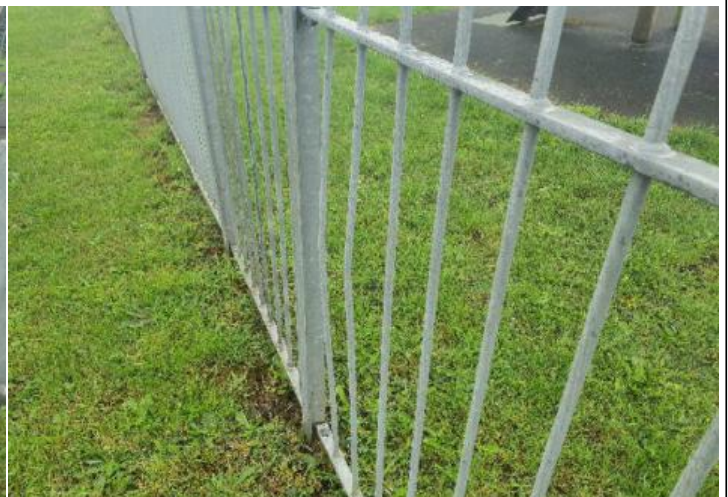
**Finding:** There is some damage to the fence sections

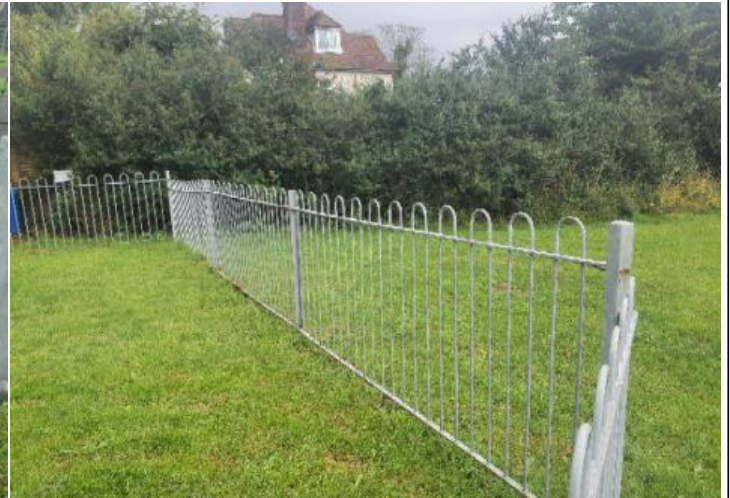
**Finding:** There are a number of loose posts around the fence

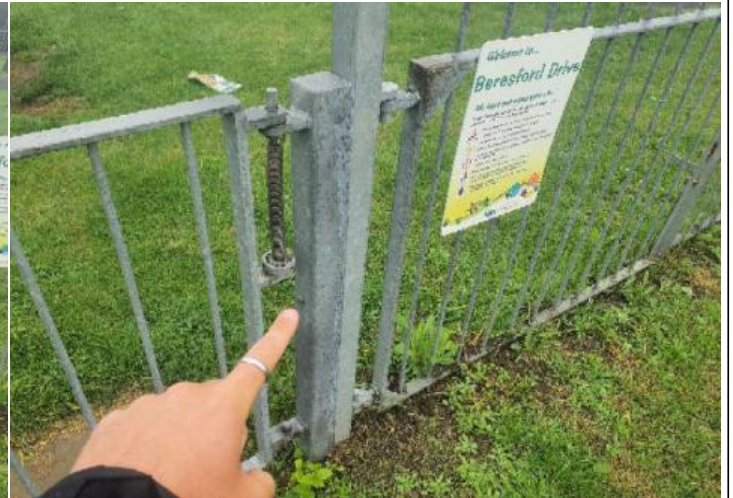
**Finding:** A number of fixing(s) have worked loose

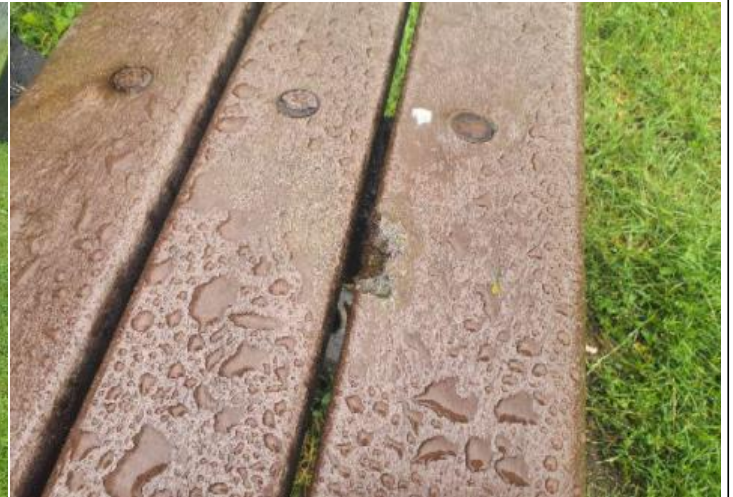
**Finding:** There is some evidence of fire damage to the item

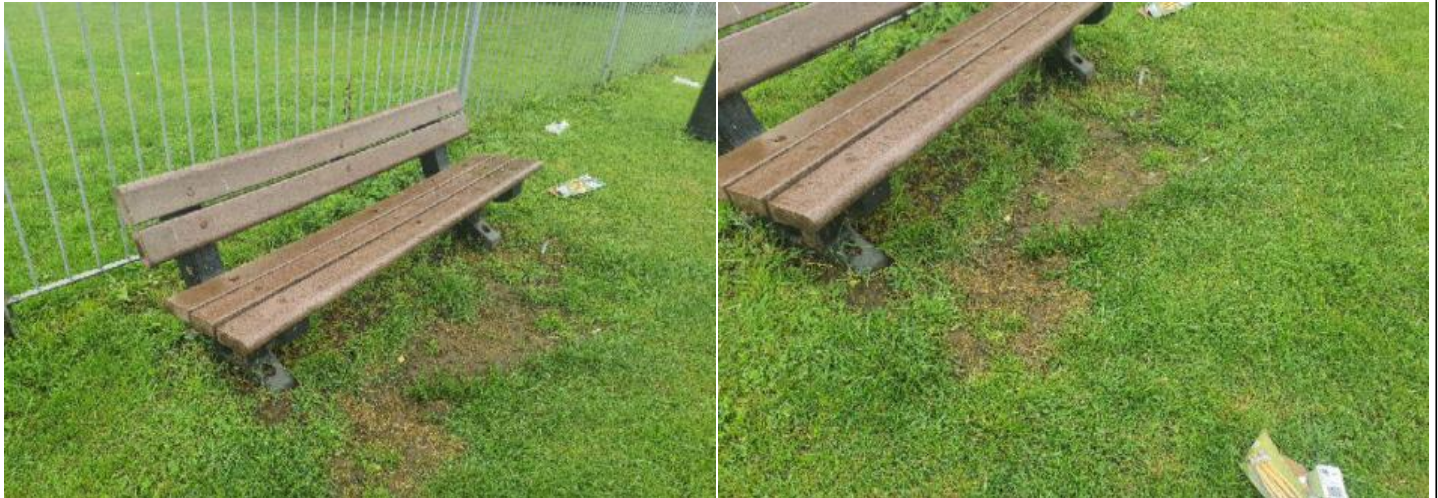
**Finding:** The surface has eroded in some areas and may be slippery in wet conditions  
**Action:** Reinstate the surface

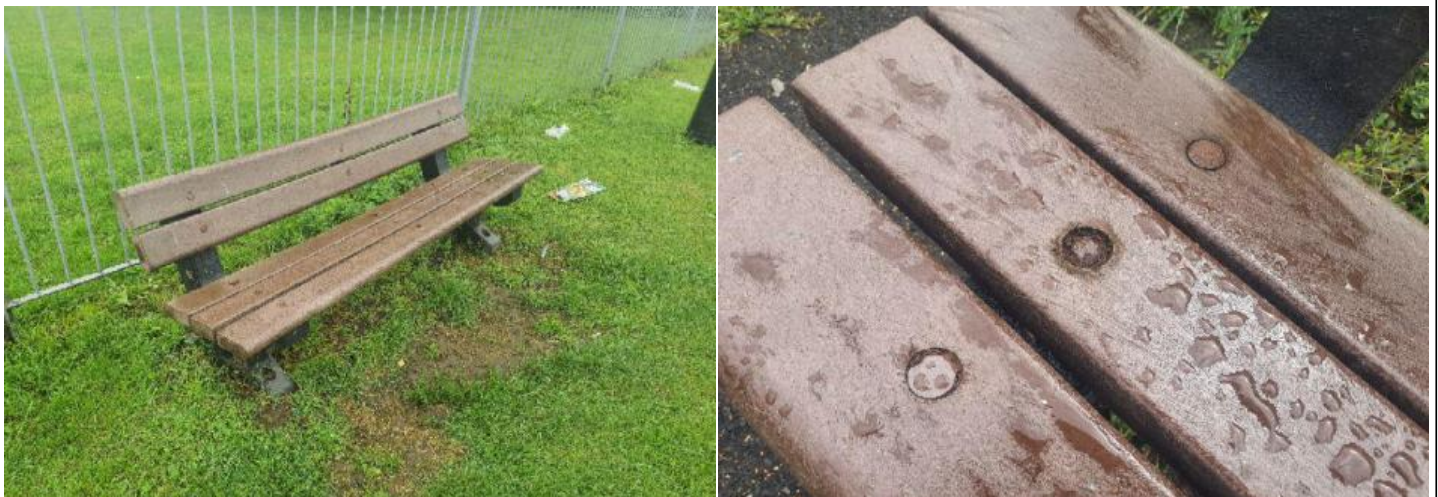
**Finding:** The fixings have corroded excessively  
**Action:** Replace all corroded fixings

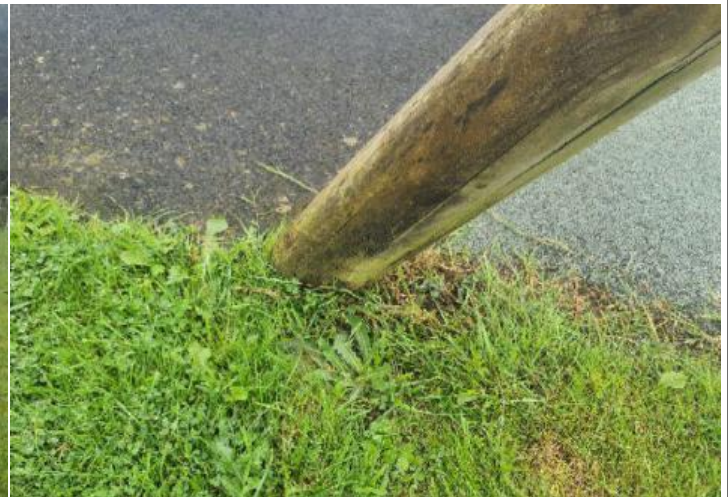
<b>Finding:</b> There is some strimmer / machinery damage apparent on the posts, this can penetrate the preservative applied to the timber and accelerate the rotting process	<b>Action:</b> Monitor for any deterioration (rot) and replace as required
---	--

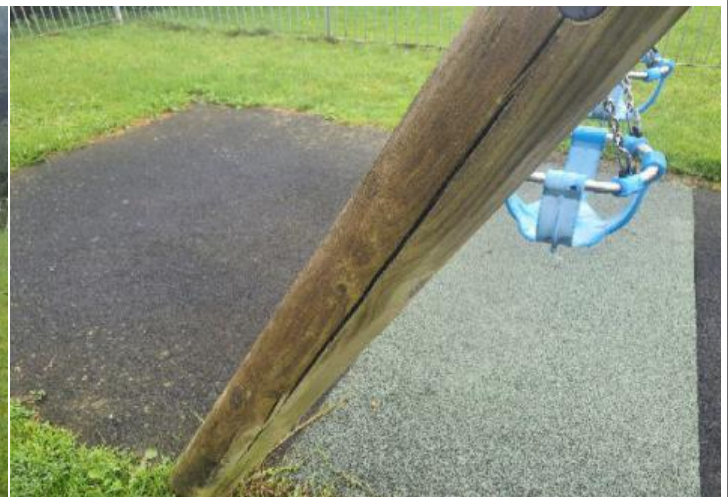
<b>Finding:</b> The timber has a number of splits/shakes or air cracks and this may affect the stability or allow water ingress which will accelerate the rotting process	<b>Action:</b> Monitor to ensure the splits do not cross through fixing points of the structure and/or cause any instability
---	--

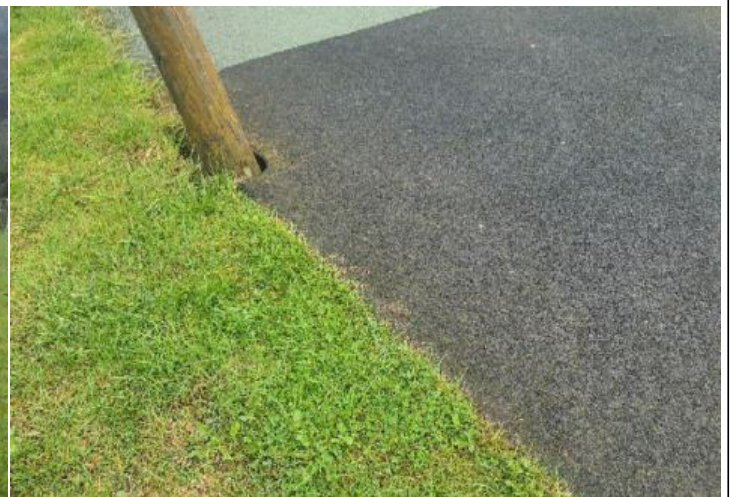
**Finding:** The surface is lifting at the edges and creating trip points

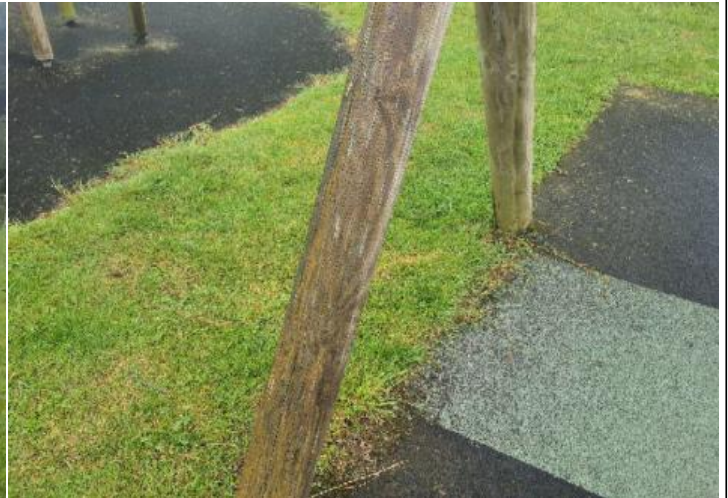
**Finding:** There is algae or moss on the surface of the equipment which can lead to the onset of rot

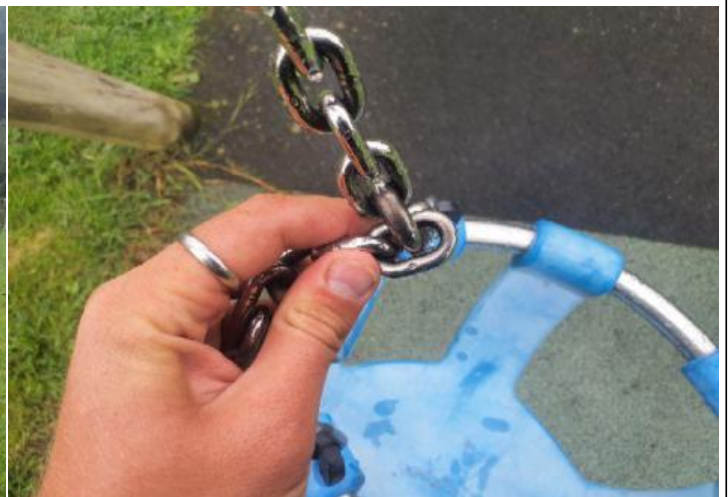
**Finding:** There is some notable evidence of chain wear

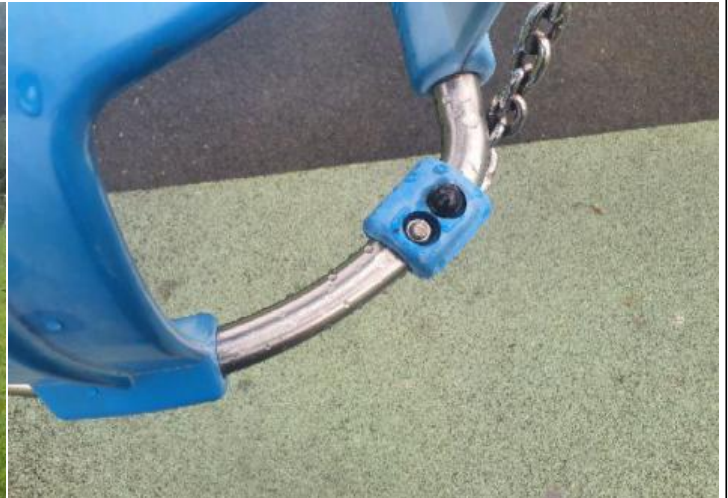
**Finding:** There are caps missing from the underside of the seats

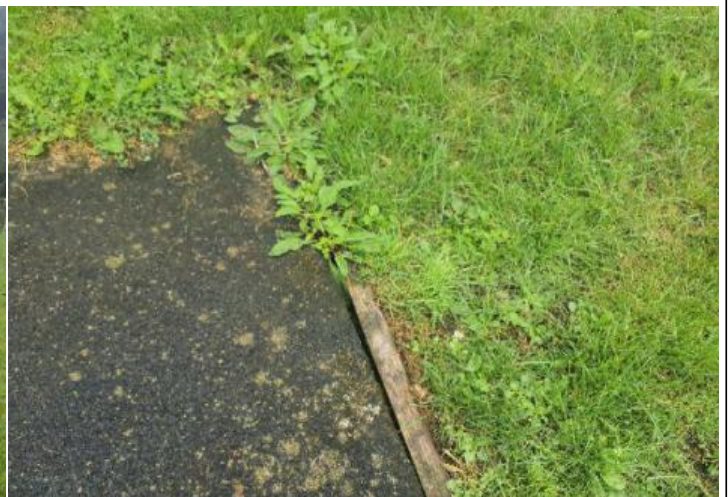
**Finding:** There are gaps opening between the surfacing and the edging surround or between the joints in the surfacing

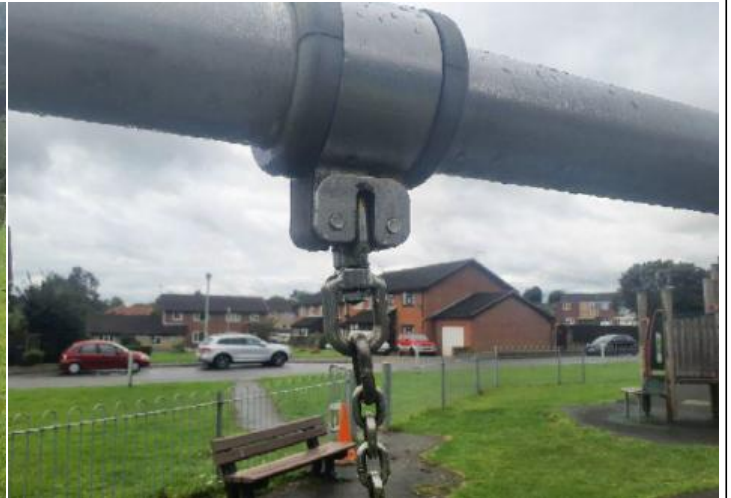
**Finding:** The swivel joint is becoming worn

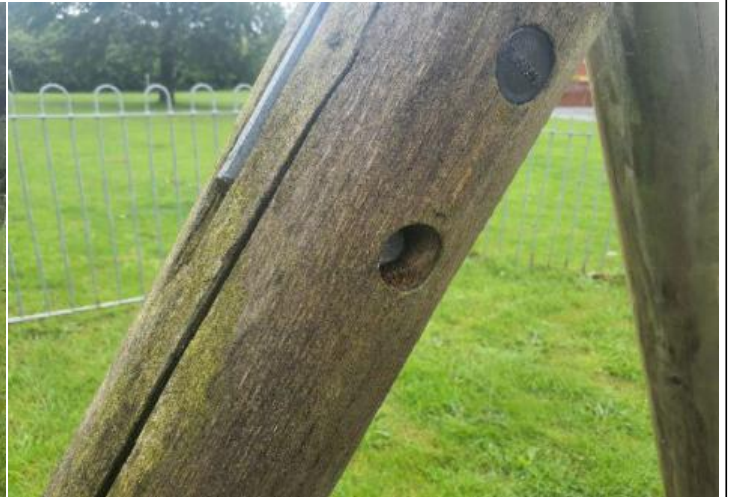
**Finding:** There is/are bolt cap covers missing or damaged on the item

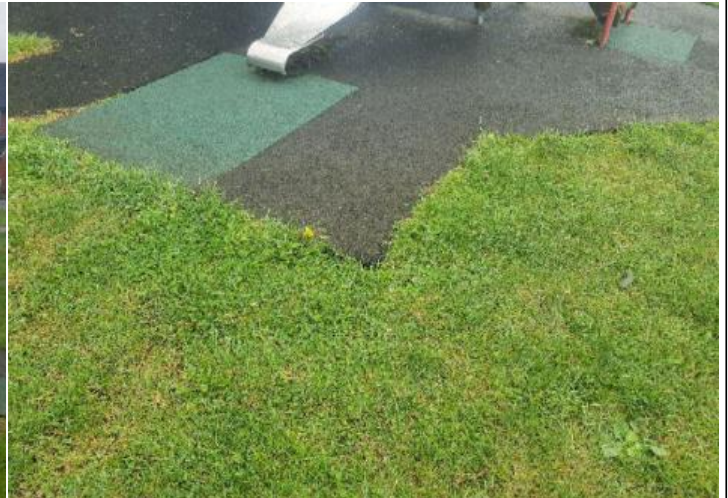
**Finding:** The surface is lifting at the edges and creating trip points

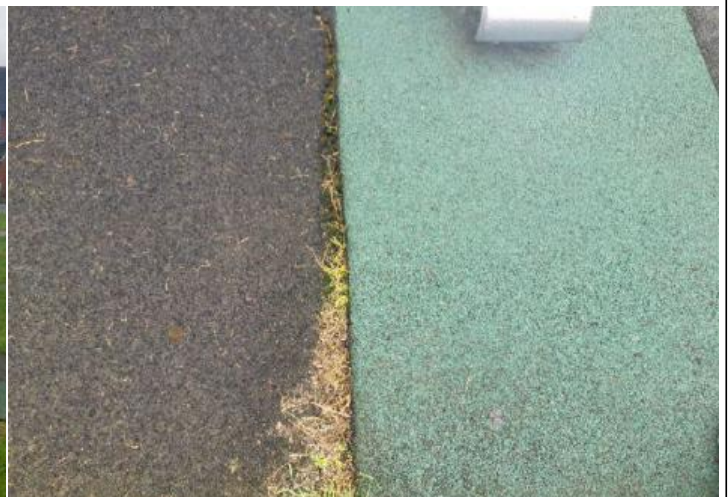
**Finding:** There are significant gaps (over 30mm) between the surface and the edging or between the joints in the surface; these are large enough for a small foot to enter

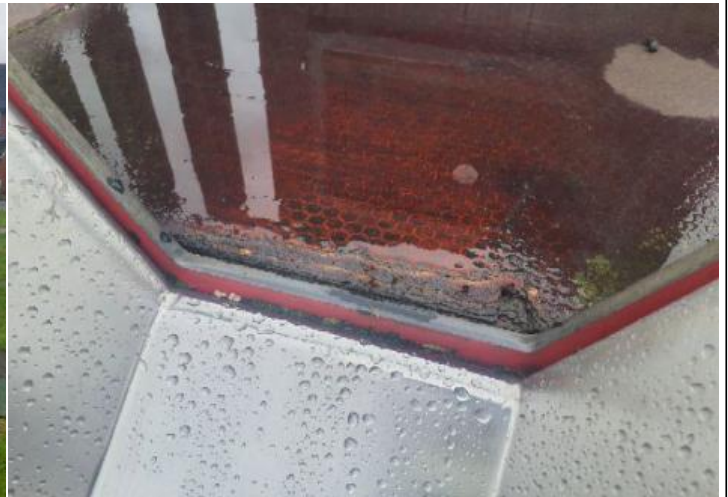
**Finding:** There is some evidence of rot in the timber

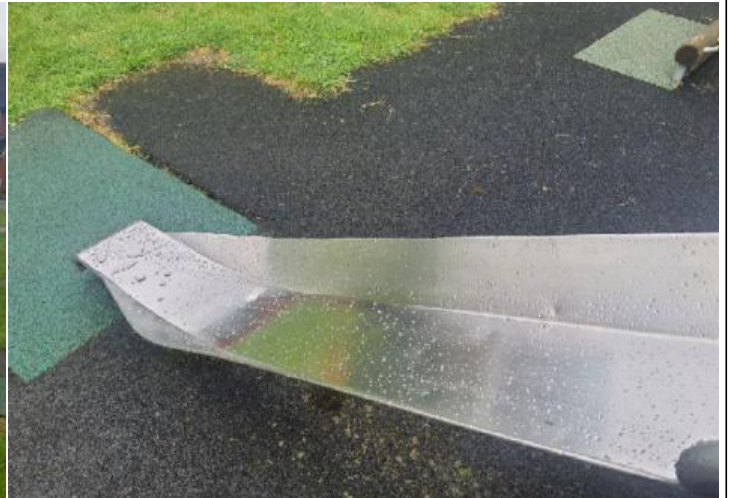
**Finding:** There are a number of dents in the slide surface

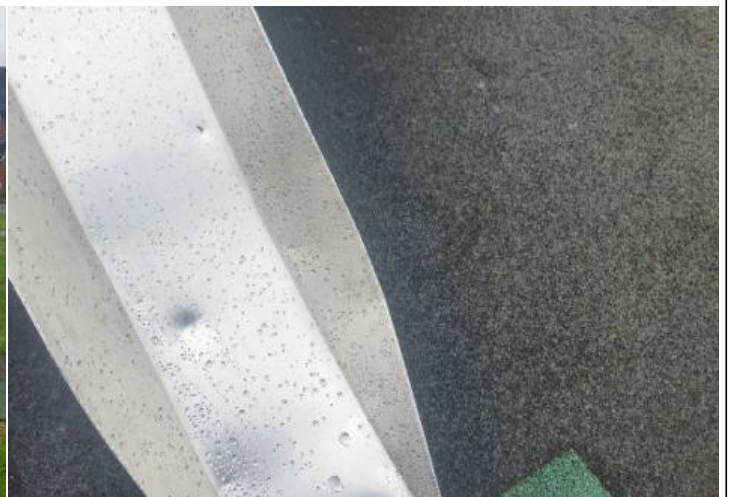
**Finding:** The side of the slide is damaged

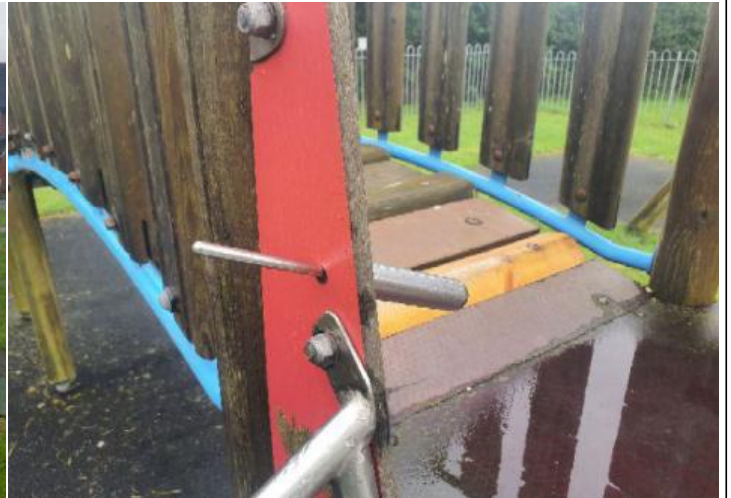
**Finding:** There is/are finger entrapment/s in the slide starting section due to missing inserts and the item fails to meet the requirements of BS EN 1176 Part 1 4.2.7.6 Entrapment of fingers

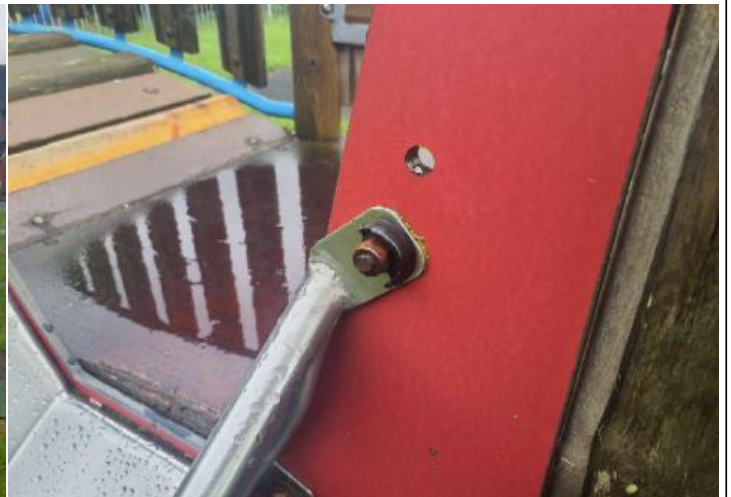
**Finding:** There is/are bolt cap covers missing or damaged on the item

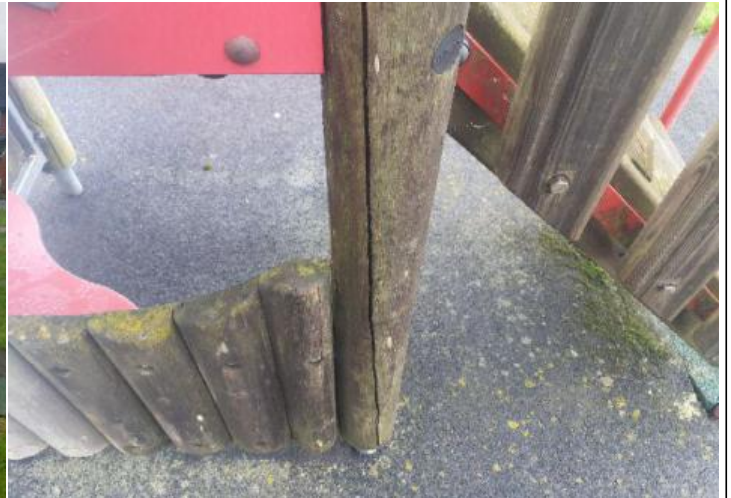
**Finding:** The timber has a number of splits/shakes or air cracks and this may affect the stability or allow water ingress which will accelerate the rotting process  
**Action:** Monitor to ensure the splits do not cross through fixing points of the structure and/or cause any instability

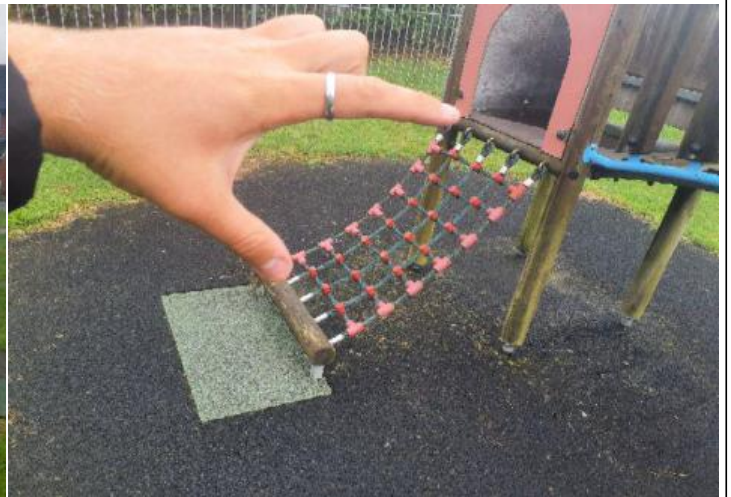
**Finding:** There are falls in excess of 600mm between adjacent components on the structure, in contravention of the recommendations set out in BS EN 1176 Part 1; 4.2.8.4  
**Action:** Monitor - No remedial work recommended

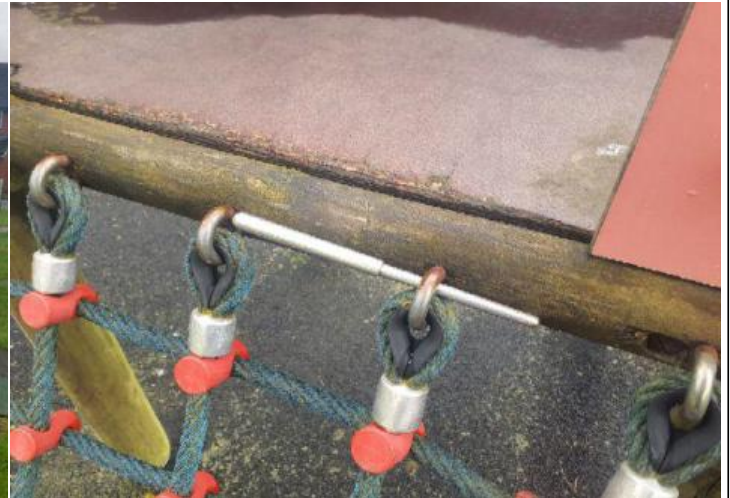
**Finding:** The connecting links are in excess of 8.6mm and less than 12mm and fail the requirements of BS EN 1176 Part 1; clause 4.2.13, Chains

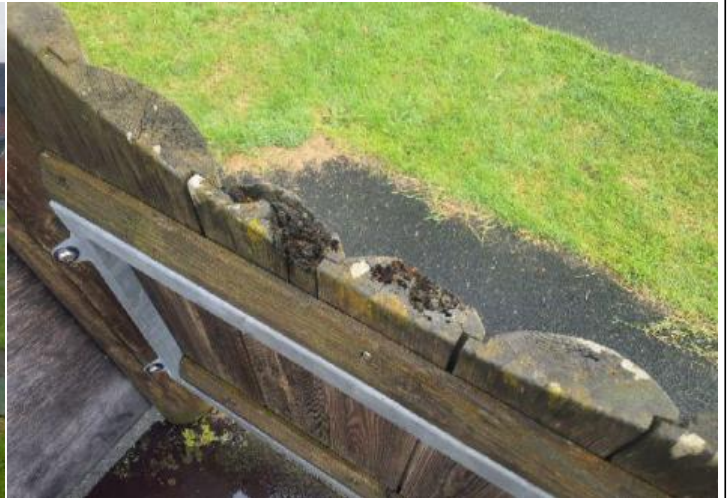
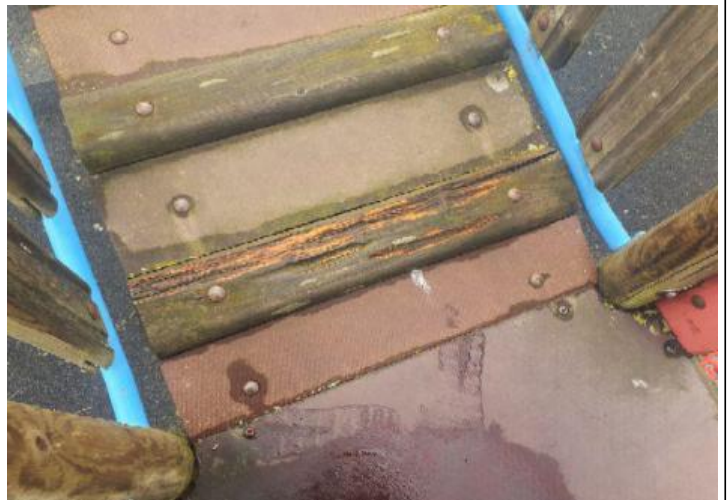
**Finding:** There are areas or parts of the timber on the structure that have rotted

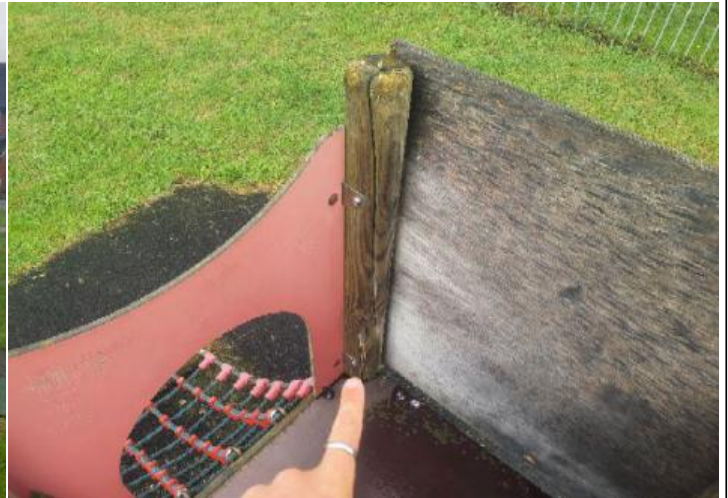
**Finding:** A number of fixing(s) have worked loose

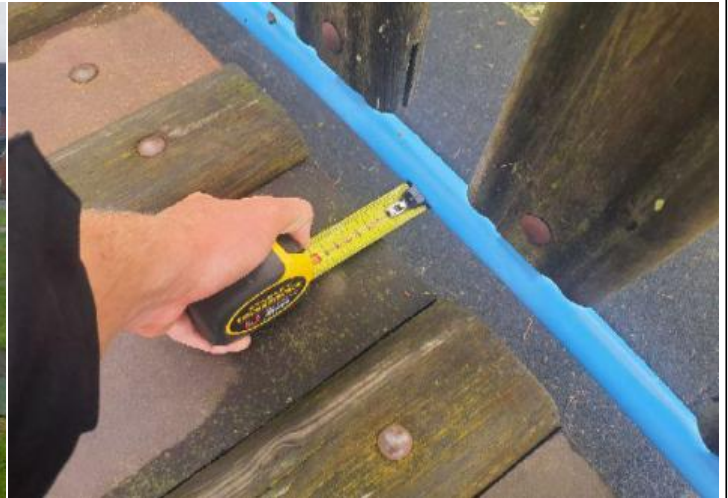
**Finding:** There are gaps in excess of 30mm in the direction of travel creating foot entrapment/s in contravention of BS EN 1176 Part 1 in the bridge  
**Action:** Monitor - no remedial action recommended

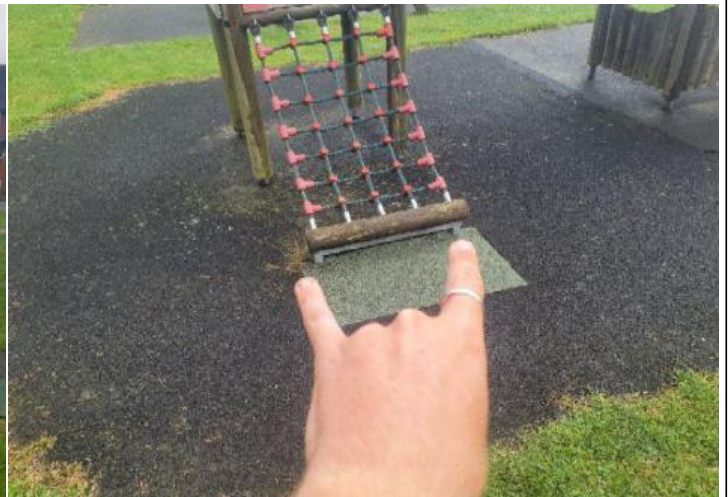
**Finding:** A number of fixing(s) have worked loose  
**Action:** Secure all loose fixings

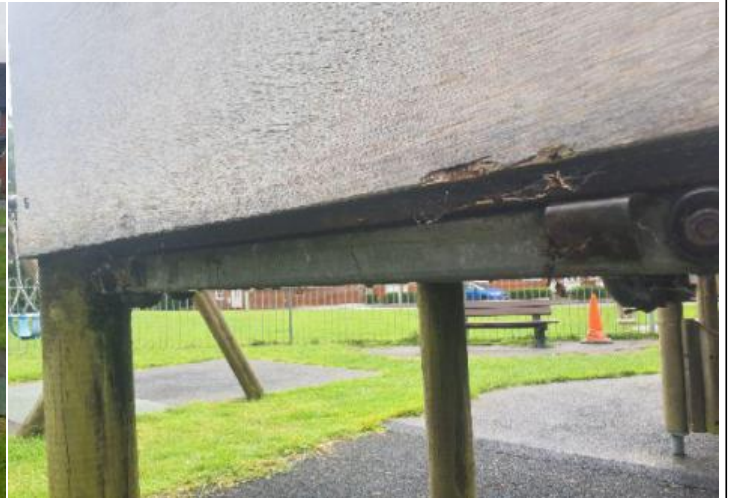
**Finding:** A barrier has been replaced and there are metal brackets remaining creating sharp edges

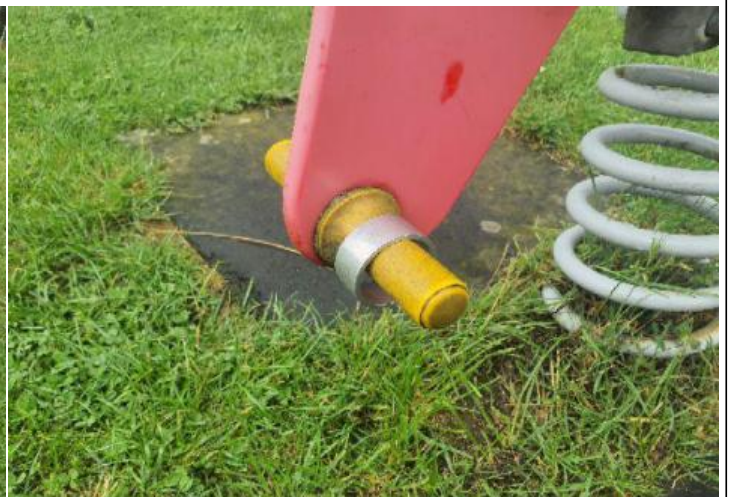
**Finding:** The end of handgrips and/or footrests have a cross section of less than 15cm<sup>2</sup> and fail to meet the requirements of BS EN 1176 Part 6

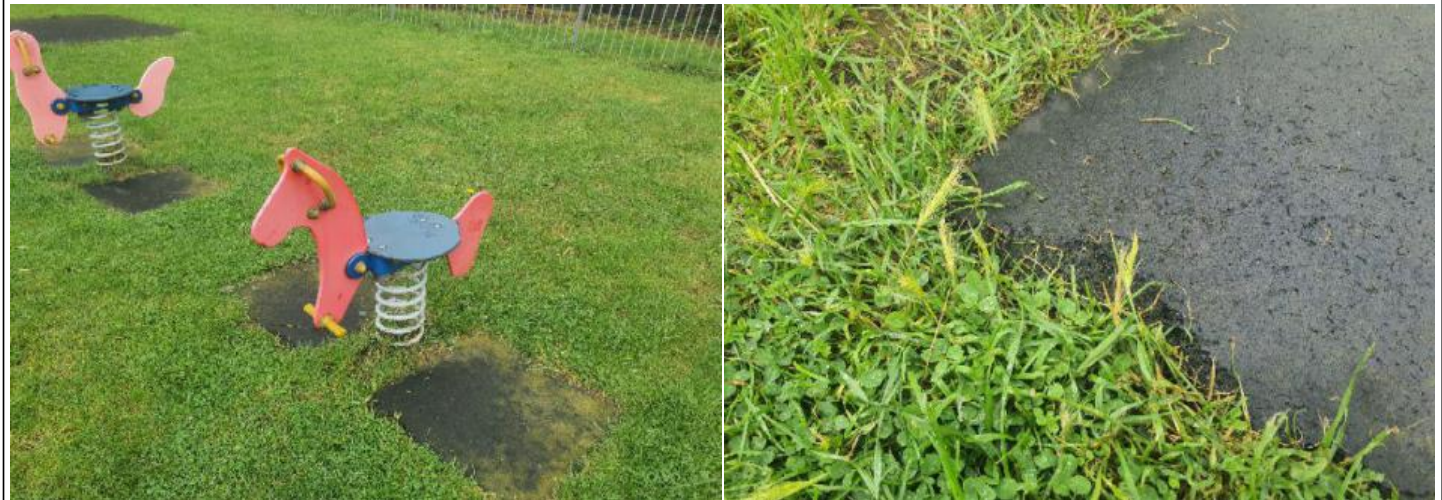
**Finding:** There is some minor damage to the surface  
**Action:** Monitor for any further deterioration and repair as required

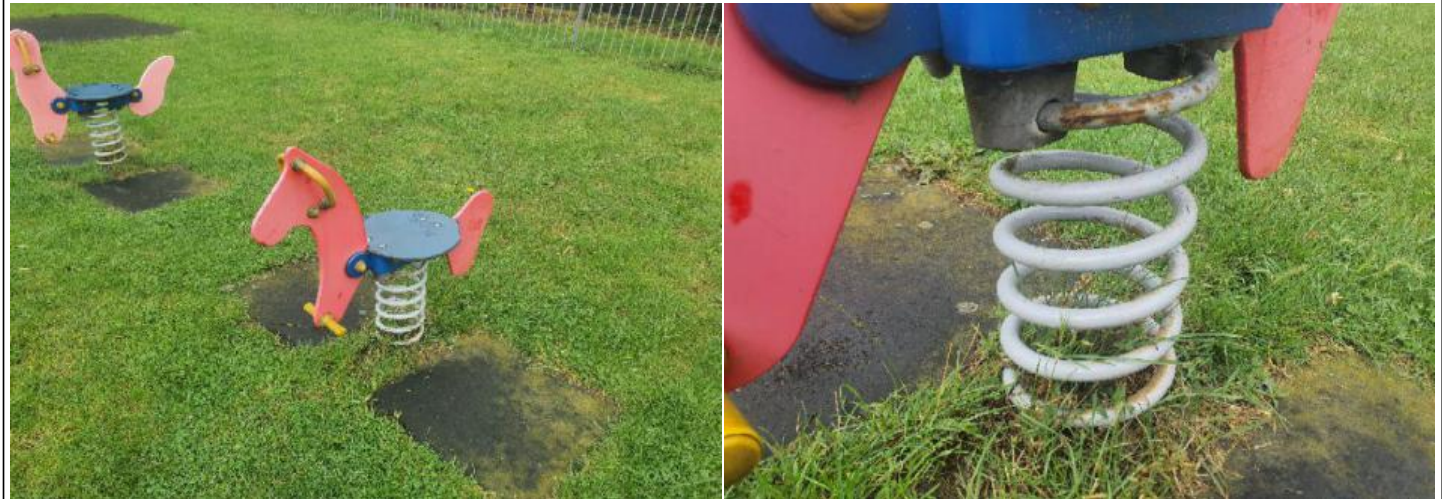
**Finding:** The paintwork on the spring has been damaged or worn exposing the metal underneath which is rusting  
**Action:** Treat any rusting components and repaint

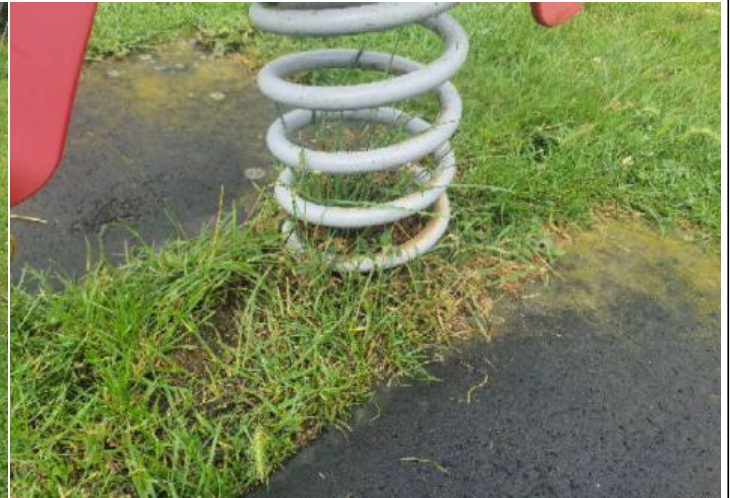
**Finding:** The U bolts clamping the spring are worn

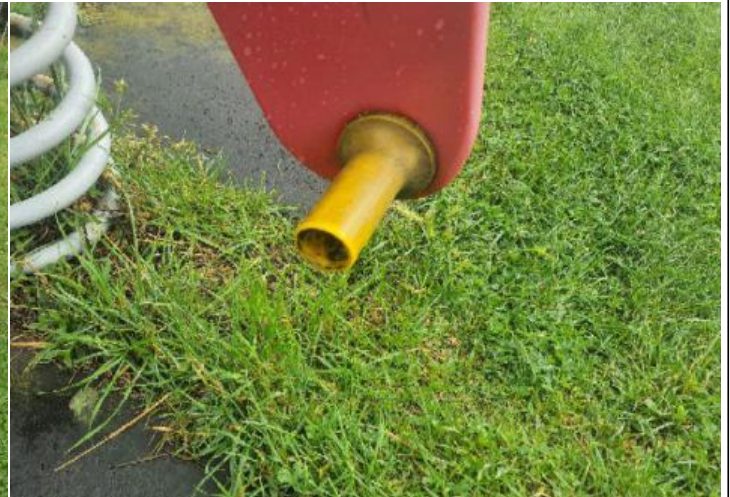
**Finding:** The end caps are missing on the Handgrips/Footrests

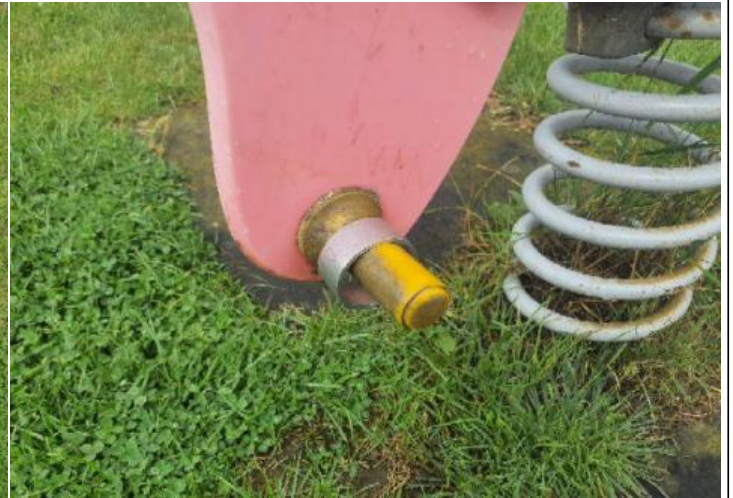
**Finding:** The end of handgrips and/or footrests have a cross section of less than 15cm<sup>2</sup> and fail to meet the requirements of BS EN 1176 Part 6  
**Action:** Monitor - No remedial work recommended

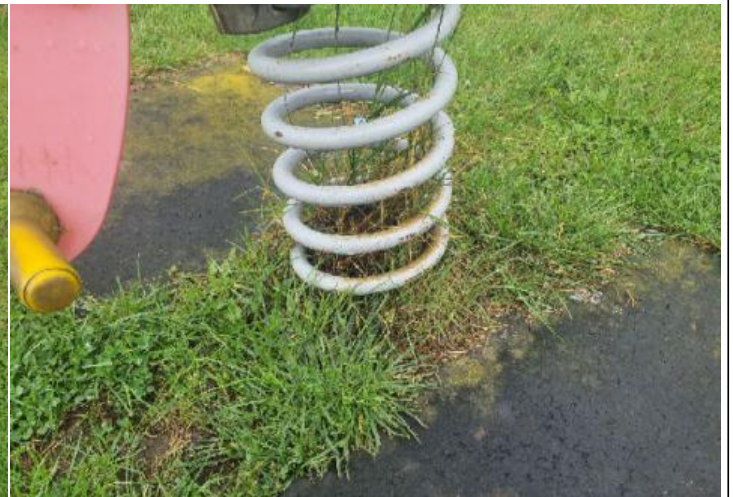
**Finding:** The U bolts clamping the spring are worn

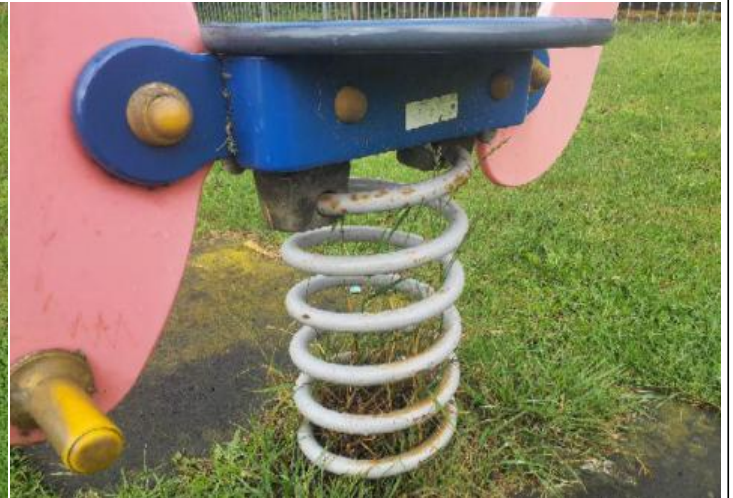
**Finding:** The paintwork on the spring has been damaged or worn exposing the metal underneath which is rusting  
**Action:** Treat any rusting components and repaint

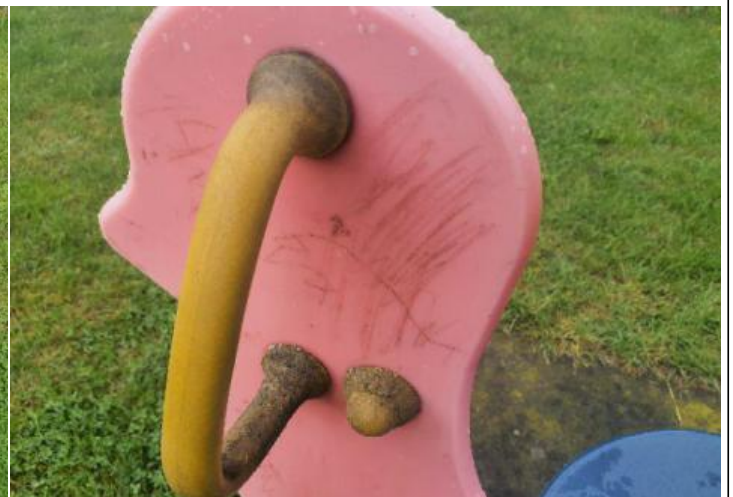
**Finding:** There is some damage to the item

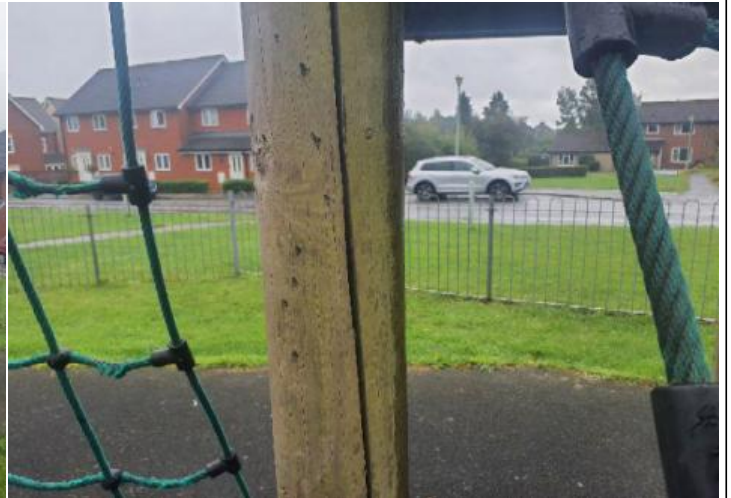
**Finding:** The timber has a number of splits/shakes or air cracks and this may affect the stability or allow water ingress which will accelerate the rotting process

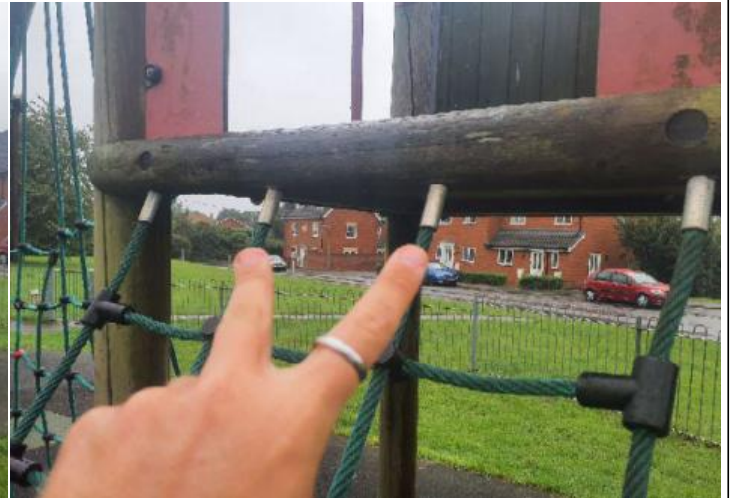
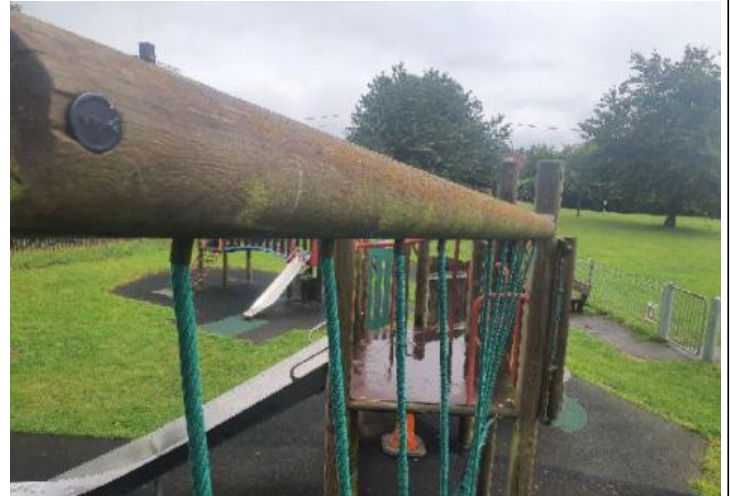
**Finding:** A number of net connector fixing(s) have worked loose

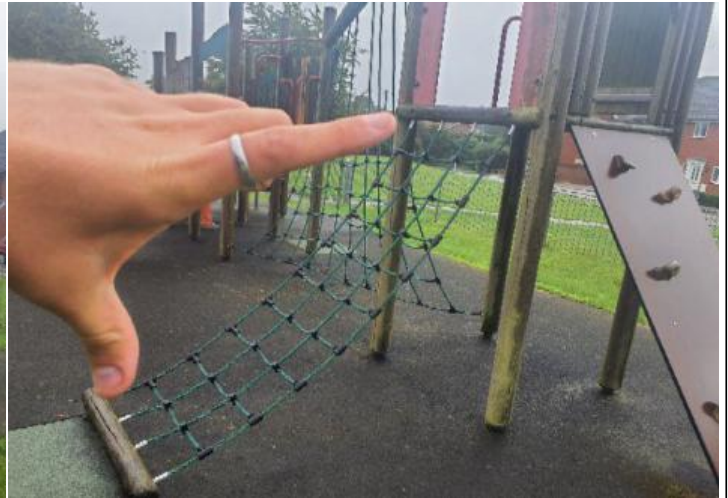
**Finding:** There are falls in excess of 600mm between adjacent components on the structure, in contravention of the recommendations set out in BS EN 1176 Part 1; 4.2.8.4

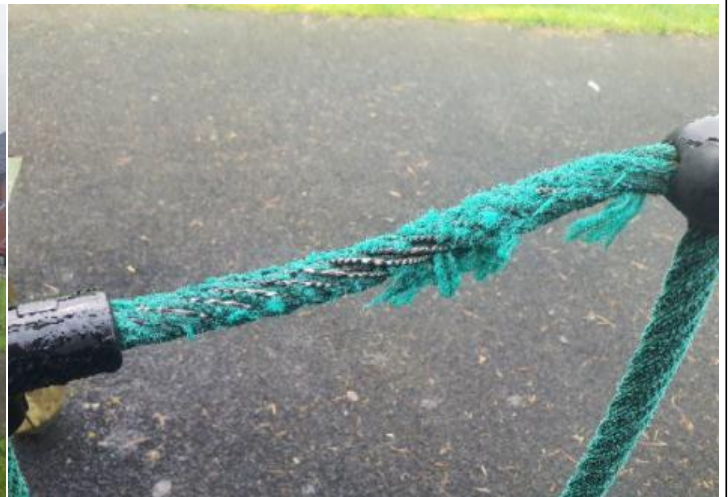
**Finding:** The rope has worn and wire strands are exposed

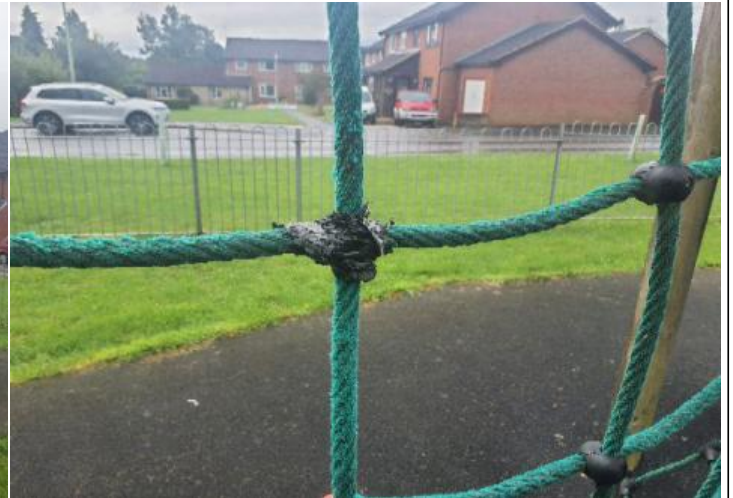
**Finding:** The ropes on this item have been taped and we are unable to fully assess the condition of the rope, ensure no wire strands are broken beneath the tape

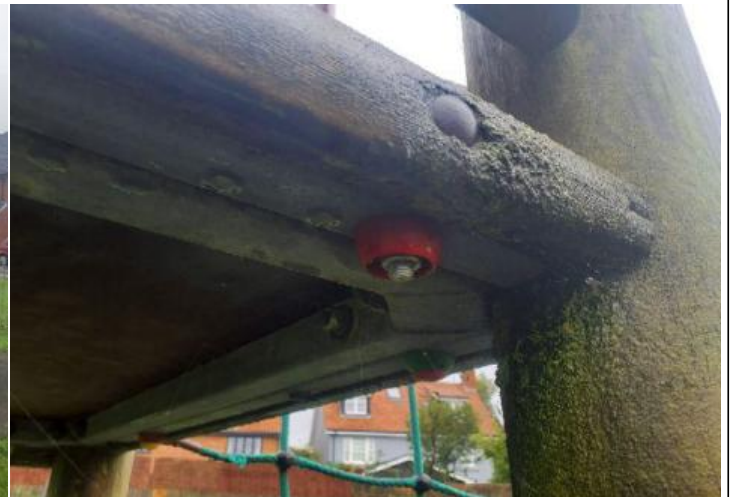
**Finding:** There is/are bolt cap covers missing or damaged on the item

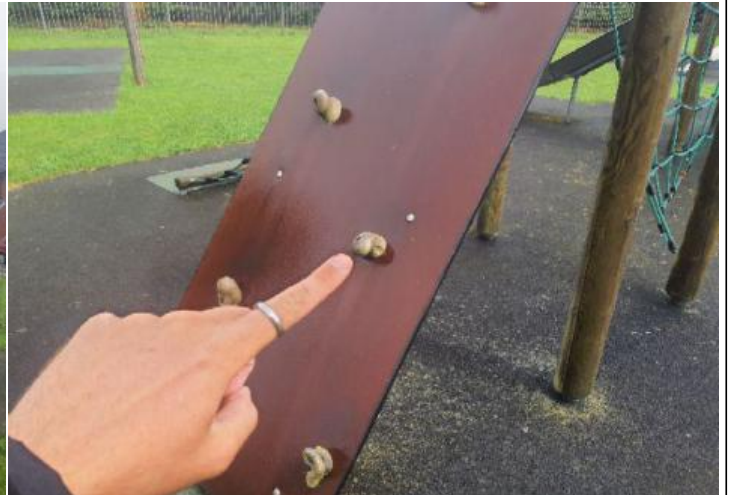
**Finding:** A number of fixing(s) have worked loose

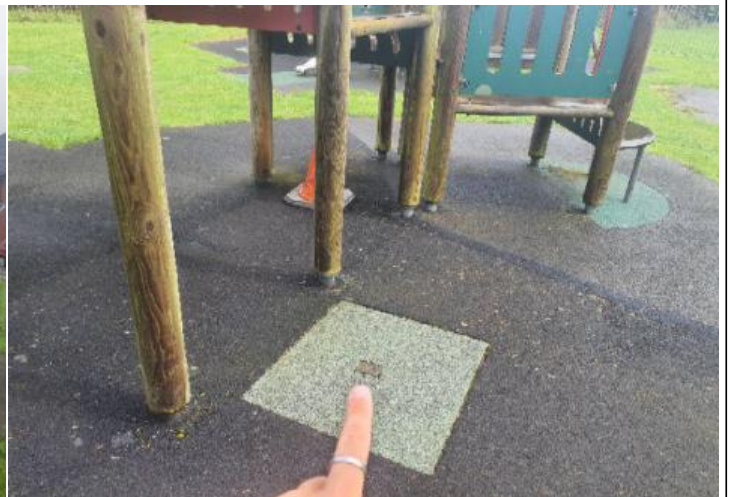
**Finding:** The wet pour has been repaired with bitmac which forms a hard object within the impact area

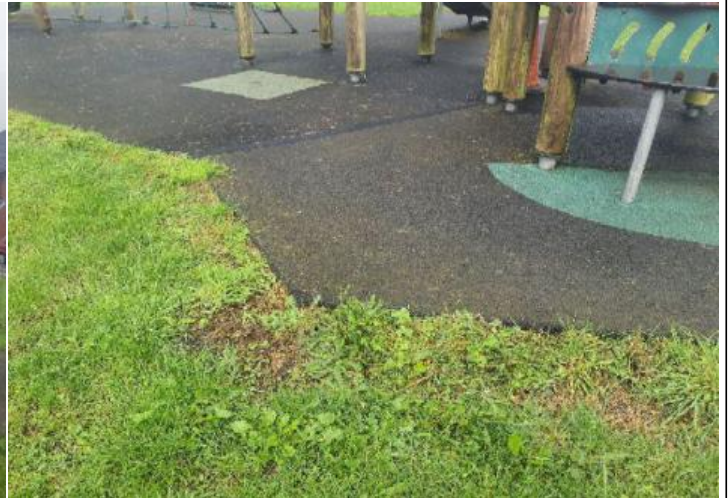
**Finding:** The surface is lifting at the edges and creating trip points
