## Annual Inspection

Melton Parish Council

Beresford Drive Play Area

Beresford Drive, Woodbridge, Suffolk, IP12 1JJ

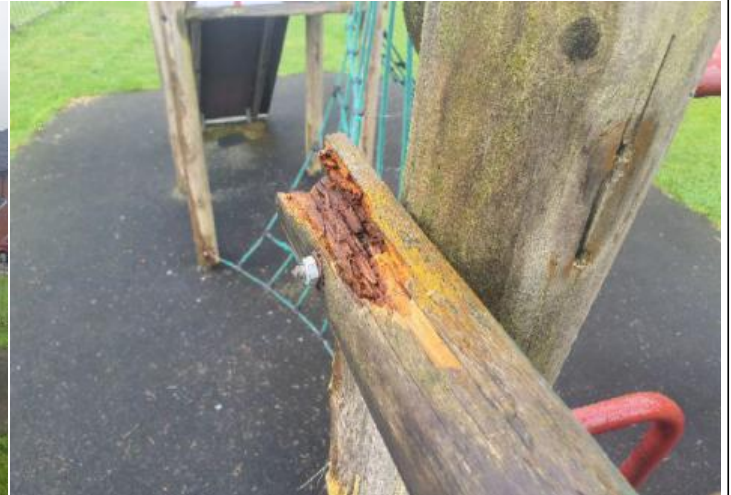
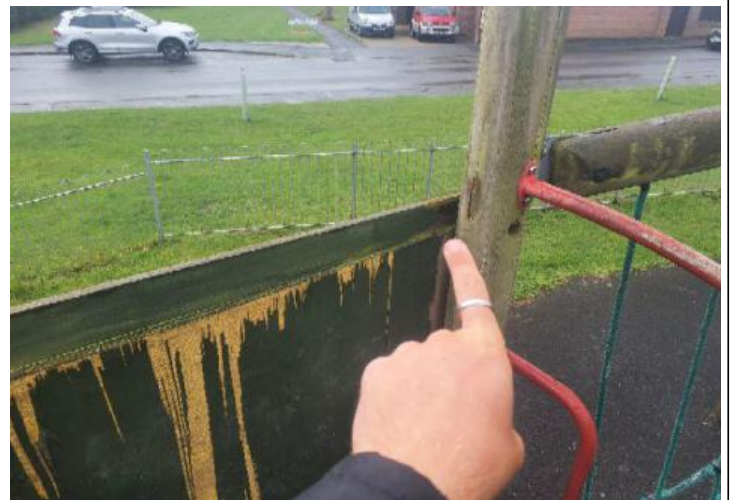
**Finding:** There are areas or parts of the timber on the structure that have rotted

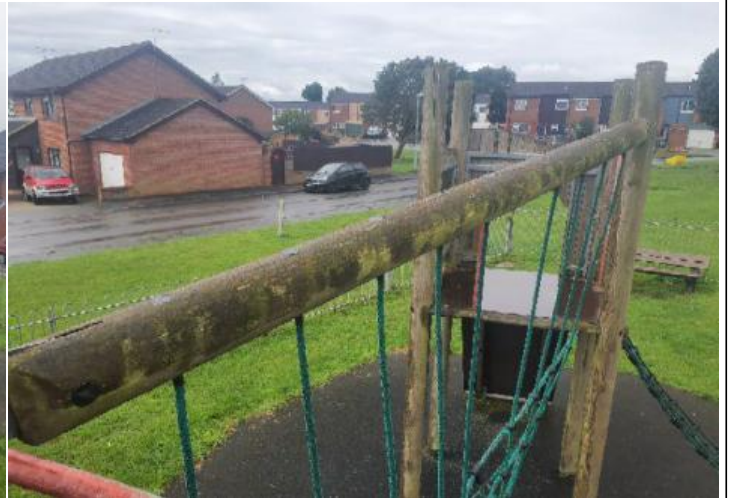
**Finding:** The inspector has some concerns about the internal condition of the timber and was unable to verify the structural integrity without further testing. We recommend a Resi-PD survey to establish the condition of the timber at it's core.

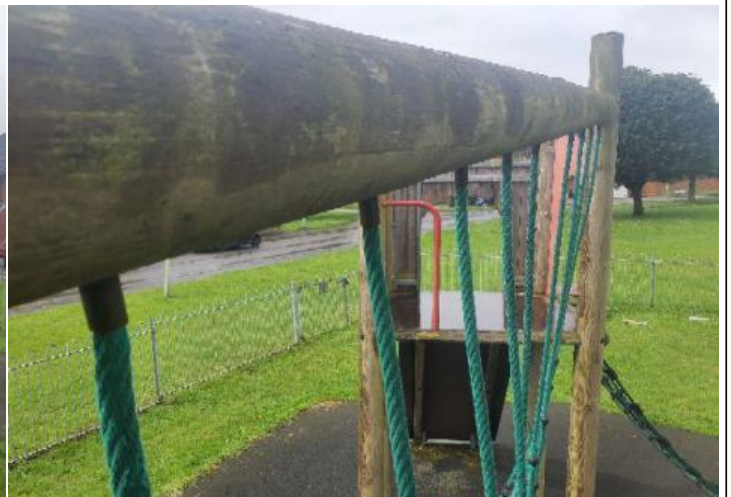
**Finding:** The net connections are corroding

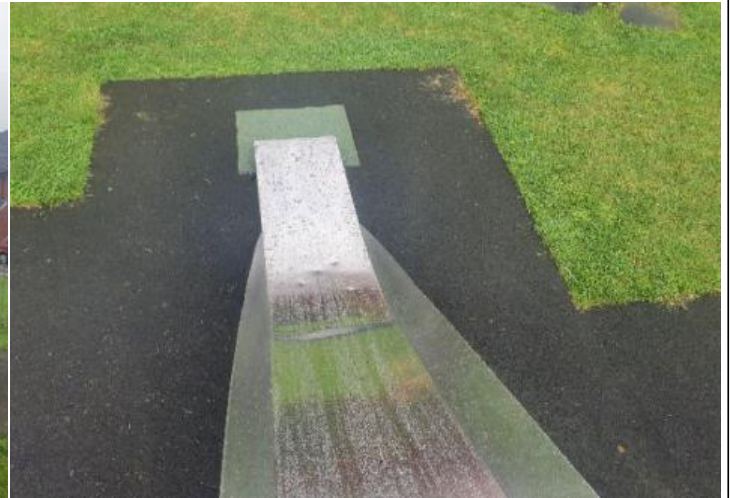
**Finding:** There are a number of dents in the slide surface

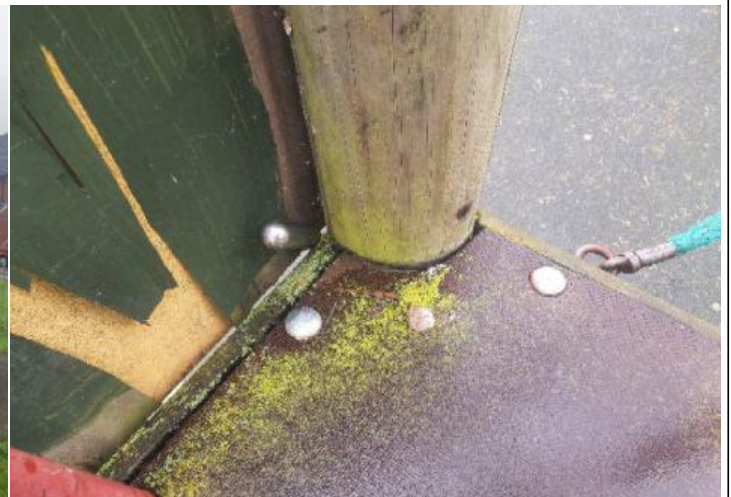
**Finding:** There is/are finger entrapment/s in the platform and the item fails to meet the requirements of BS EN 1176 Part 1 4.2.7.6 Entrapment of fingers

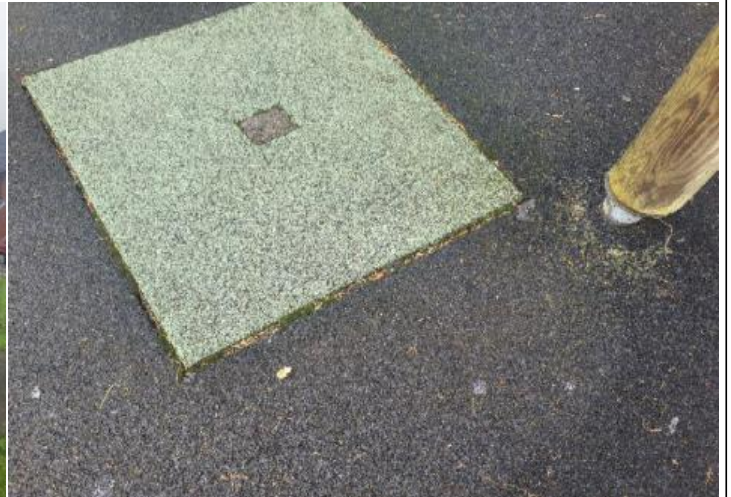
**Finding:** There are gaps opening between the surfacing and the edging surround or between the joints in the surfacing

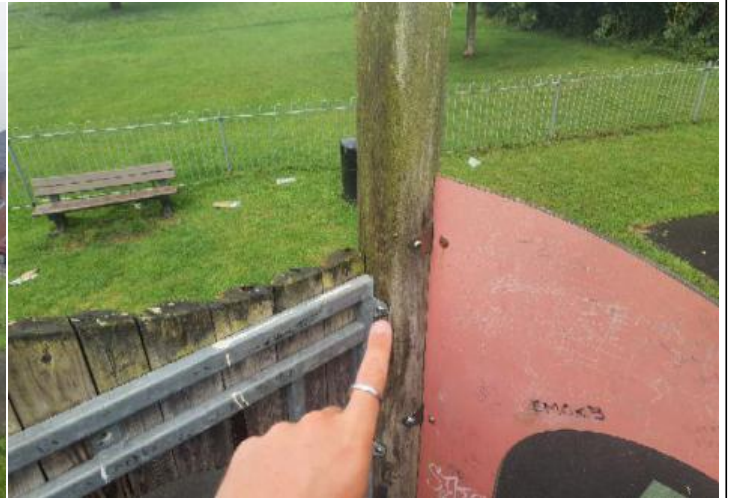
**Finding:** A number of fixing(s) have worked loose

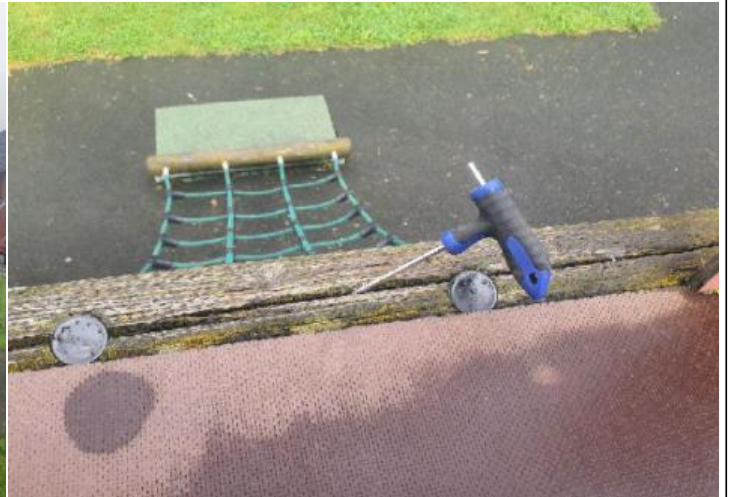
**Finding:** There is some evidence of rot in the timber

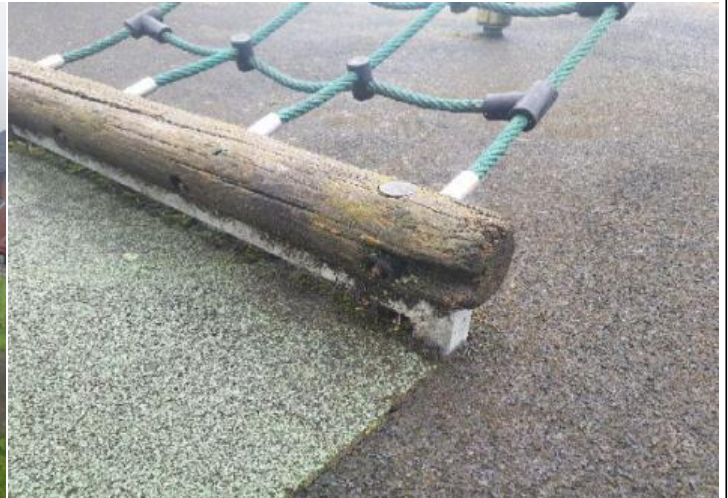
**Finding:** There is some damage to the item

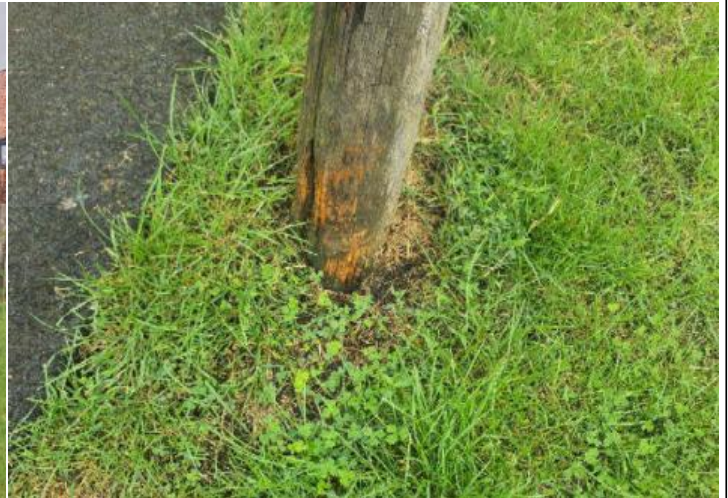
**Finding:** There is some strimmer / machinery damage apparent on the posts, this can penetrate the preservative applied to the timber and accelerate the rotting process

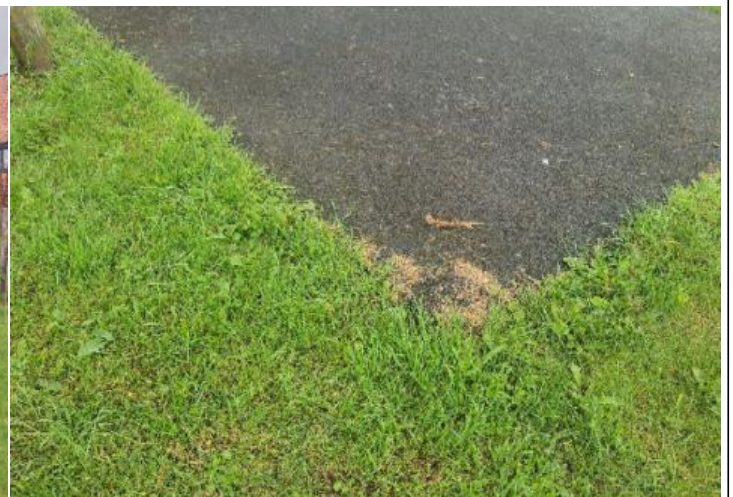
**Finding:** The surface is lifting at the edges and creating trip points  
**Action:** Repair perimeter of surfacing to remove trip points

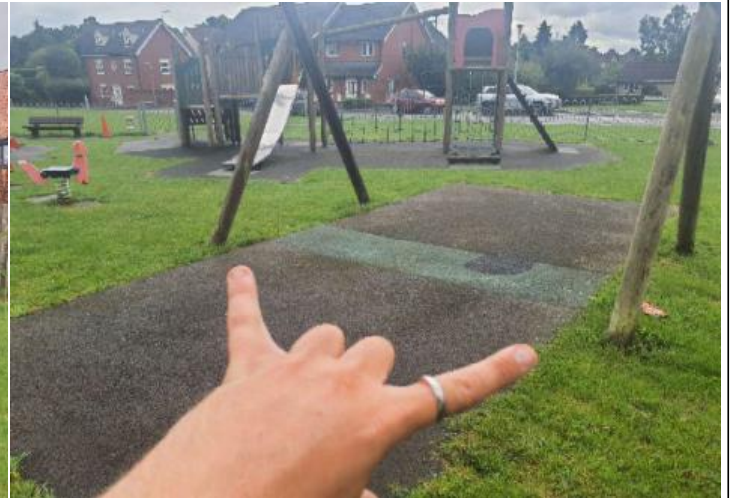
**Finding:** There is some evidence of rot in the timber

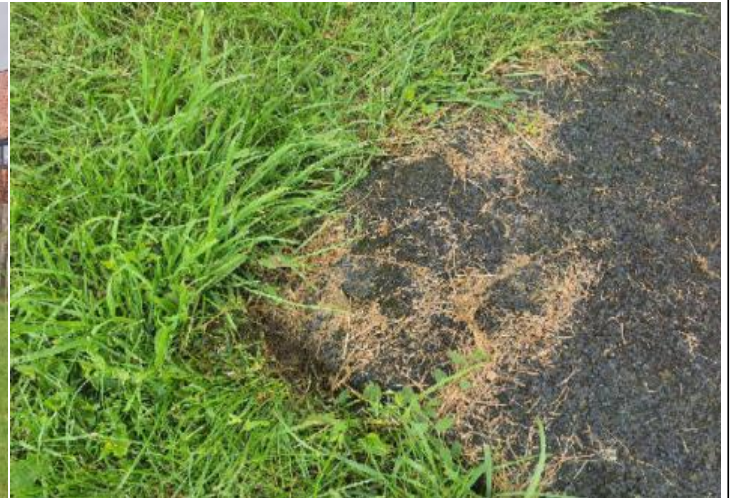
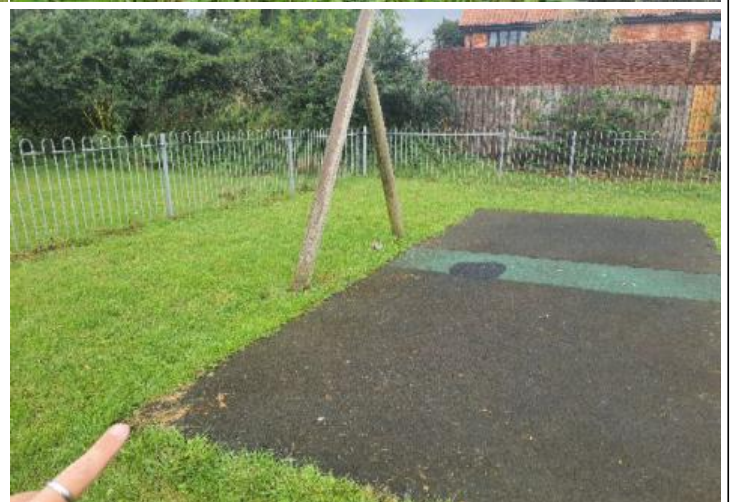
**Finding:** There is some minor damage to the surface

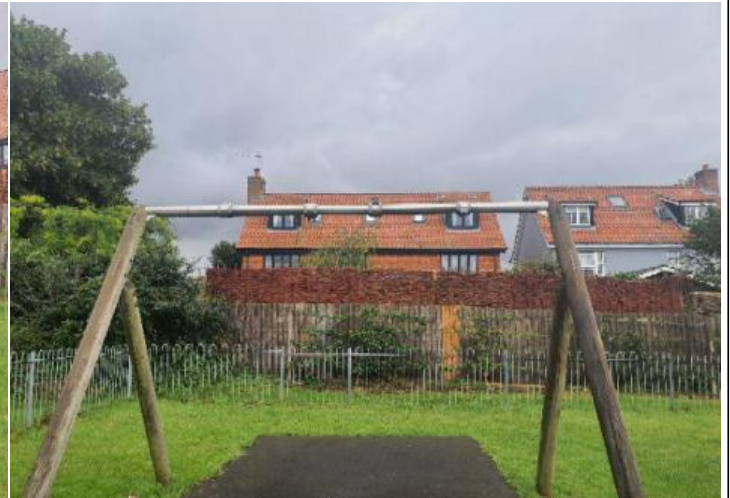
**Finding:** The seat(s) and suspension were missing at the time of inspection and the inspector was unable to make a full compliance assessment
