## Operational Inspection

Melton Parish Council

Melton Recreation Ground  
Melton Road , IP12 1PF

Operational Inspection - 1-September-2023 - 07:37 Inspector Dan Carr

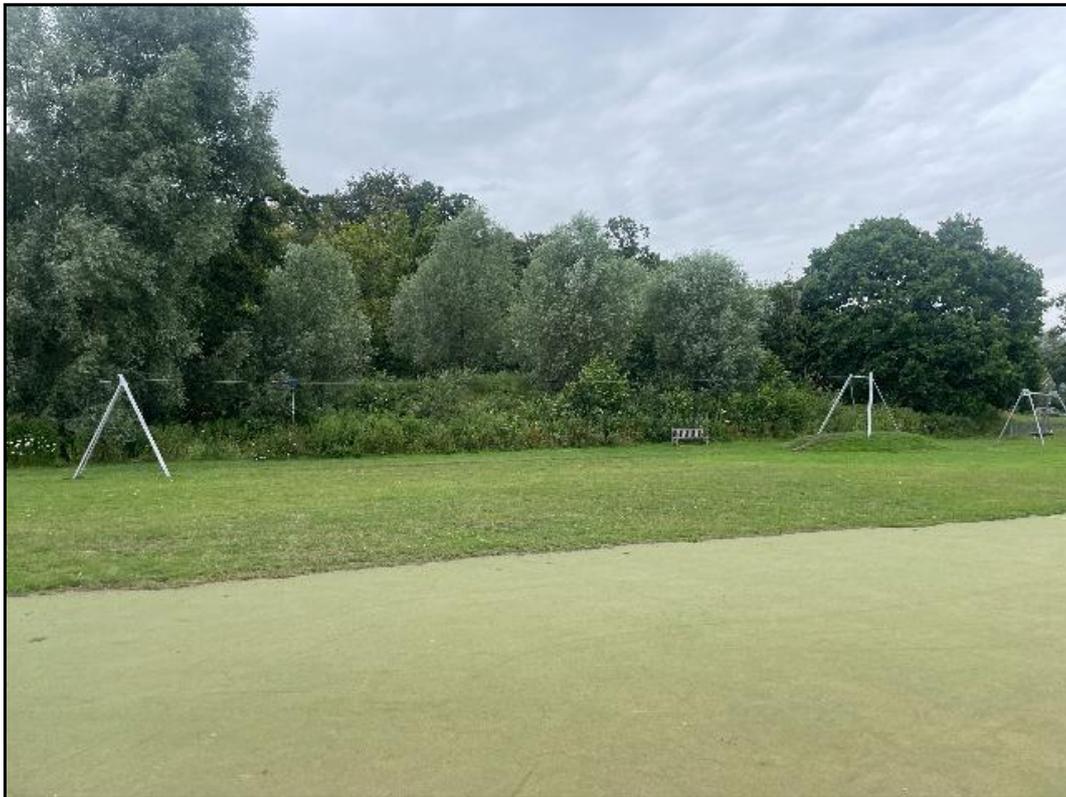
**i** 6 - Low Risk

**Item:** Cable Runway  
**Manufacturer:** Kompan Ltd  
**Surface Type:** Grass  
**Item Quantity:** 1  
**Equipment Compliance:** N/A  
**Surface Area Compliance:** N/A

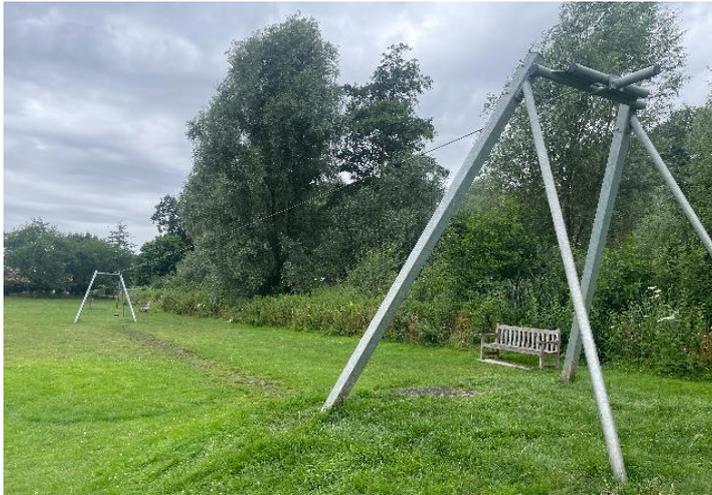
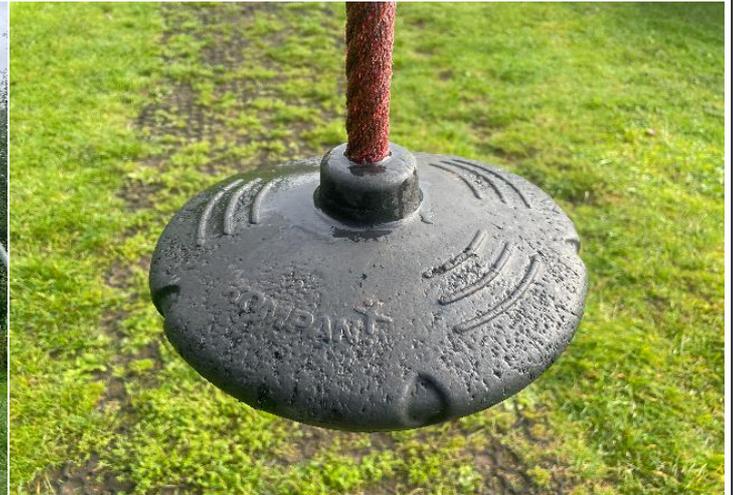
**i** 6 - Low Risk (Finding 2)

**Finding:** The cableway seat has been damaged

**Action:** Monitor for any further deterioration and replace as required

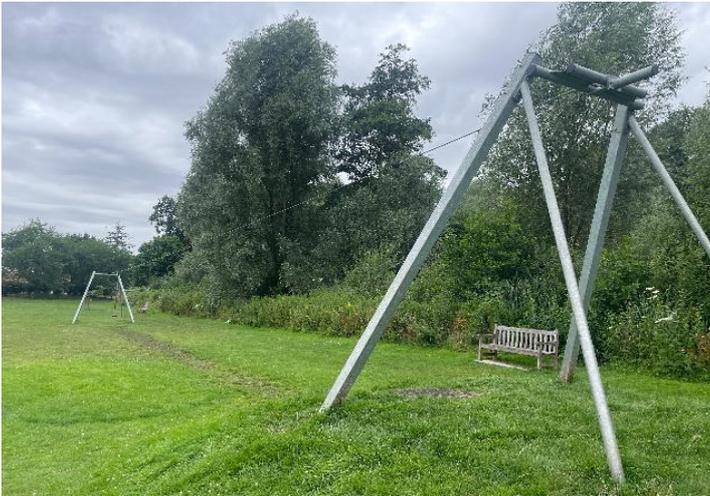
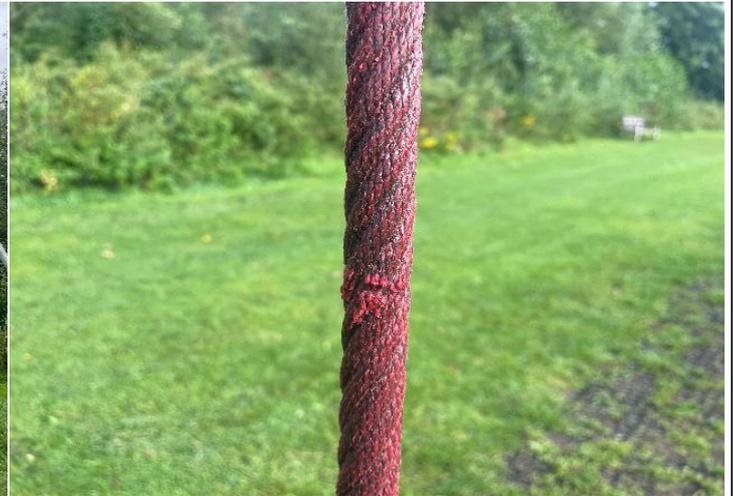
**Finding:** The ropes/nets are worn/damaged in places

**Action:** Monitor for any further deterioration and repair or replace as required

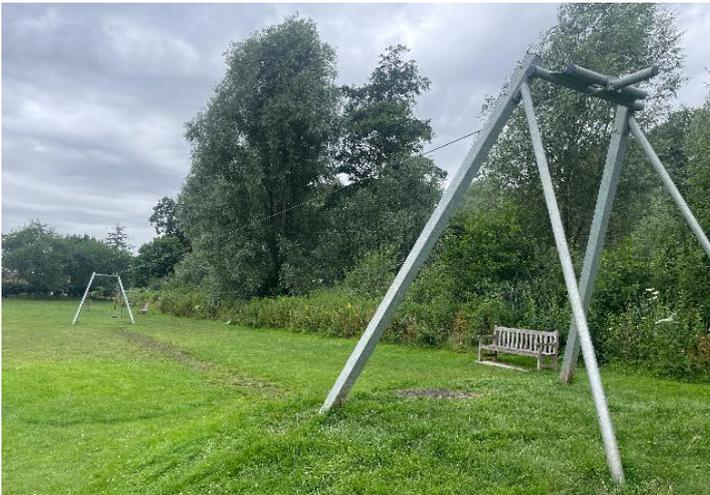
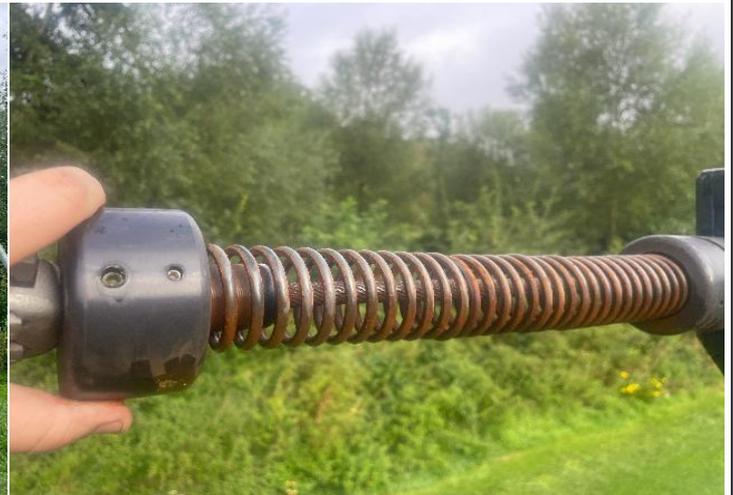
**Finding:** There is surface corrosion / rust present on the item

**Action:** Consider treating the item

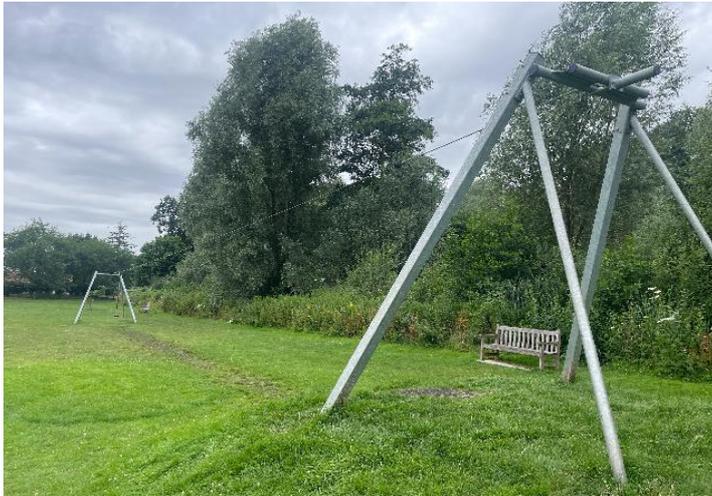
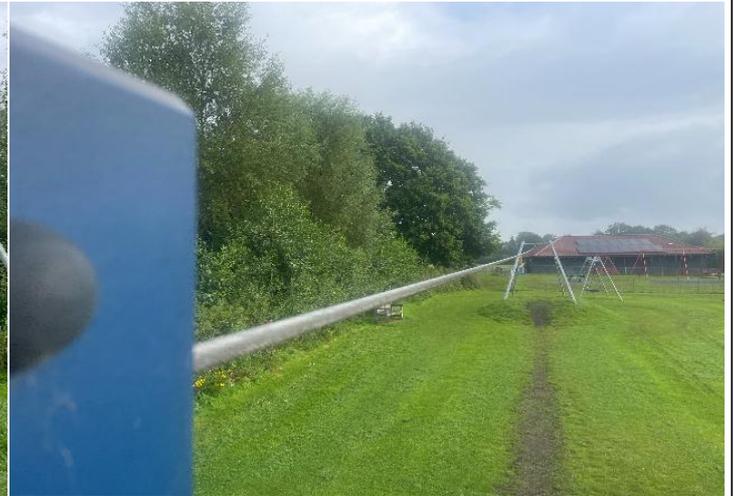
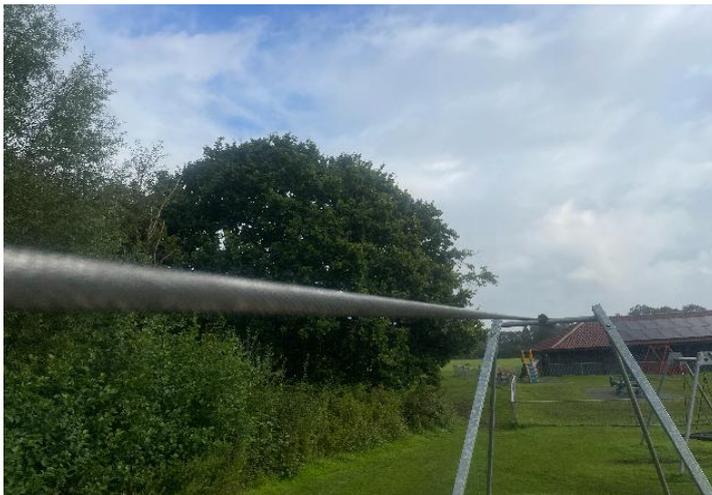
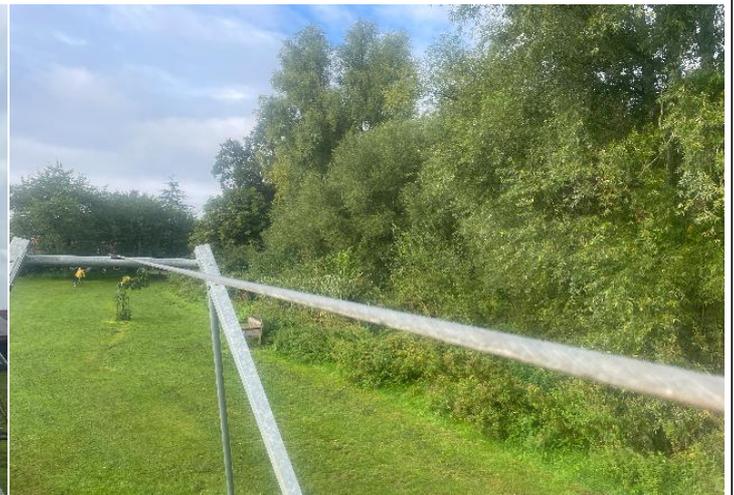
**Finding:** Main cable, buffers and travelling unit inspected

**Action:** Monitor and inspect inline with Manufacturers guidance
