# Pond Condition assessment and management recommendations for Burkes Pond, Melton Parish Council.

## Background:

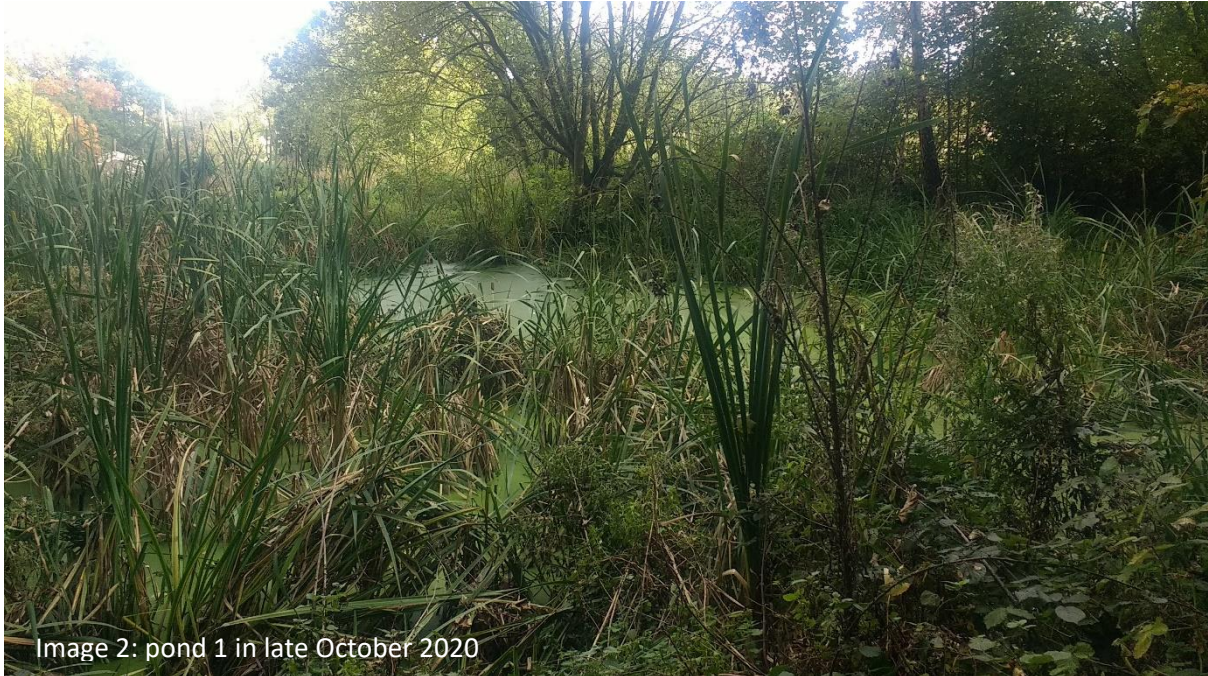
Image 2: pond 1 in late October 2020

An initial visit made in October of 2020 showed pond 1 (115 m<sup>2</sup>) to be in late successional stage, with shaded eutrophic water, dominated with duckweed, encroaching scrubby growth (bramble) low water levels and dominant false bullrush, see image 2 below.

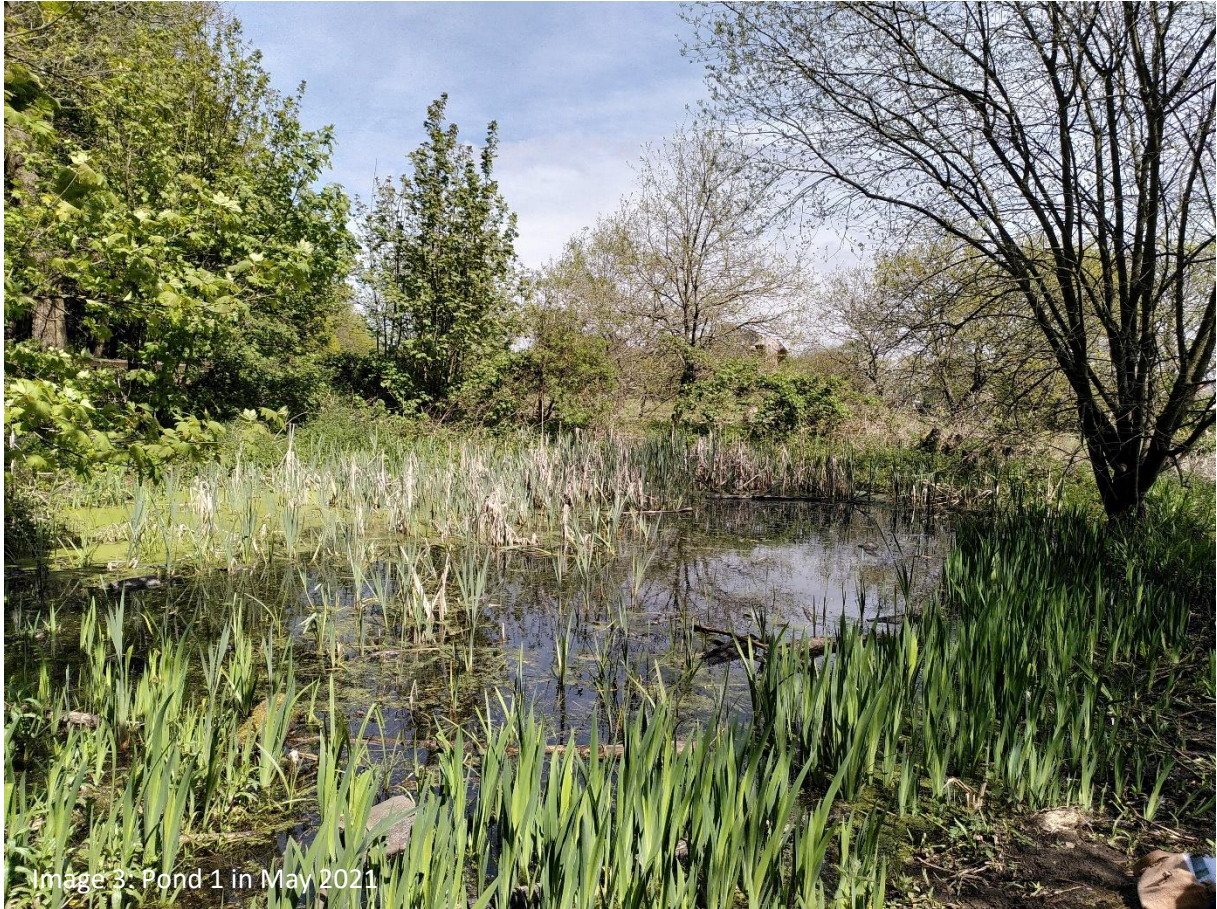
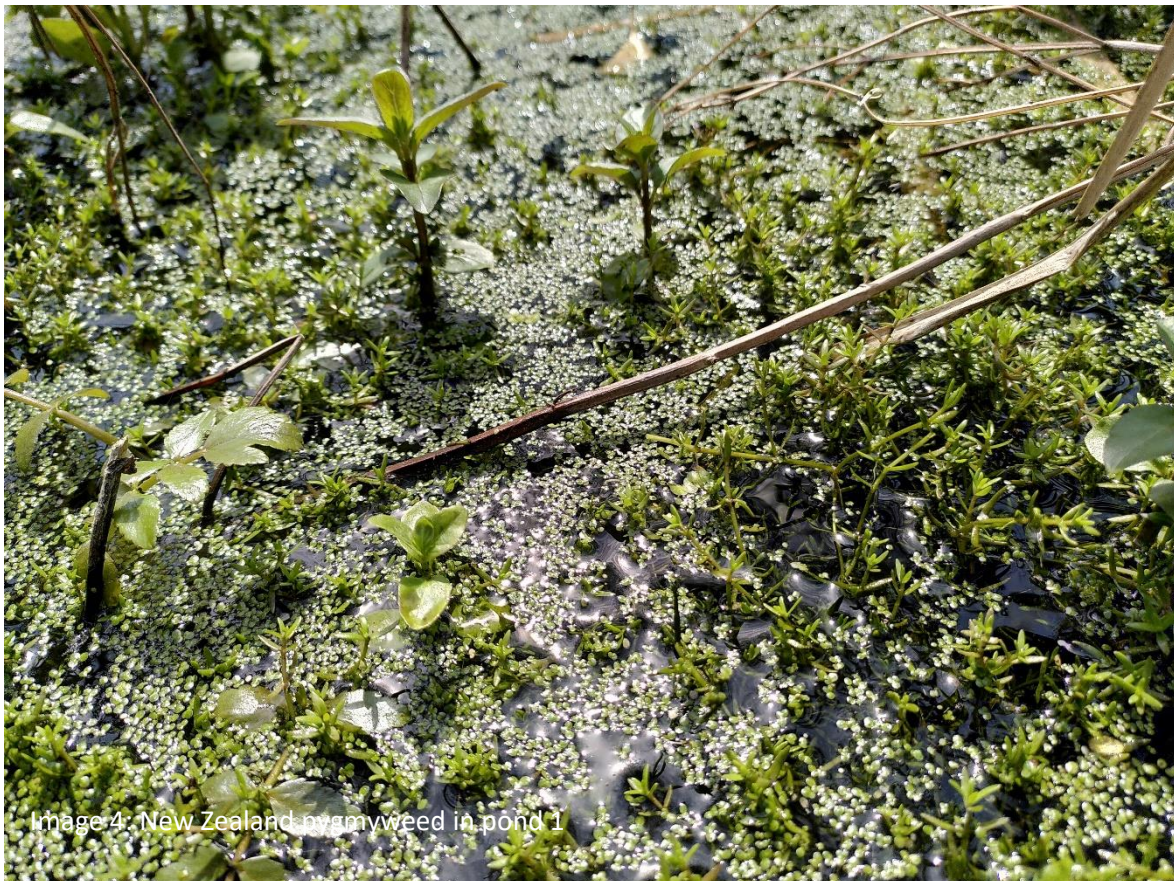
Revisiting pond 1 in May 2021 a very different situation was presented. Works over the winter had cleared much of the encroaching bramble scrub, giving a more open pond surface and accessible banks. Image 3 below. Great numbers of frog tadpoles were present in all the shallow water edges of the pond. Duckweed, false bullrush and flag iris were the dominant plant species. Some low numbers of broadleaved emergent plants were present, including hairy willowherb, water mint, water cress and fools water cress, all of which are also present in distinct patches across the entire of the marshy woodland edge. In addition, the non-native and invasive New Zealand pigmyweed was noted growing in a small patch at the northwest corner, image 4 below. The water was noted to be clear and appeared not to be subject to pollution. It is likely that the duckweed will become dominant again over the summer.

The base of the pond was clearly very silted, with a large volume of leaf litter and some large woody debris which have been added by the locals. There were no floating leaved pond plants as a result of this siltation.

Pond 1 appears to be approaching late-stage succession with the lack of rooted aquatic vegetation across its surface and clear evidence of siltation/organic matter accumulation. The pond may persist at this stage for many years without any intervention necessary but the significant finding of New Zealand pigmyweed and dominance of false bullrush across 50% of its surface suggest that this will not be the case and management would be timely. The presence of a range of emergent marginal plants and clear water suggest a lack of pollution which is positive, the pond has much duckweed suggesting that it is both shaded and eutrophic (nutrient rich).

The below table of management recommendations are listed in order of importance. It is critical that no mechanical intervention is progressed at Pond 1 until New Zealand pigmyweed is suitably contained/controlled. It is likely that interventions here will be limited to small scale hand works in the foreseeable future.

Progress scheme of control and monitoring for New Zealand Pigmyweed	<ul style="list-style-type: none"> <li>- Monitor the habitats across the entirety of this spring fed hillside to ensure spread is caught early.</li> <li>- Develop and implement a scheme of chemical control for the patch that has established within pond 1.</li> <li>- Publicise activities to reduce risks from vegetative spread through vectors such as dogs swimming.</li> </ul>
If control is ineffective, consider risks further	<ul style="list-style-type: none"> <li>- Ineffective control may prompt more extreme action, such as filling the pond in to eradicate the invasive species.</li> <li>- If this is necessary, then creating new ponds will become important, pending no further identified spread.</li> </ul>
Restore pond 2 to provide clean water habitat, provided that no spread of pigmyweed is noted.	<ul style="list-style-type: none"> <li>- Between November and February (to avoid protected species risk), completely desilt pond 2 to original base to re-set the clock of succession.</li> <li>- Utilise skilled contractor with 360° excavator.</li> <li>- Reduce shading through selective removal of trees to S and SE of pond.</li> <li>- Remove all false bullrush and vast majority of organic sediments.</li> <li>- Spread material thinly on downslope side of pond bank.</li> <li>- Ensure that outfall area is maintained at current level.</li> </ul>

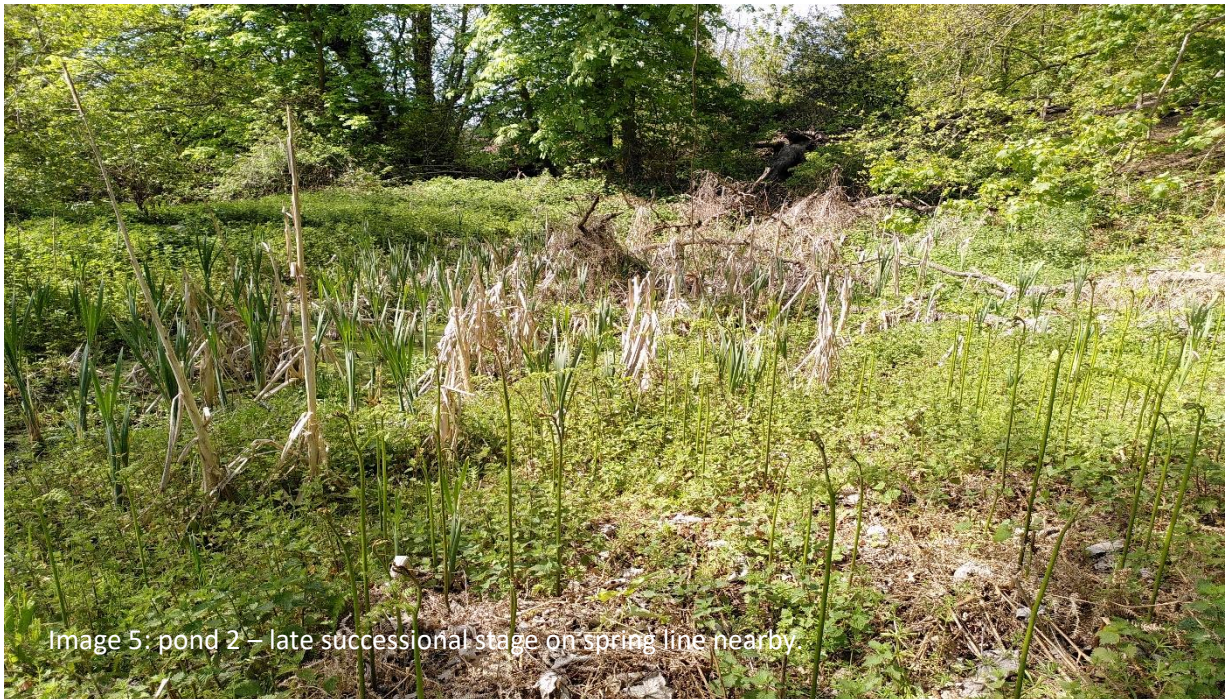
Image 5: pond 2 – late successional stage on spring line nearby

Pond 2 (58m<sup>2</sup>) sits at the head of an emergent spring watercourse and appears to have been artificially created here with an adjacent bank of built-up material. This pond is also in late successional stages, dominated by false bullrush. The pond supports a similar range of species to Pond 1, water cress and water mint are key emergent plants and bittersweet is added to the list as a late-stage colonist. The pond clearly has a deep organic sediment base and is somewhat shaded by adjacent willow and sycamore trees.

Pond 2 is rather further in its process of succession than pond 1. Water quality appears to be good, if eutrophic, and some flow was noted. This pond presents a good opportunity to restore a small clean water wildlife habitat, and managed in conjunction with pond 1 presents a nice opportunity to create a habitat network.

Identify areas to dig series of small ponds on slope, creating a freshwater habitat mosaic.	<ul style="list-style-type: none"> <li>- Create a mosaic of wetland pond habitat across the hillside, utilising the spring water flow to ensure that ponds are full year-round.</li> <li>- Ensure that NZ pigmyweed is under control and not spreading away from Pond 1 in first instance.</li> <li>- Target areas that have wet soil year-round, ponds on spring fed streams are useful, as are pond in existing flats or depressions.</li> <li>- Create soil bunds with arising material.</li> <li>- Avoid areas already dominated with false bullrush.</li> <li>- See map below for indicative layout of how this project could look.</li> </ul>
The following recommendations are assuming successful control and monitoring of NZ pigmyweed.	
Reduce shading at pond 1.	<ul style="list-style-type: none"> <li>- Once NZ pigmyweed under control and monitoring, some careful reduction in shading at pond 1 will be beneficial, the bank to the SE hosts willow, sycamore and birch that could be effectively coppiced to reduce shading</li> </ul>
