Annual Inspection

Melton Parish Council

Beresford Drive Play Area

Beresford Drive, Woodbridge, Suffolk, IP12 1JJ

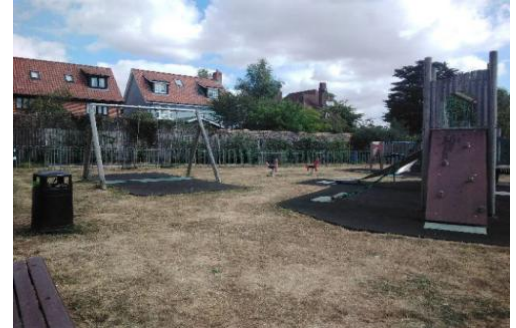
Item: Site General
Manufacturer: Owner/Operator
Surface Type: N/A
Item Quantity: 1
Equipment Compliance: N/A
Surface Area Compliance: N/A

There is weed / vegetation growth on, between, or around the edges of the surfacing - Remove weed / vegetation growth

There is some minor damage to the surface - Monitor for any further deterioration and repair as required

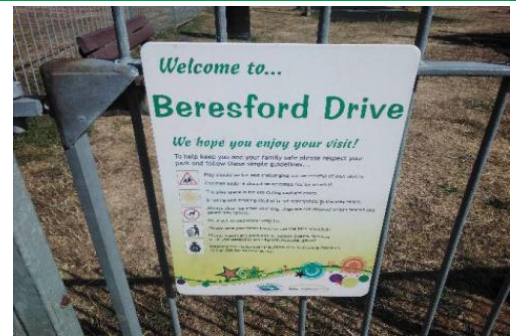
Item: Sign
Manufacturer: Owner/Operator
Surface Type: N/A
Item Quantity: 1
Equipment Compliance: N/A
Surface Area Compliance: N/A

A sign is damaged - Replace

8 - Low Risk

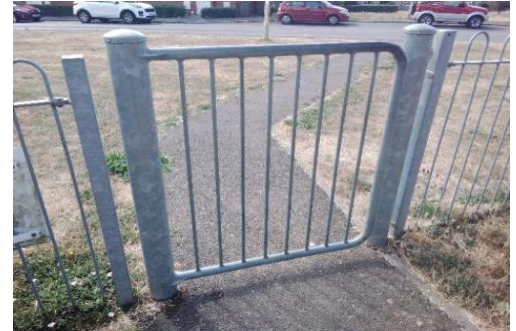
Item: Gate - Self Closing
Manufacturer: Medway Gate Co.
Surface Type: Bitmac
Item Quantity: 1
Equipment Compliance: N/A
Surface Area Compliance: N/A

There are trip hazards at the edges of the surface - Reinstate surrounding surface levels to remove the trip points

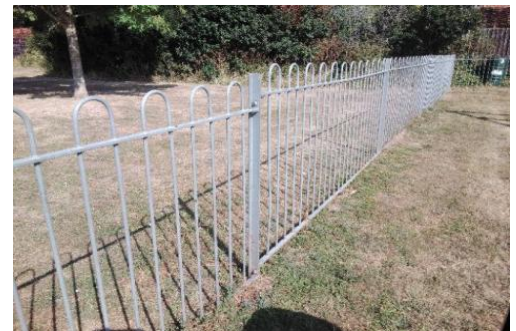
Item: Fence - Bow Top
Manufacturer: Not Identified
Surface Type: Grass
Item Quantity: 1
Equipment Compliance: N/A
Surface Area Compliance: N/A

There is some damage to the fence sections - Monitor for any further deterioration and repair as required

There are a number of loose posts around the fence - Monitor for any further deterioration and reset as required

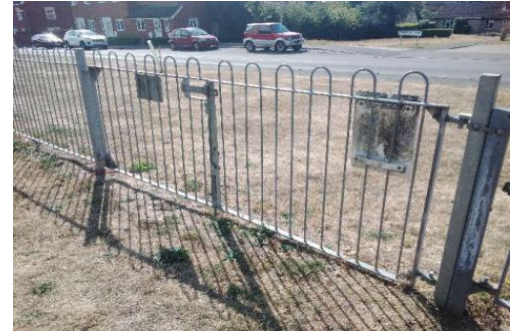
Item: Gate - Maintenance
Manufacturer: Not Identified
Surface Type: Grass
Item Quantity: 1
Equipment Compliance: N/A
Surface Area Compliance: N/A

There is no padlock on the maintenance gate - Provide a padlock to secure the gate

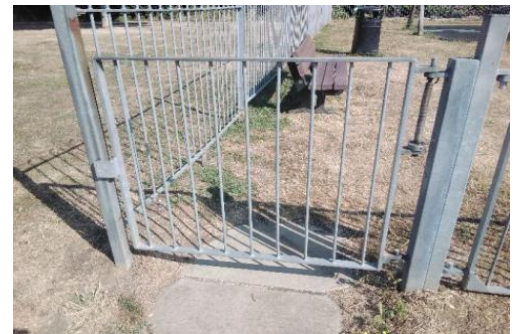
Item: Gate - Self Closing
Manufacturer: Not Identified
Surface Type: Paving Slabs
Item Quantity: 1
Equipment Compliance: N/A
Surface Area Compliance: N/A

A number of fixing(s) have worked loose - Secure all loose fixings

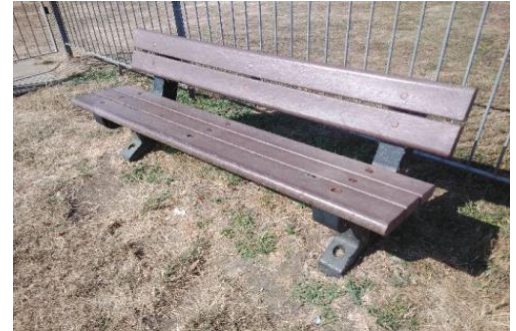
Item: Bench
Manufacturer: Broxap
Surface Type: Grass
Item Quantity: 1
Equipment Compliance: N/A
Surface Area Compliance: N/A

There is some evidence of fire damage to the item - Monitor for any further deterioration and repair as required

The fixings have corroded excessively - Replace all corroded fixings

The surface has eroded in some areas and may be slippery in wet conditions - Reinstate the surface

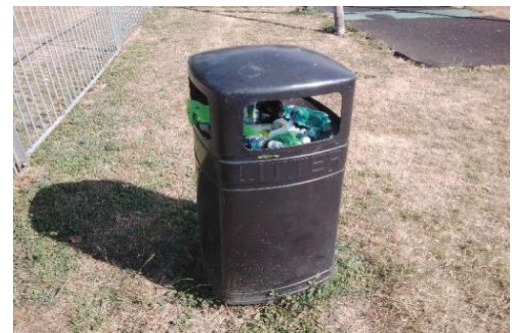
Item: Litter Bin
Manufacturer: Not Identified
Surface Type: Grass
Item Quantity: 1
Equipment Compliance: N/A
Surface Area Compliance: N/A

The lid or door of the litter bin is not secured - Ensure the lid or door is kept locked

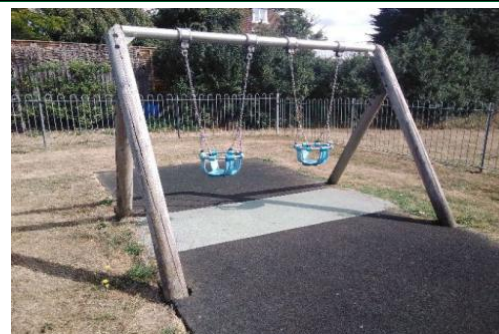
Item: 1 Bay 2 Seat (Cradle)
Manufacturer: Playdale Playgrounds Ltd
Surface Type: Wet Pour
Item Quantity: 1
Equipment Compliance: Yes
Surface Area Compliance: Yes

There are trip hazards at the edges of the surface - Reinstate surrounding surface levels to remove the trip points

There are gaps opening between the surfacing and the edging surround or between the joints in the surfacing - Monitor for any further deterioration and repair as required

The swivel joint is becoming worn - Monitor for any further deterioration and replace

The timber has a number of splits/shakes or air cracks and this may affect the stability or allow water ingress which will accelerate the rotting process - Monitor to ensure the splits do not cross through fixing points of the structure and/or cause any instability

There is some strimmer / machinery damage apparent on the posts, this can penetrate the preservative applied to the timber and accelerate the rotting process - Monitor for any deterioration (rot) and replace as required

There are caps missing from the underside of the seats - Replace missing caps under the seats

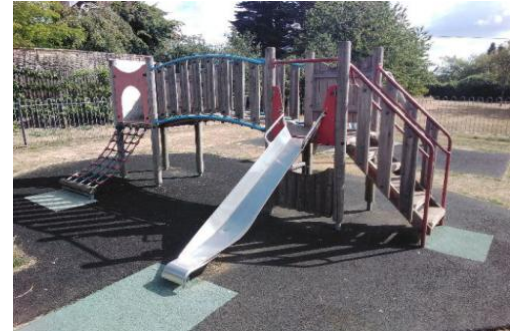
Item: Multi Play (Toddler)
Manufacturer: Playdale Playgrounds Ltd
Surface Type: Wet Pour
Item Quantity: 1
Equipment Compliance: No
Surface Area Compliance: Yes

There are trip hazards at the edges of the surface - Reinstate surrounding surface levels to remove the trip points

There are gaps opening between the surfacing and the edging surround or between the joints in the surfacing - Monitor for any further deterioration and repair as required

There is/are bolt cap covers missing or damaged on the item - Replace missing or damaged bolt cap covers

There is some evidence of rot in the timber - Monitor for any further deterioration and replace as required

There are falls in excess of 600mm between adjacent components on the structure, in contravention of the recommendations set out in BS EN 1176 Part 1; 4.2.8.4 - Monitor - No remedial work recommended

There are significant gaps (over 30mm) between the surface and the edging or between the joints in the surface; these are large enough for a small foot to enter - Repair surfacing

There are a number of dents in the slide surface - Monitor for any further deterioration and repair as required

There are splits in the timber running through fixing points and creating some instability in the structure - Replace all affected timber parts

A barrier has been replaced and there protruding fixings beneath - Remove the protruding fixings

A number of fixing(s) have worked loose - Secure all loose fixings

There are areas or parts of the timber on the structure that have rotted - Replace all affected timbers

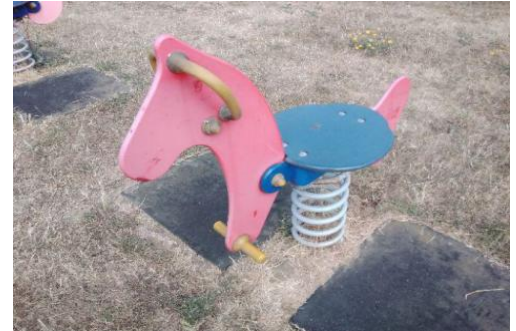
Item: Spring Horse
Manufacturer: Ledon
Surface Type: Rubber Tiles
Item Quantity: 1
Equipment Compliance: No
Surface Area Compliance: Yes

The end of handgrips and/or footrests have a cross section of less than 15cm² and fail to meet the requirements of BS EN 1176 Part 6 - Monitor - No remedial work recommended

There is algae, silt or moss growth on the surface resulting in slippery conditions - Clean and treat appropriately

The U bolts clamping the spring are worn - Monitor for any further deterioration and replace as required

There is some minor damage to the surface - Monitor for any further deterioration and repair as required

The paintwork on this item has been damaged or worn exposing the metal underneath which is rusting - Treat any rusting components and repaint

There is/are bolt cap covers missing or damaged on the item - Replace missing or damaged bolt cap covers

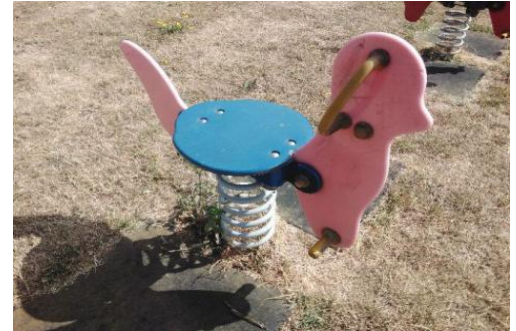
Item: Spring Bird
Manufacturer: Ledon
Surface Type: Rubber Tiles
Item Quantity: 1
Equipment Compliance: No
Surface Area Compliance: Yes

There is algae, silt or moss growth on the surface resulting in slippery conditions - Clean and treat appropriately

The U bolts clamping the spring are worn - Monitor for any further deterioration and replace as required

The paintwork on this item has been damaged or worn exposing the metal underneath which is rusting - Treat any rusting components and repaint

The end of handgrips and/or footrests have a cross section of less than 15cm² and fail to meet the requirements of BS EN 1176 Part 6 - Monitor - No remedial work recommended

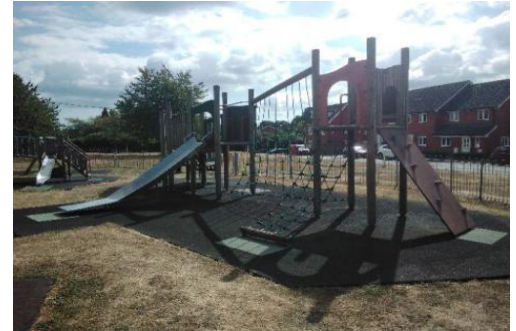
Item: Multi Play (Junior)
Manufacturer: Playdale Playgrounds Ltd
Surface Type: Wet Pour
Item Quantity: 1
Equipment Compliance: No
Surface Area Compliance: Yes

There are trip hazards at the edges of the surface - Reinstate surrounding surface levels to remove the trip points

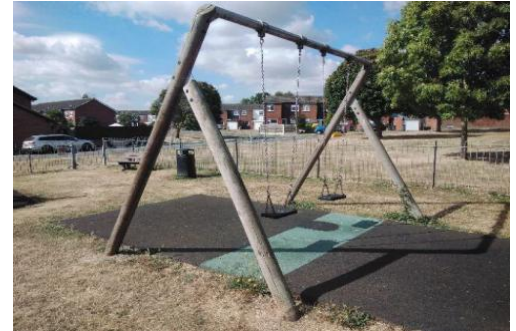
Item: 1 Bay 2 Seat (Flat)
Manufacturer: Playdale Playgrounds Ltd
Surface Type: Wet Pour
Item Quantity: 1
Equipment Compliance: No
Surface Area Compliance: Yes

There is some strimmer / machinery damage apparent on the posts, this can penetrate the preservative applied to the timber and accelerate the rotting process - Monitor for any deterioration (rot) and replace as required

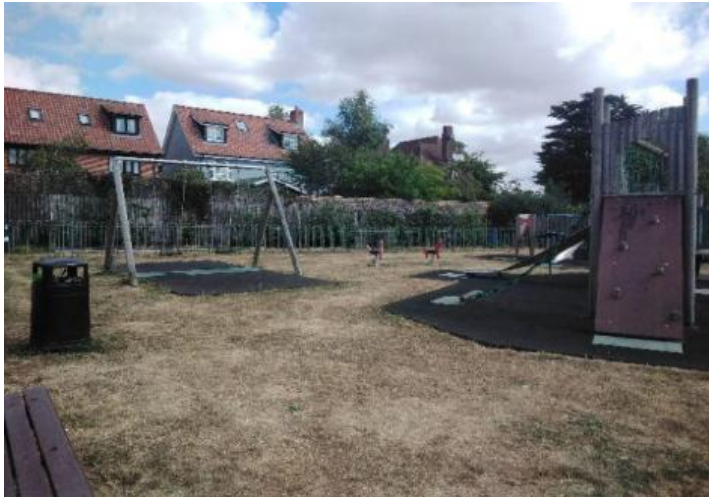
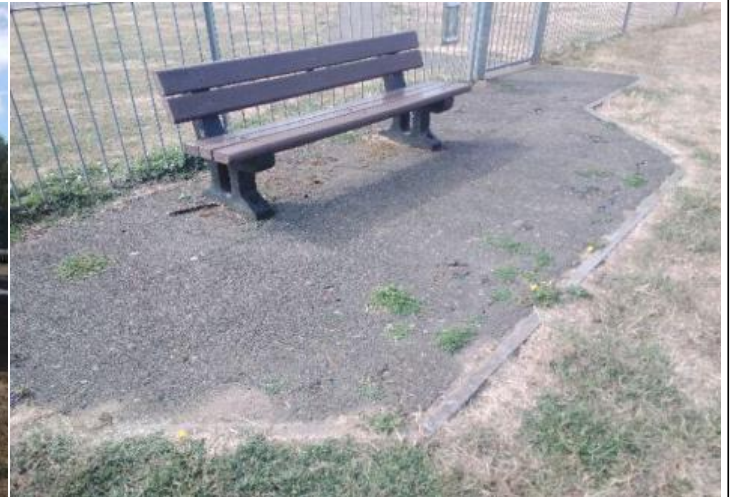
Item: Ancillary Items - Site General
Manufacturer: Owner/Operator

Finding: There is weed / vegetation growth on, between, or around the edges of the surfacing **Action:** Remove weed / vegetation growth

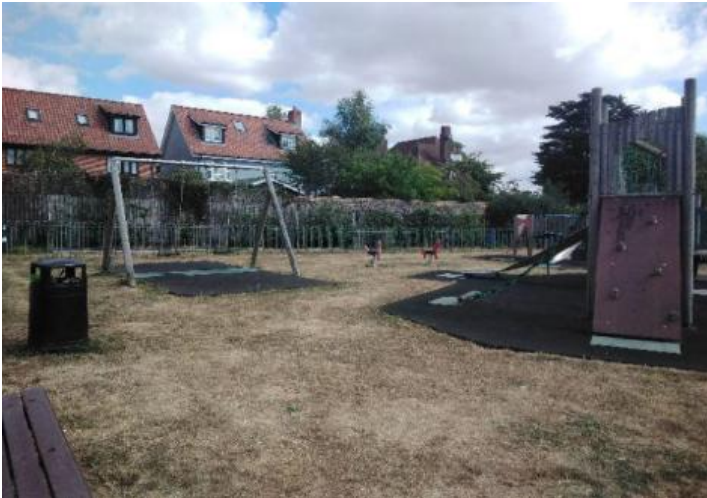
Item: Ancillary Items - Site General
Manufacturer: Owner/Operator

Finding: There is some minor damage to the surface

Action: Monitor for any further deterioration and repair as required

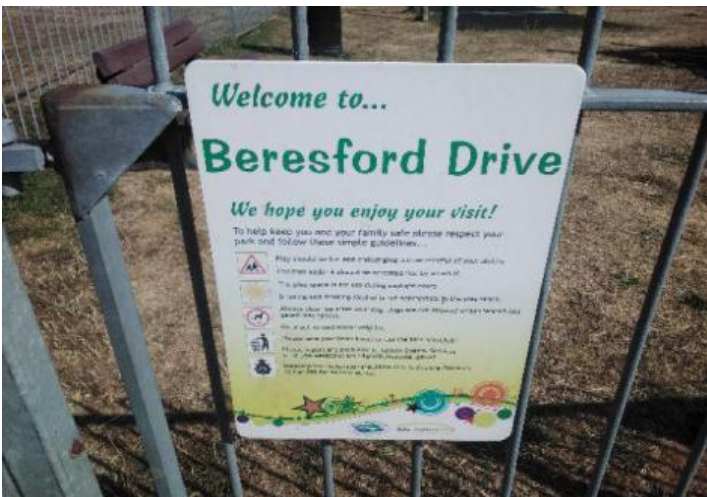
Item: Ancillary Items - Sign
Manufacturer: Owner/Operator

Finding: A sign is damaged

Action: Replace

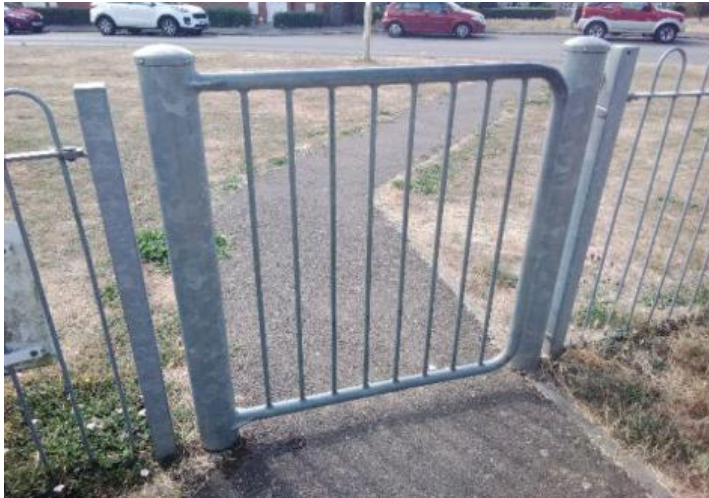
Item: Gates - Gate - Self Closing
Manufacturer: Medway Gate Co.

Finding: There are trip hazards at the edges of the surface

Action: Reinstate surrounding surface levels to remove the trip points

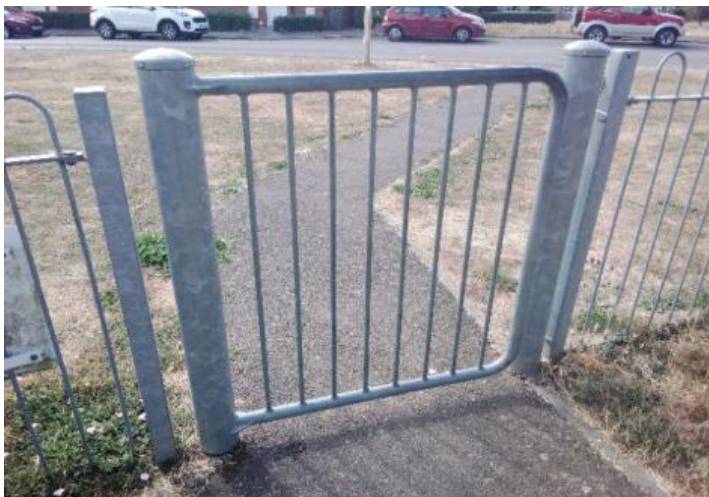
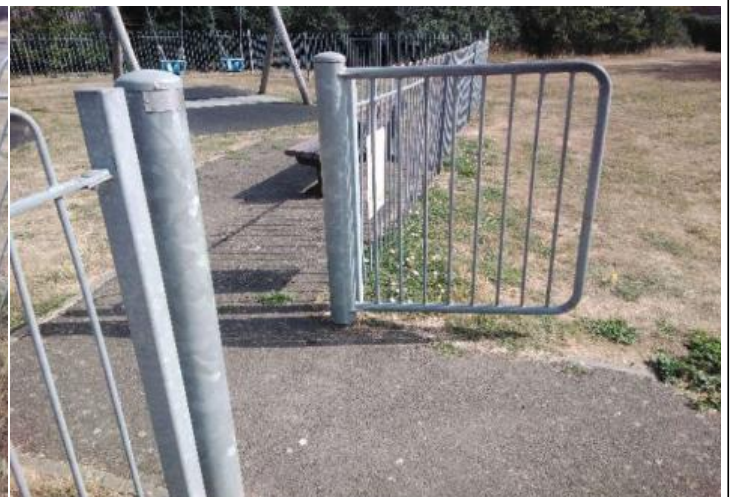
Item: Gates - Gate - Self Closing
Manufacturer: Medway Gate Co.

Finding: The gate is not operating correctly

Action: Take effective action to ensure the gate closes between 4 and 8 seconds

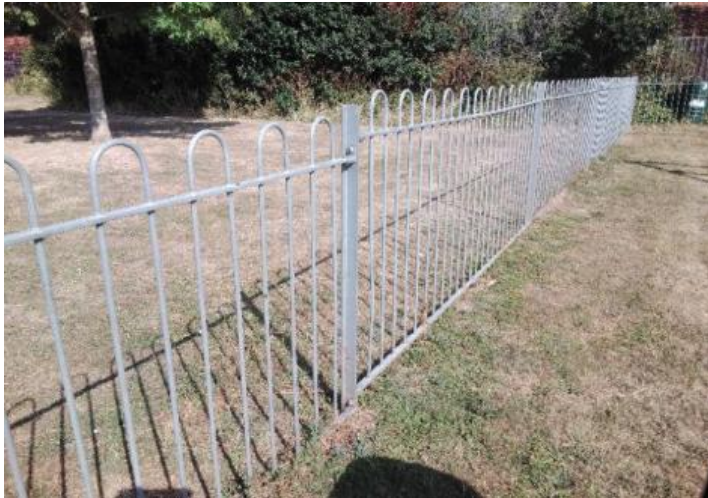
Item: Fences - Fence - Bow Top
Manufacturer: Not Identified

Finding: There is some damage to the fence sections

Action: Monitor for any further deterioration and repair as required

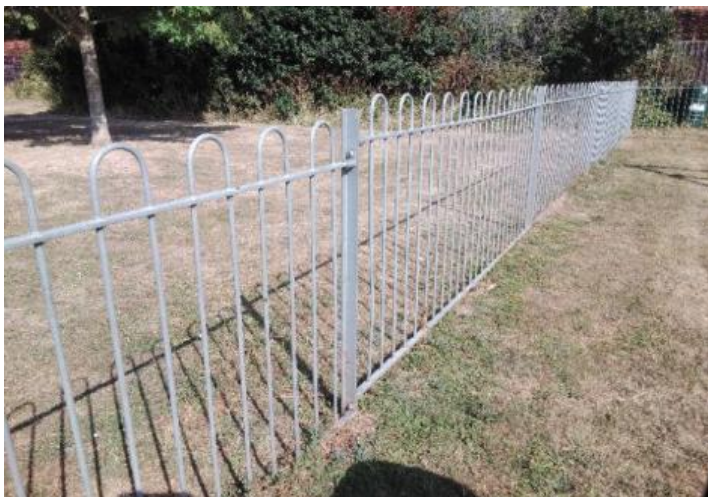
Item: Fences - Fence - Bow Top
Manufacturer: Not Identified

Finding: There are a number of loose posts around the fence

Action: Monitor for any further deterioration and reset as required

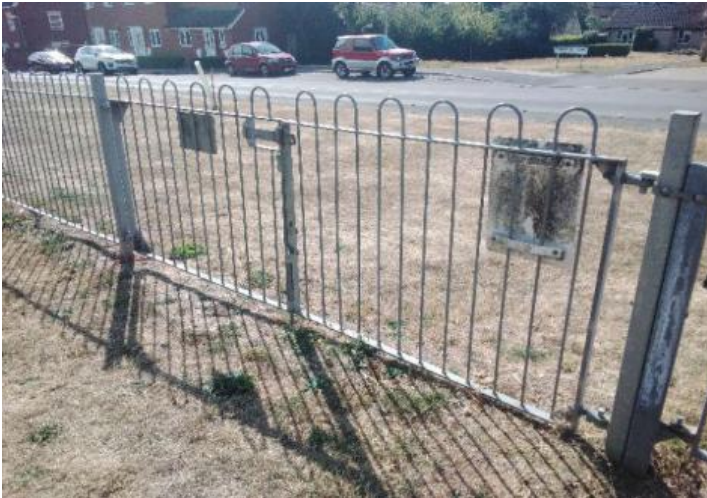
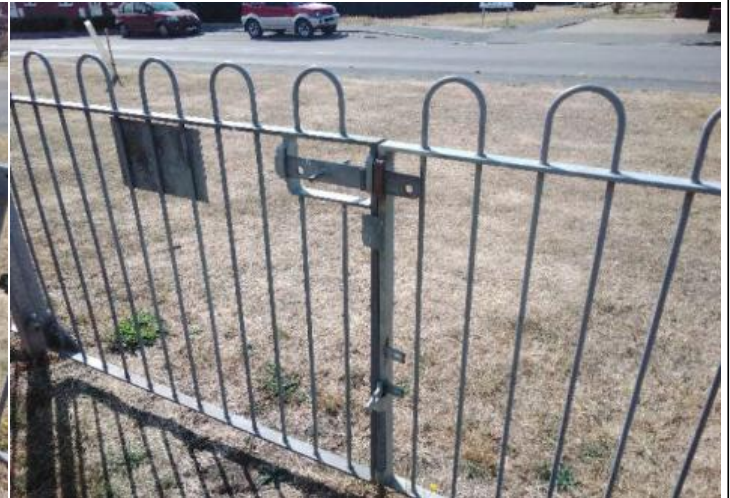
Item: Gates - Gate - Maintenance
Manufacturer: Not Identified

Finding: There is no padlock on the maintenance gate

Action: Provide a padlock to secure the gate

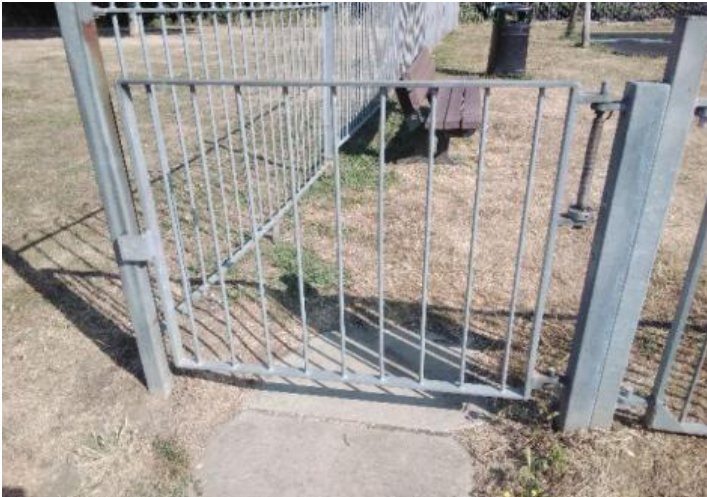
Item: Gates - Gate - Self Closing
Manufacturer: Not Identified

Finding: A number of fixing(s) have worked loose

Action: Secure all loose fixings

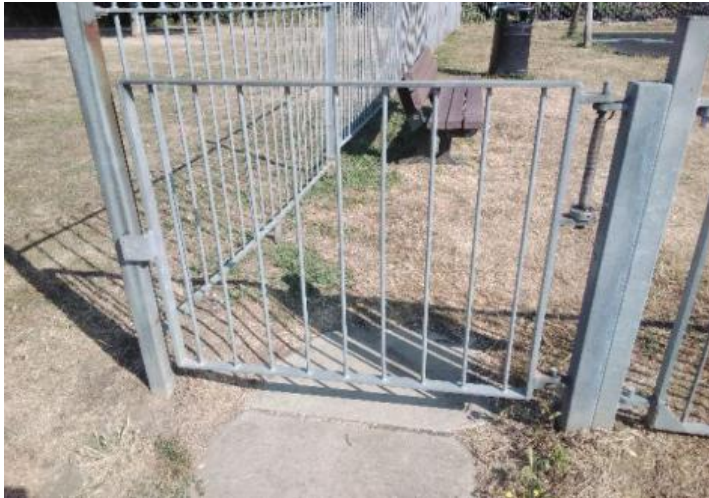
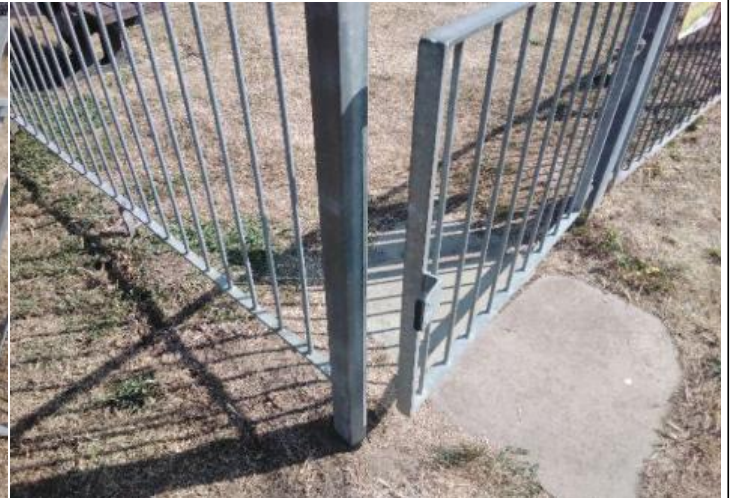
Item: Gates - Gate - Self Closing
Manufacturer: Not Identified

Finding: The gate is not operating correctly

Action: Take effective action to ensure the gate closes between 4 and 8 seconds

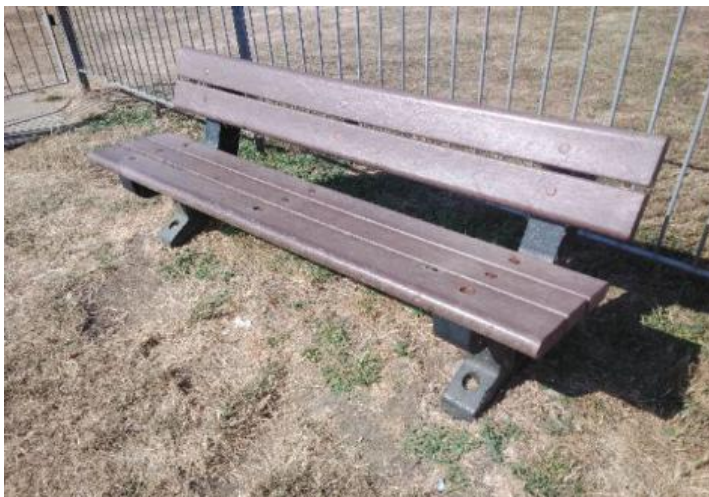
Item: Ancillary Items - Bench
Manufacturer: Broxap

Finding: There is some evidence of fire damage to the item

Action: Monitor for any further deterioration and repair as required

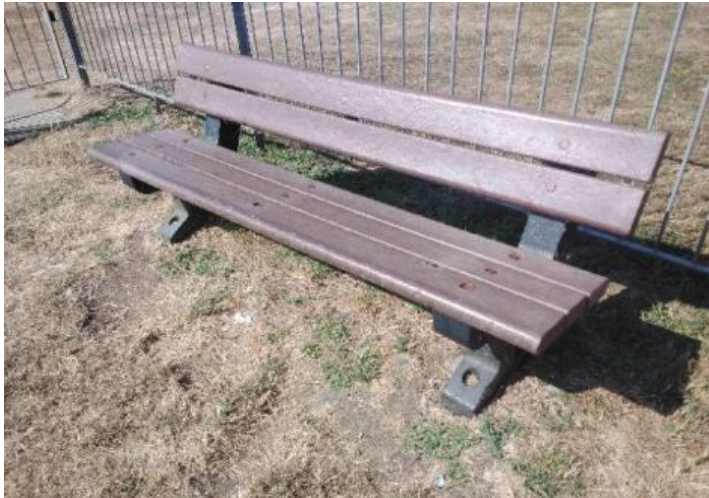
Item: Ancillary Items - Bench
Manufacturer: Broxap

Finding: The fixings have corroded excessively

Action: Replace all corroded fixings

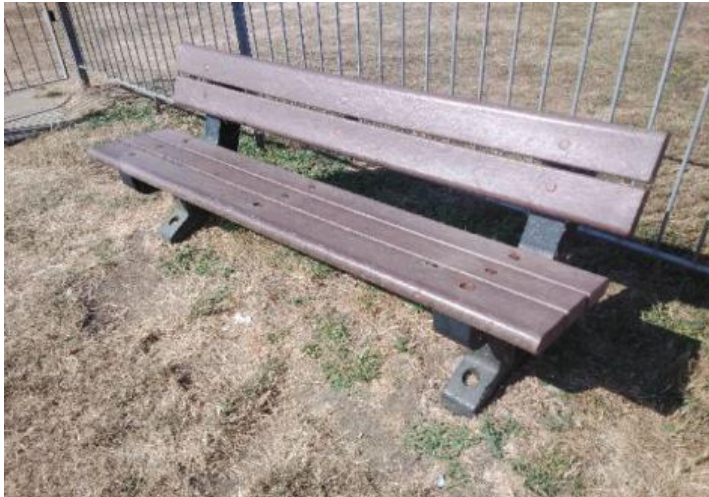
Item: Ancillary Items - Bench
Manufacturer: Broxap

Finding: The surface has eroded in some areas and may be slippery in wet conditions

Action: Reinstate the surface

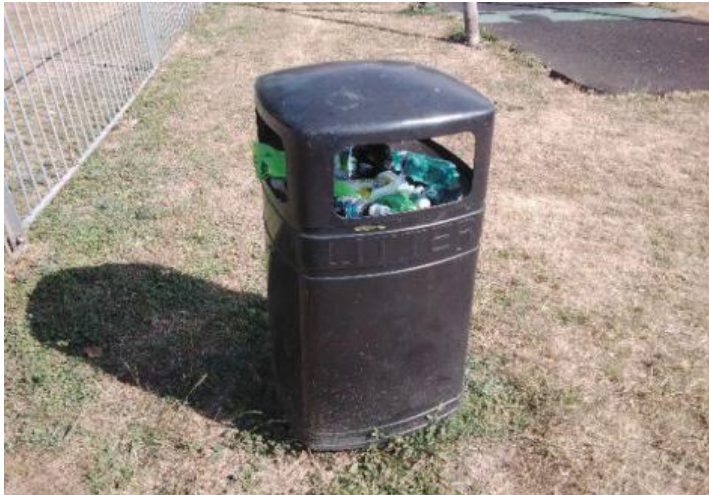
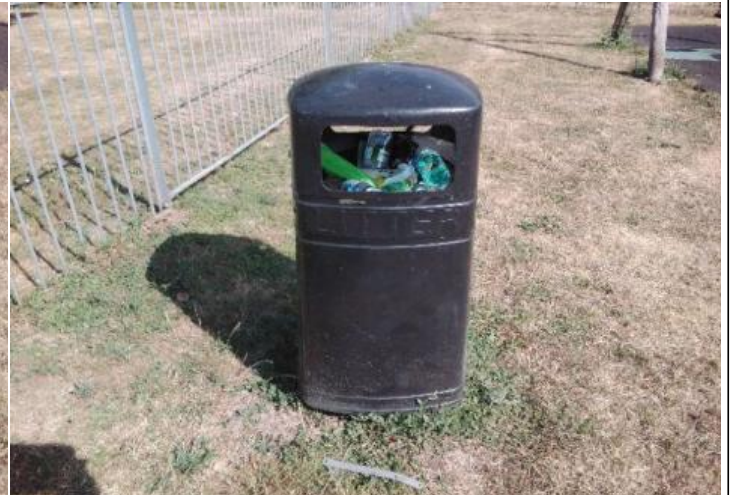
Item: Ancillary Items - Litter Bin
Manufacturer: Not Identified

Finding: The lid or door of the litter bin is not secured

Action: Ensure the lid or door is kept locked

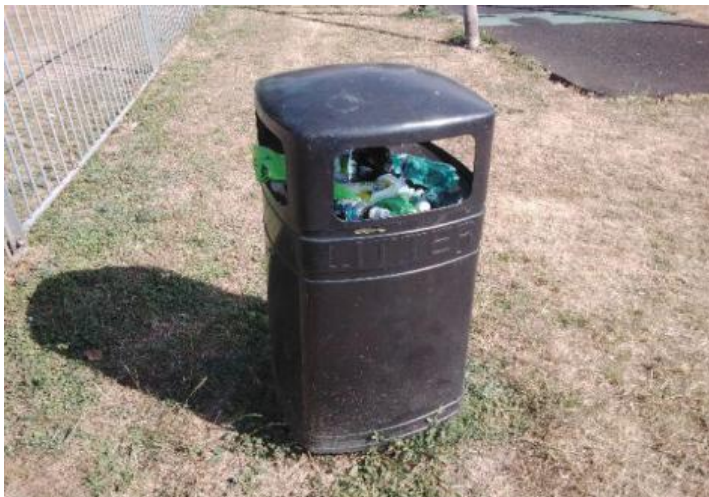
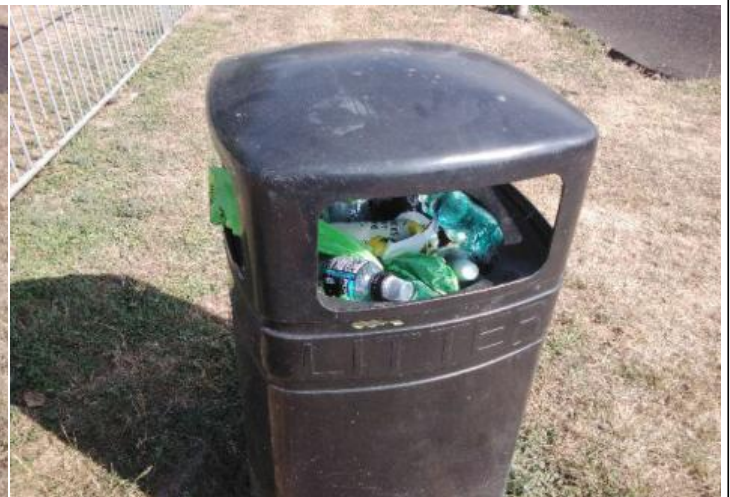
Item: Ancillary Items - Litter Bin
Manufacturer: Not Identified

Finding: The litter bin is full

Action: Empty and review the collection routine

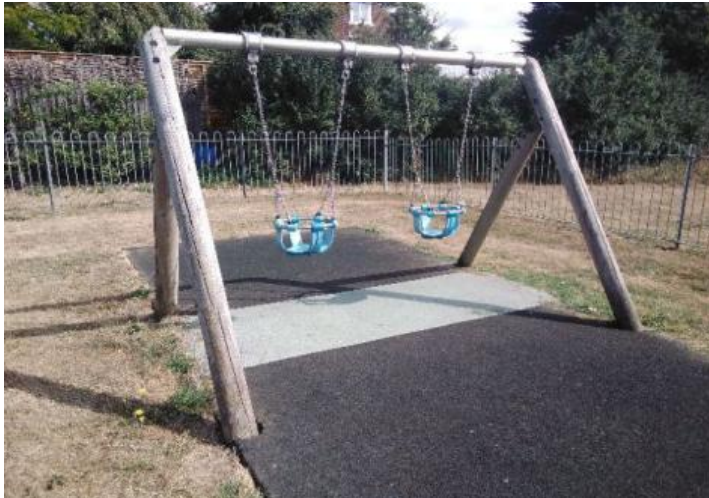
Item: Swings - 1 Bay 2 Seat (Cradle)
Manufacturer: Playdale Playgrounds Ltd

Finding: There are trip hazards at the edges of the surface

Action: Reinstate surrounding surface levels to remove the trip points

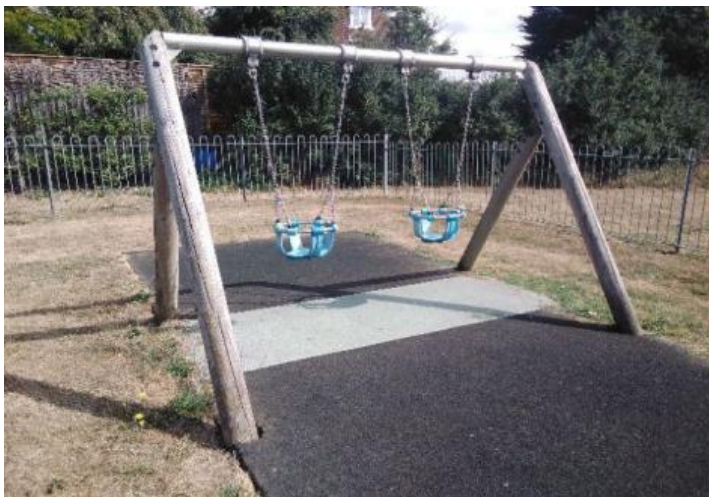
Item: Swings - 1 Bay 2 Seat (Cradle)
Manufacturer: Playdale Playgrounds Ltd

Finding: The timber has a number of splits/shakes or air cracks and this may affect the stability or allow water ingress which will accelerate the rotting process

Action: Monitor to ensure the splits do not cross through fixing points of the structure and/or cause any instability

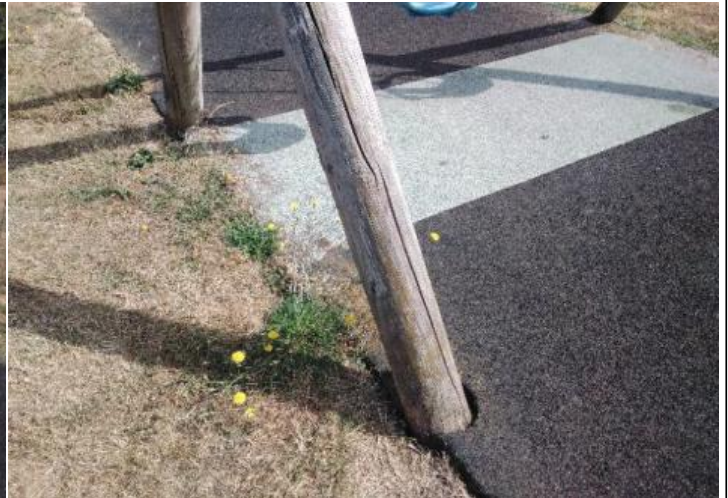
Item: Swings - 1 Bay 2 Seat (Cradle)
Manufacturer: Playdale Playgrounds Ltd

Finding: There is algae or moss on the surface of the equipment

Action: Clean and treat appropriately

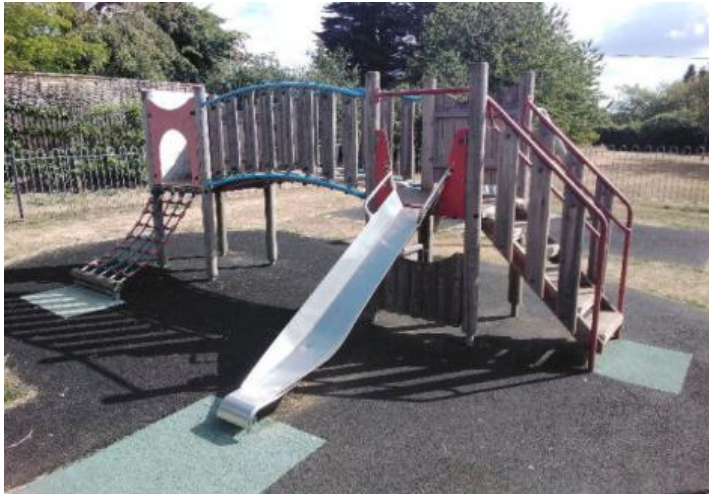
Finding: There are trip hazards at the edges of the surface

Action: Reinstate surrounding surface levels to remove the trip points

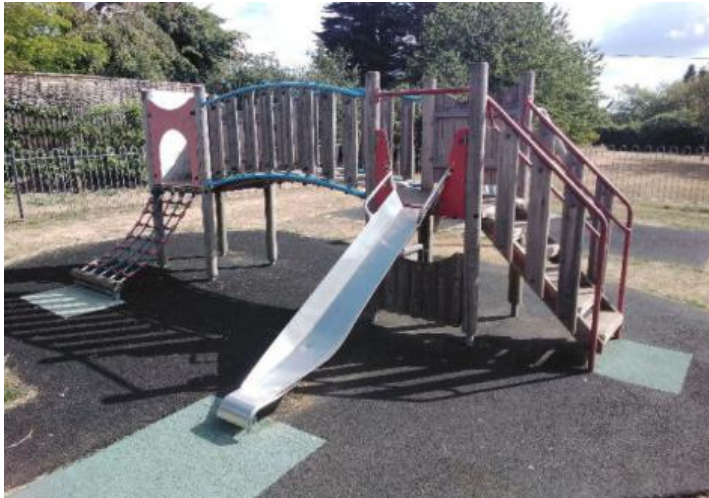
Finding: There are significant gaps (over 30mm) between the surface and the edging or between the joints in the surface; these are large enough for a small foot to enter

Action: Repair surfacing

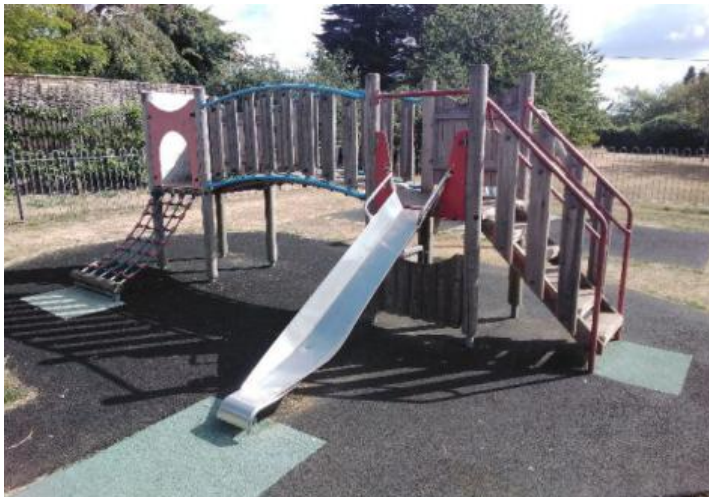
Finding: There are gaps opening between the surfacing and the edging surround or between the joints in the surfacing

Action: Monitor for any further deterioration and repair as required

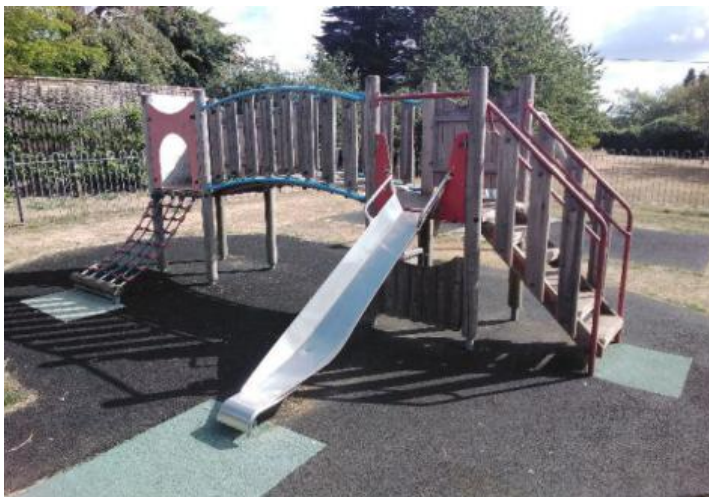
Finding: There is/are bolt cap covers missing or damaged on the item

Action: Replace missing or damaged bolt cap covers

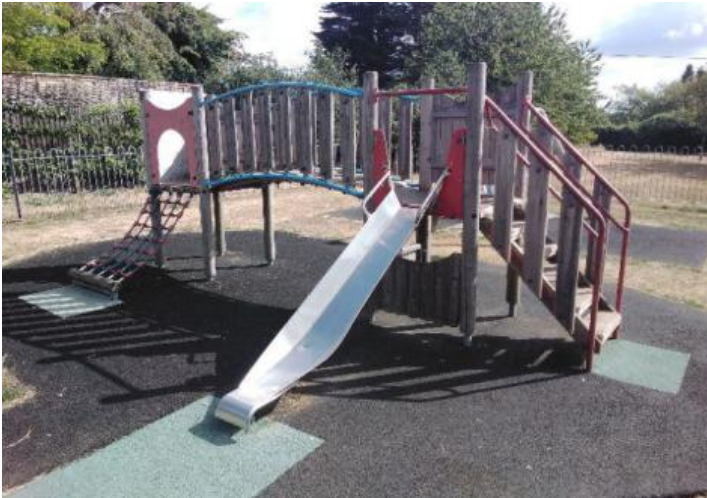
Finding: There is some evidence of rot in the timber

Action: Monitor for any further deterioration and replace as required

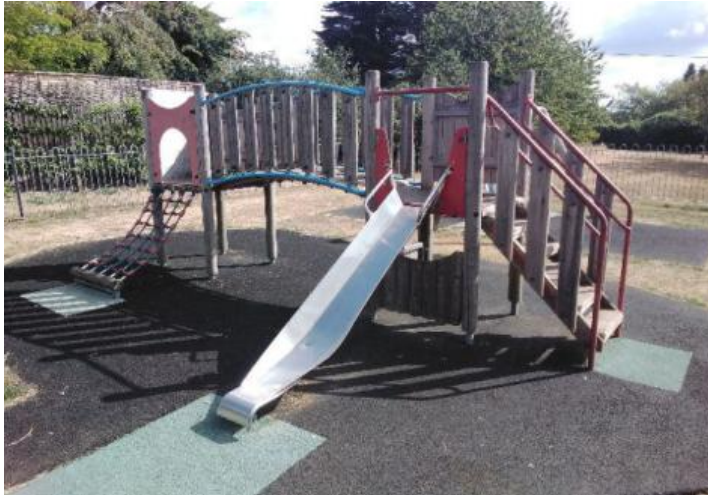
Finding: There are areas or parts of the timber on the structure that have rotted

Action: Replace all affected timbers

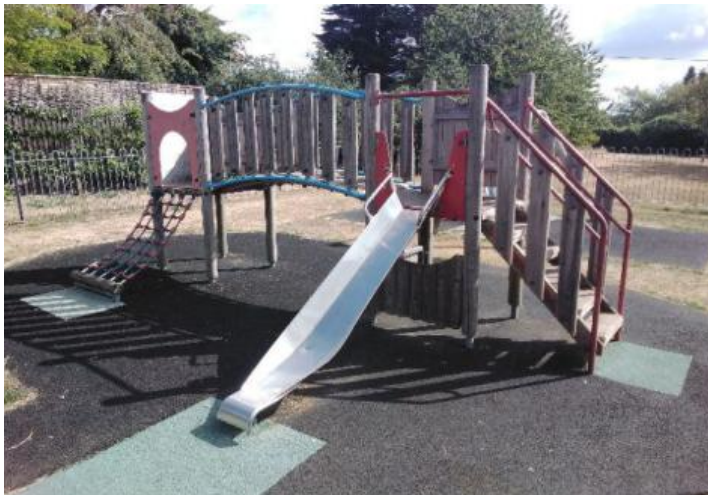
Finding: There is some evidence of rot in the timber

Action: Monitor for any further deterioration and replace as required

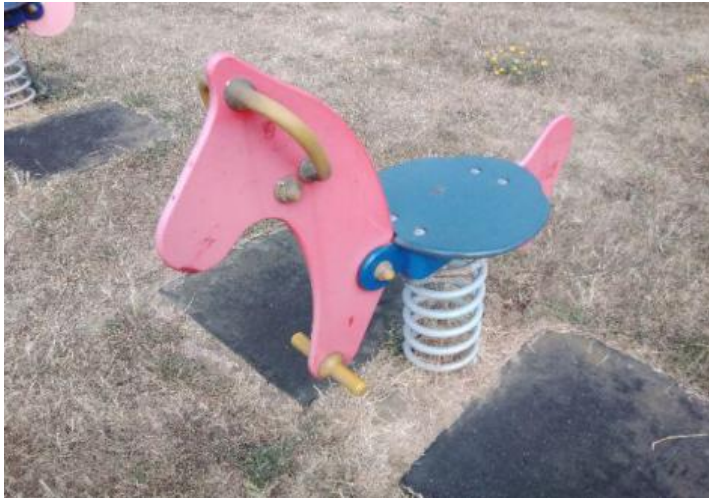
Finding: The end of handgrips and/or footrests have a cross section of less than 15cm² and fail to meet the requirements of BS EN 1176 Part 6
Action: Monitor - No remedial work recommended

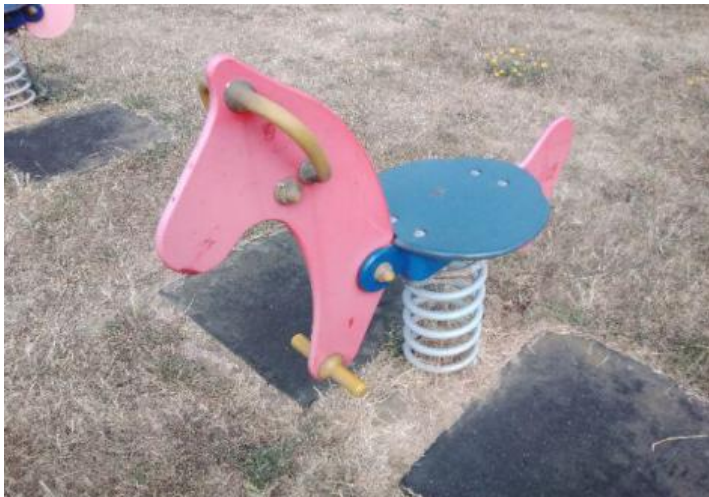
Finding: There is some minor damage to the surface

Action: Monitor for any further deterioration and repair as required

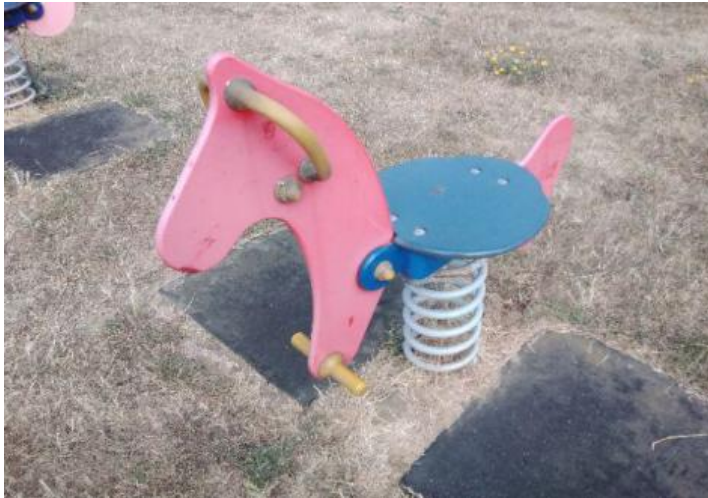
Finding: There is algae, silt or moss growth on the surface resulting in slippery conditions

Action: Clean and treat appropriately

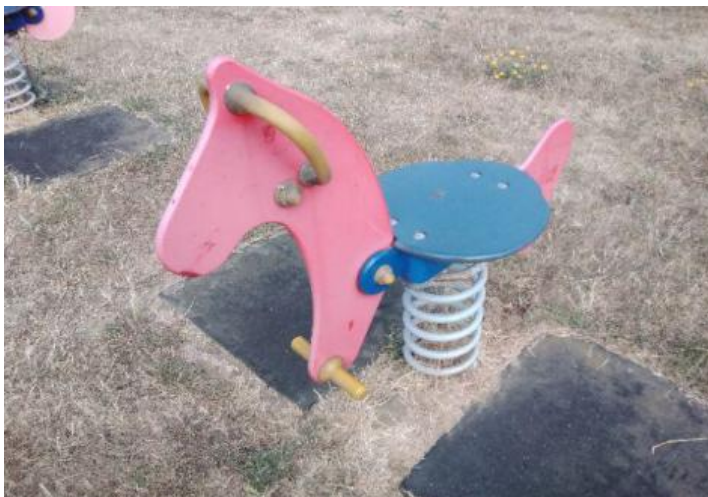
Finding: The paintwork on this item has been damaged or worn exposing the metal underneath which is rusting

Action: Treat any rusting components and repaint

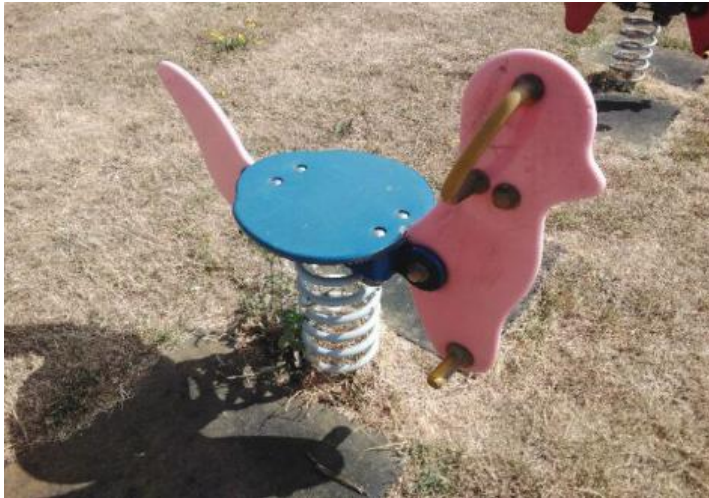
Finding: There is algae, silt or moss growth on the surface resulting in slippery conditions

Action: Clean and treat appropriately

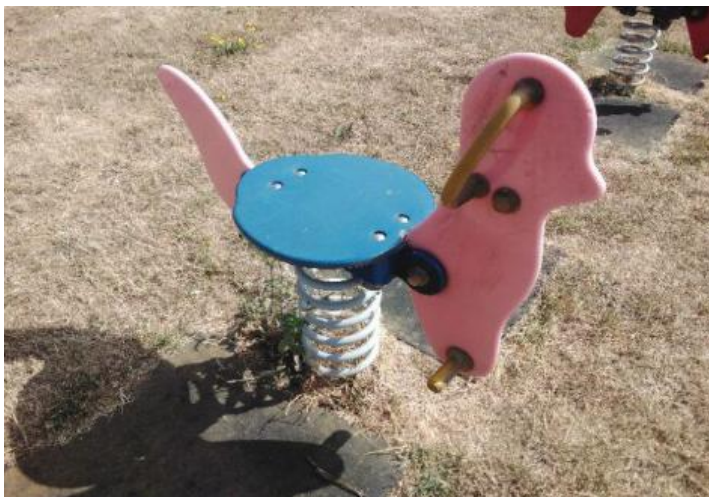
Finding: The paintwork on this item has been damaged or worn exposing the metal underneath which is rusting

Action: Treat any rusting components and repaint

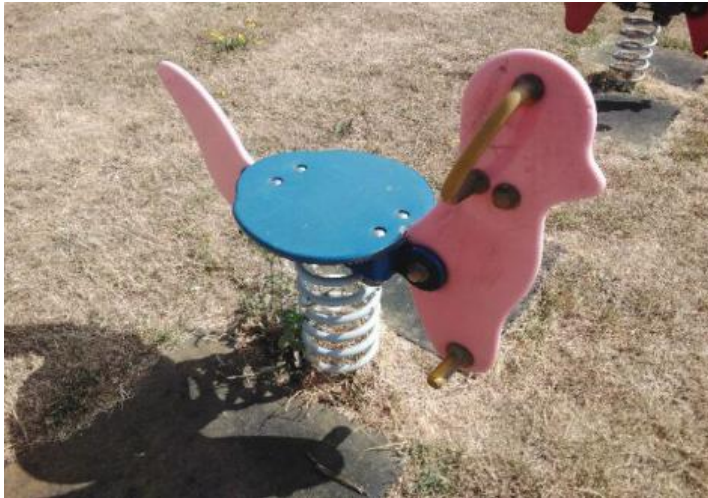
Finding: The U bolts clamping the spring are worn

Action: Monitor for any further deterioration and replace as required

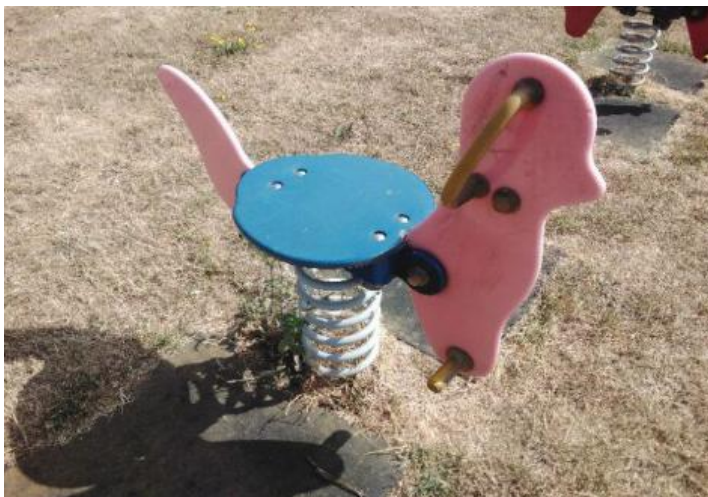
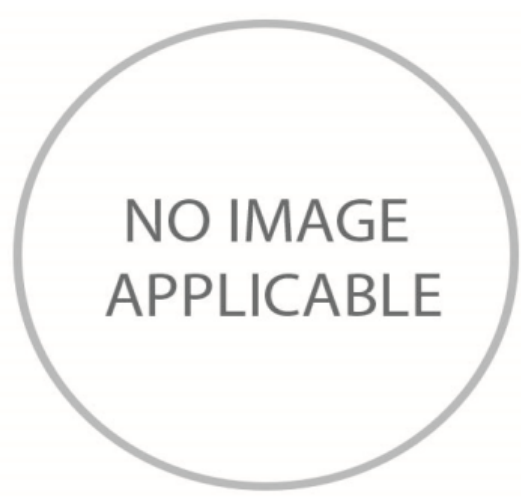
Finding: The end of handgrips and/or footrests have a cross section of less than 15cm² and fail to meet the requirements of BS EN 1176 Part 6

Action: Monitor - No remedial work recommended

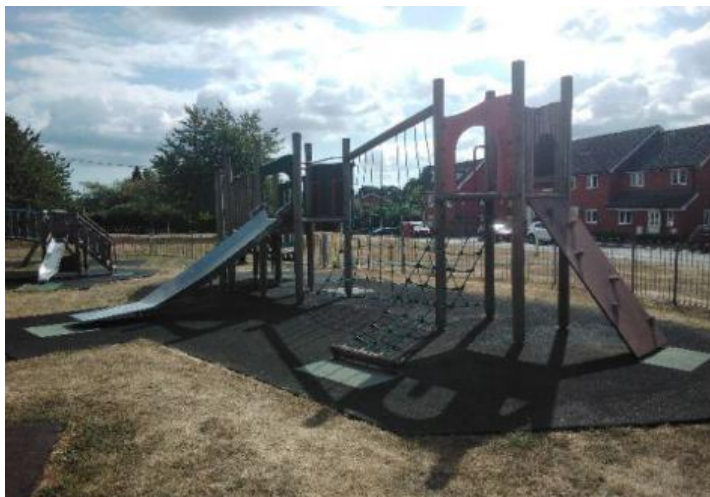
Finding: There are trip hazards at the edges of the surface

Action: Reinstate surrounding surface levels to remove the trip points

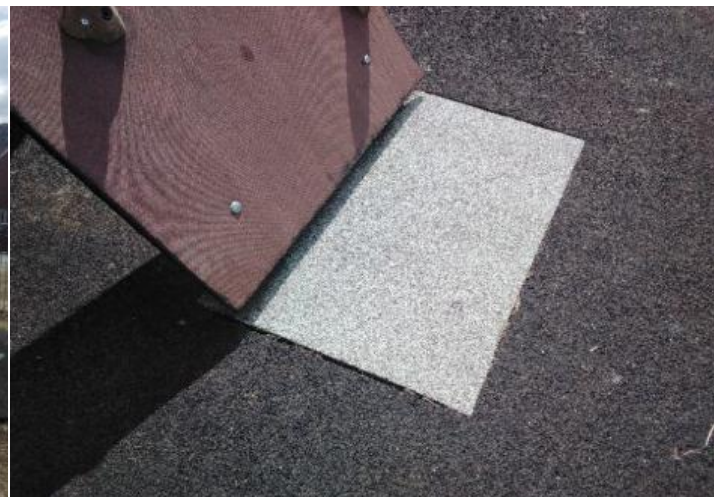
Finding: There are gaps opening between the surfacing and the edging surround or between the joints in the surfacing

Action: Monitor for any further deterioration and repair as required

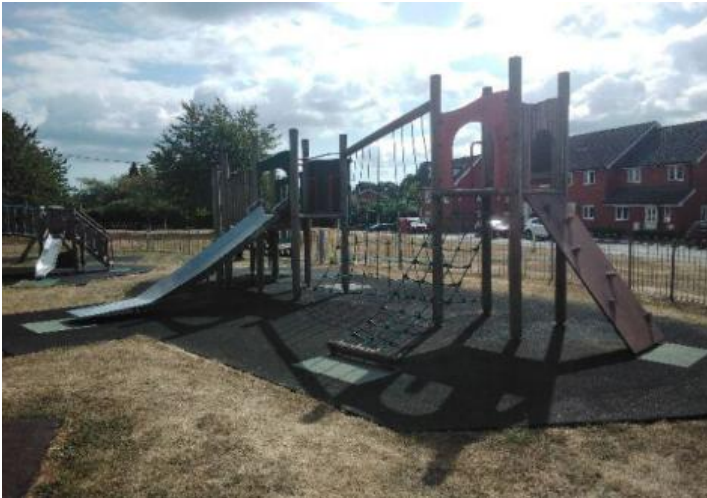
Finding: There is algae, silt or moss growth on the surface resulting in slippery conditions

Action: Clean and treat appropriately

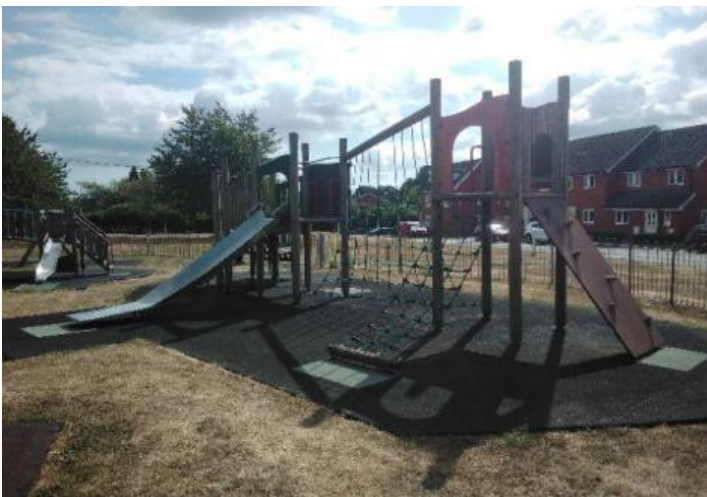
Finding: The timber has a number of splits/shakes or air cracks and this may affect the stability or allow water ingress which will accelerate the rotting process

Action: Monitor to ensure the splits do not cross through fixing points of the structure and/or cause any instability

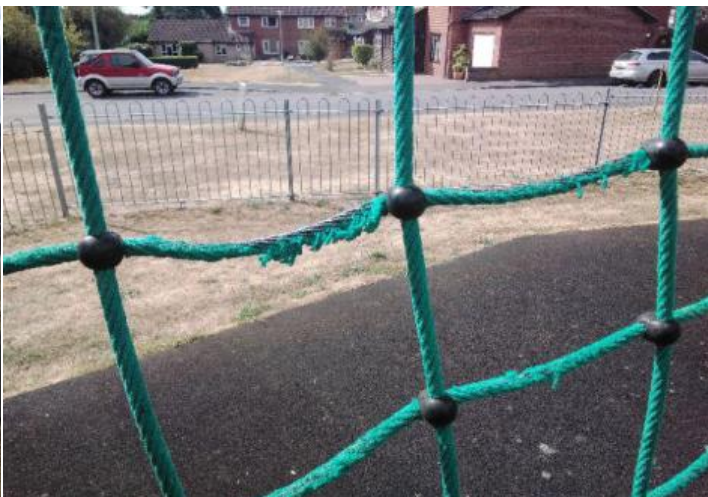
Finding: The ropes/nets are worn/damaged in places

Action: Monitor for any further deterioration and repair or replace as required

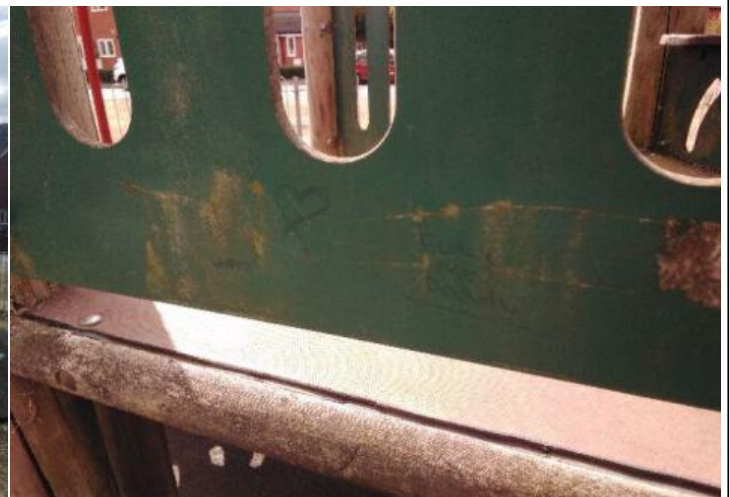
Finding: There is offensive graffiti present

Action: Remove as soon as practicable
