Annual Inspection

Melton Parish Council

Beresford Drive Play Area

Beresford Drive, Woodbridge, Suffolk, IP12 1JJ

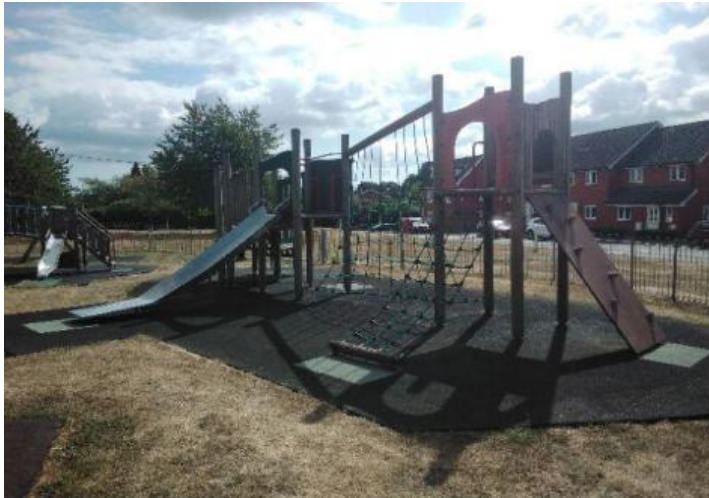
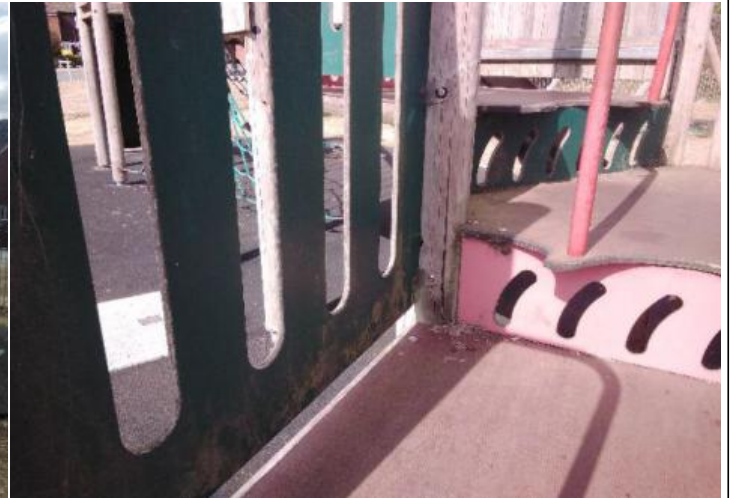
Finding: There is algae or moss on the surface of the equipment

Action: Clean and treat appropriately

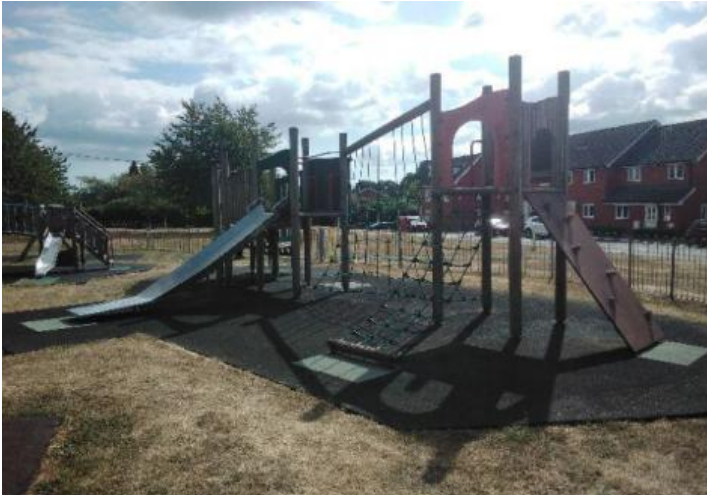
Finding: There are areas or parts of the timber on the structure that have rotted

Action: Replace all affected timbers

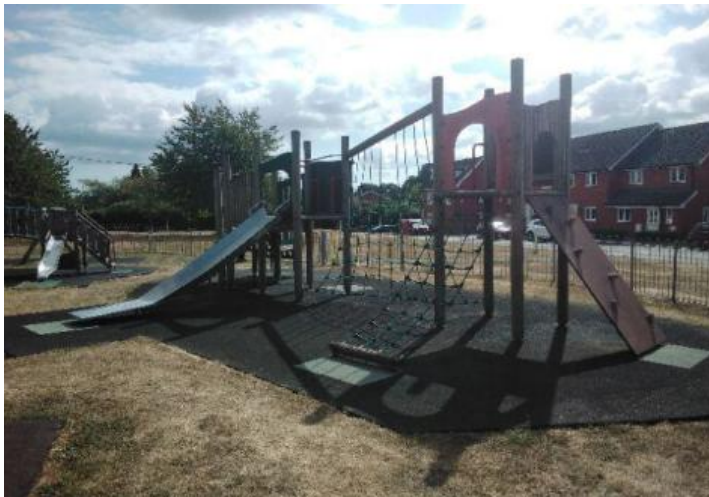
Finding: The item has missing component(s)

Action: Consider replacing missing components

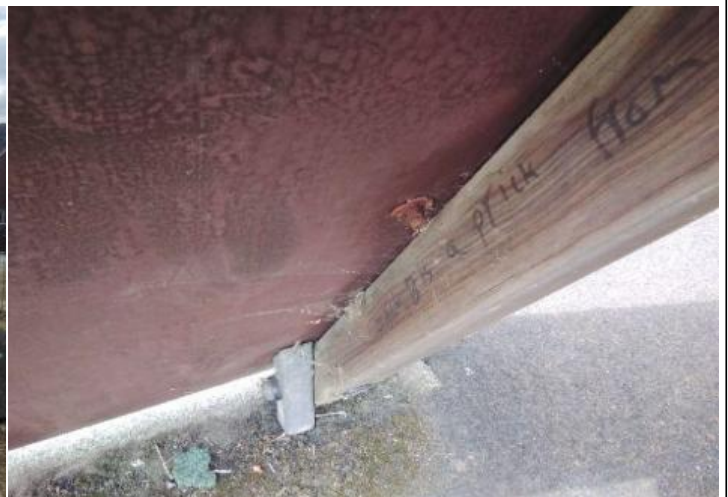
Finding: There are projecting bolt thread(s) present

Action: Remove excess thread length and deburr or provide cap

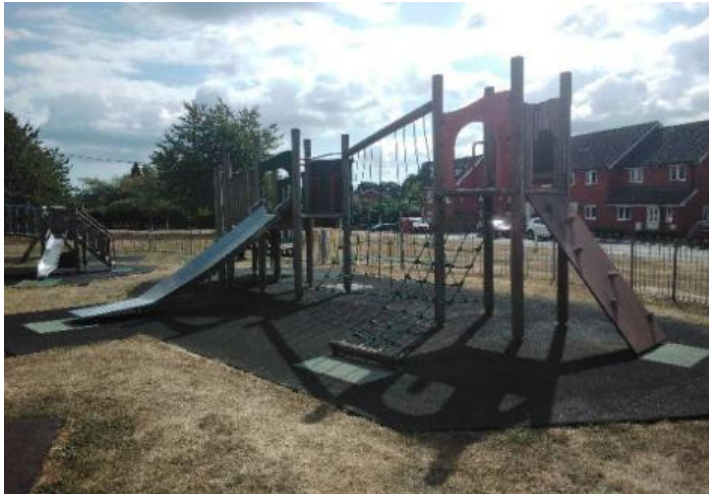
Finding: There is some evidence of rot in the timber

Action: Monitor for any further deterioration and replace as required

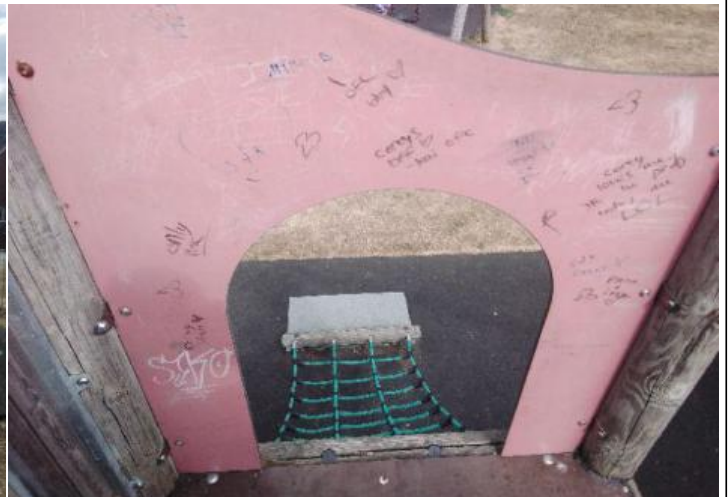
Finding: There is some graffiti present
Action: Remove the graffiti

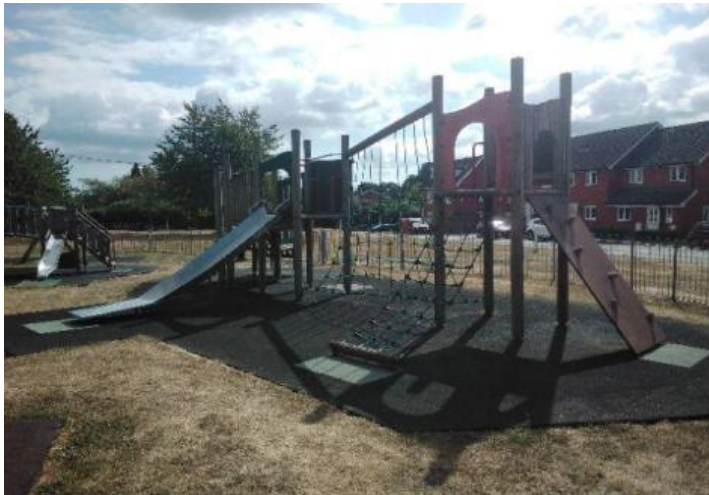
Finding: The tower is becoming unstable

Action: Repair or replace as required

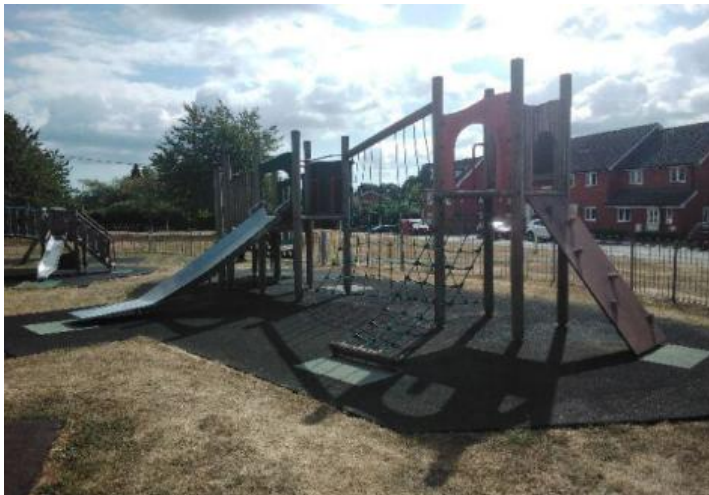
Finding: There are falls in excess of 600mm between adjacent components on the structure, in contravention of the recommendations set out in BS EN 1176 Part 1; 4.2.8.4

Action: Monitor - No remedial work recommended

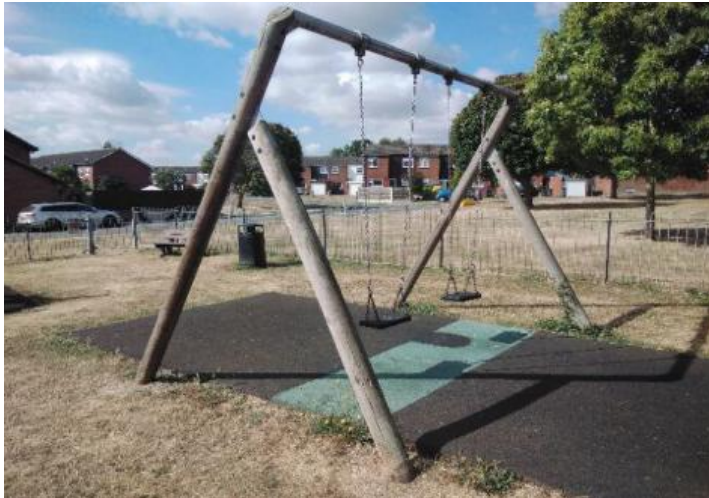
Finding: There is some strimmer / machinery damage apparent on the posts, this can penetrate the preservative applied to the timber and accelerate the rotting process

Action: Monitor for any deterioration (rot) and replace as required

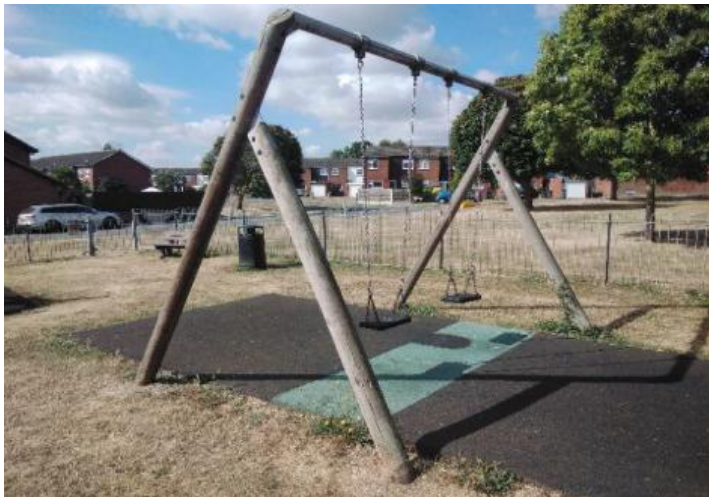
Finding: The timber has a number of splits/shakes or air cracks and this may affect the stability or allow water ingress which will accelerate the rotting process

Action: Monitor to ensure the splits do not cross through fixing points of the structure and/or cause any instability

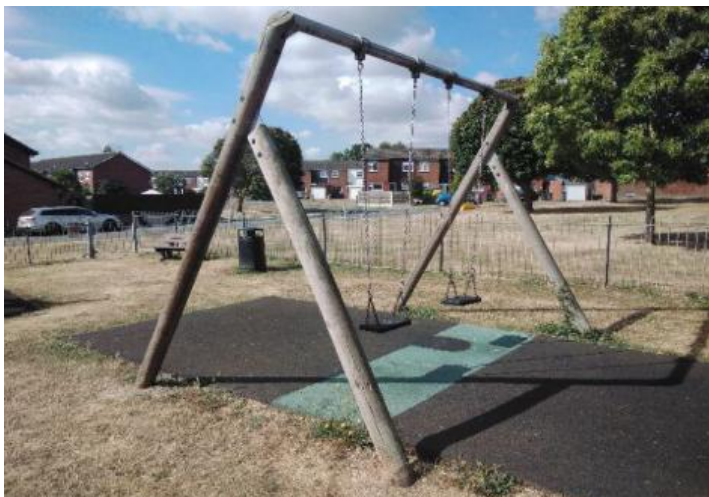
Finding: The chain openings are in excess of the 8.6mm as recommended by BS EN 1176

Action: Monitor - No remedial work recommended

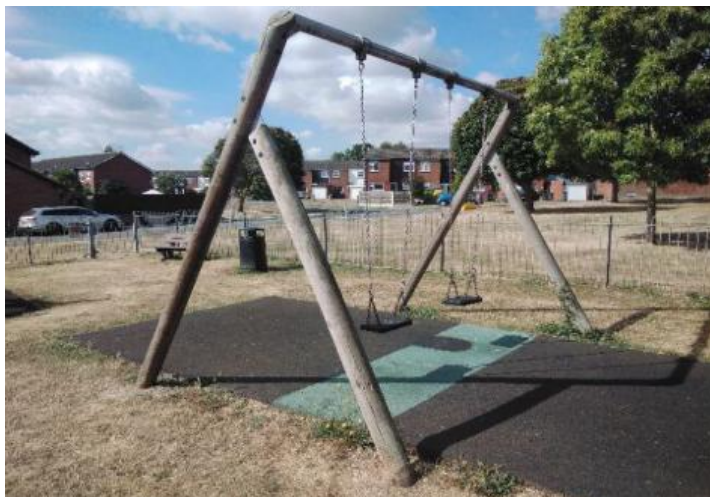
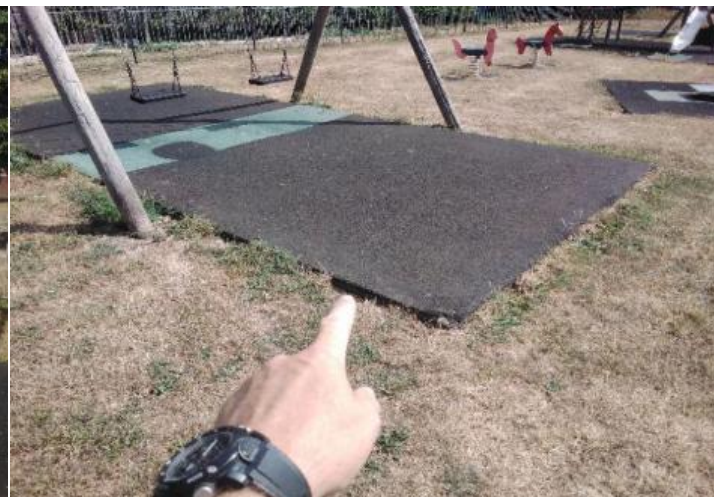
Finding: There are trip hazards at the edges of the surface

Action: Reinstate surrounding surface levels to remove the trip points

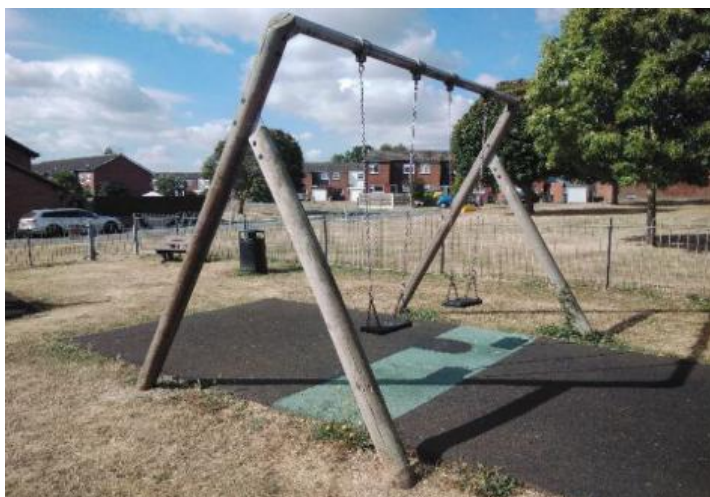
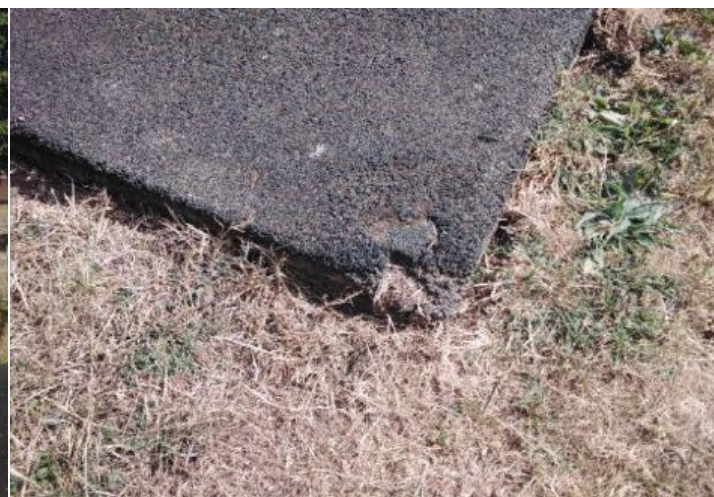
Finding: There is some minor damage to the surface

Action: Monitor for any further deterioration and repair as required

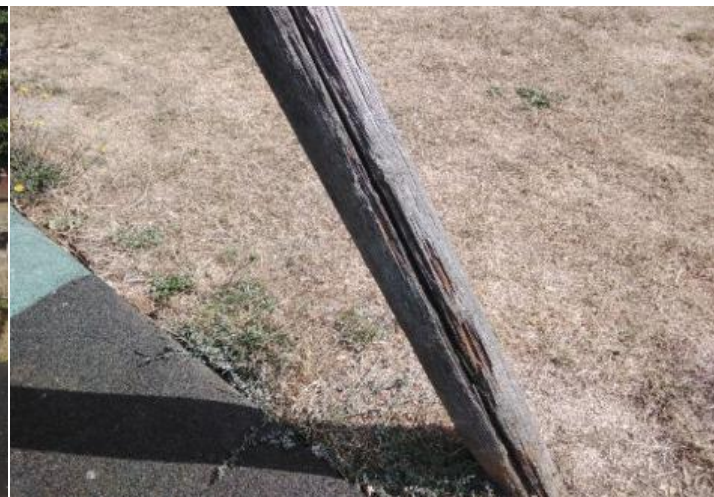
Finding: There is some damage to the support

Action: Monitor for any further deterioration and repair as required

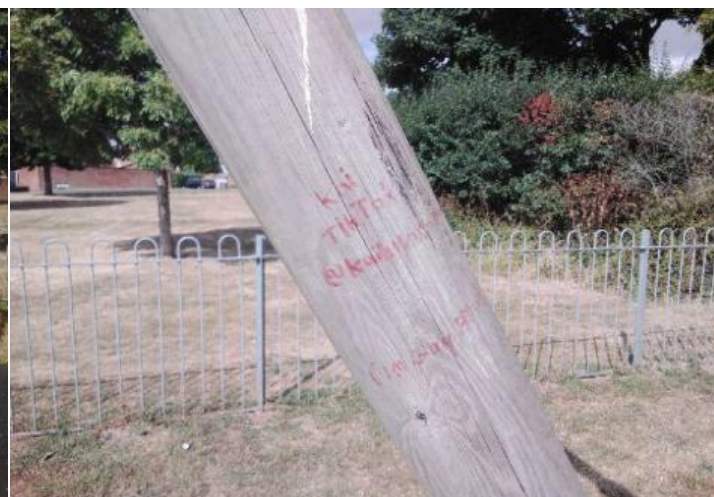
Finding: There is some graffiti present

Action: Remove the graffiti

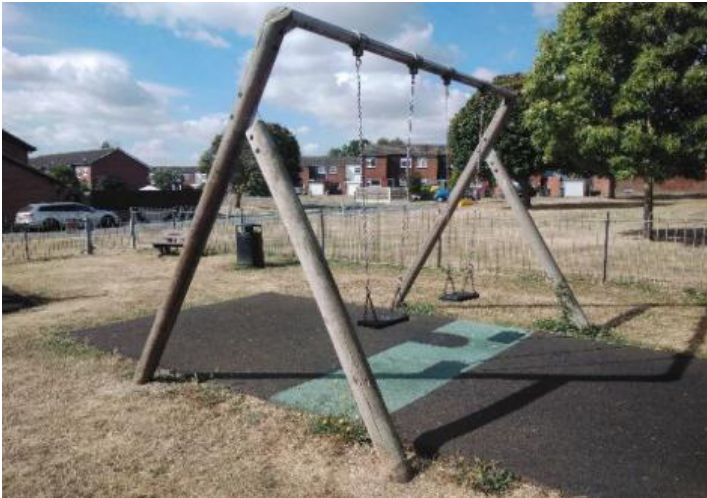
Item: Swings - 1 Bay 2 Seat (Flat)
Manufacturer: Playdale Playgrounds Ltd

Risk Level: L - Low Risk
Surface: Wet Pour

Finding: The swivel joint is becoming worn

Action: Monitor for any further deterioration and replace as required

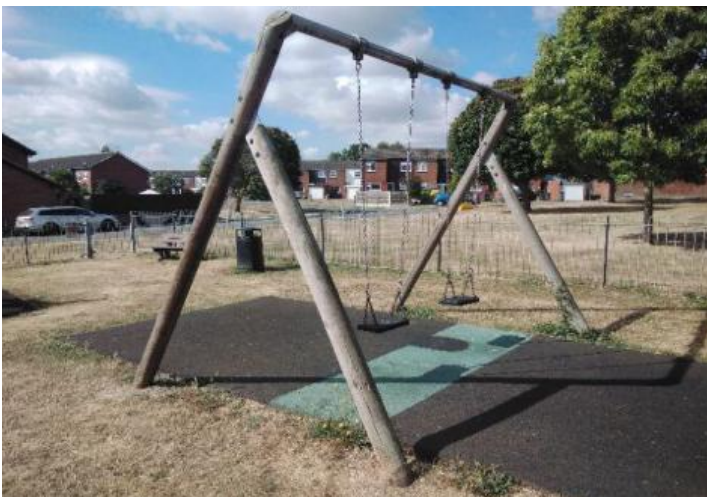
Item: Swings - 1 Bay 2 Seat (Flat)
Manufacturer: Playdale Playgrounds Ltd

Risk Level: L - Low Risk
Surface: Wet Pour

Finding: The swing seat connectors have some wear present

Action: Monitor for further deterioration and replace when 40% worn

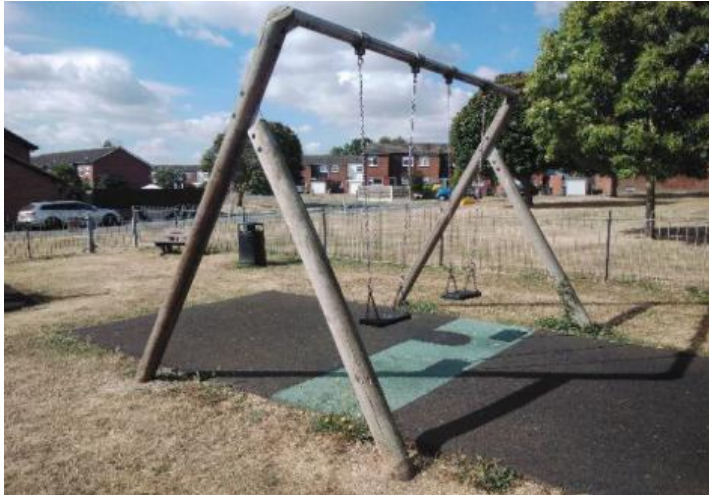
Item: Swings - 1 Bay 2 Seat (Flat)
Manufacturer: Playdale Playgrounds Ltd

Risk Level: M - Moderate Risk
Surface: Wet Pour

Finding: There are areas or parts of the timber on the structure that have rotted

Action: Replace all affected timbers
