the play inspection company

Annual Inspection

Melton Parish Council

Melton Road

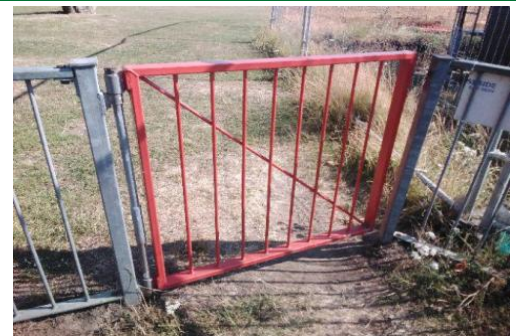
Item: Gate
Manufacturer: Unknown
Surface Type: N/A
Item Quantity: 1
Equipment Compliance: N/A
Surface Area Compliance: N/A

There are openings that are less than 12mm that could trap or crush fingers - Where possible a 12mm gap should be maintained on both sides or between the gate leaves

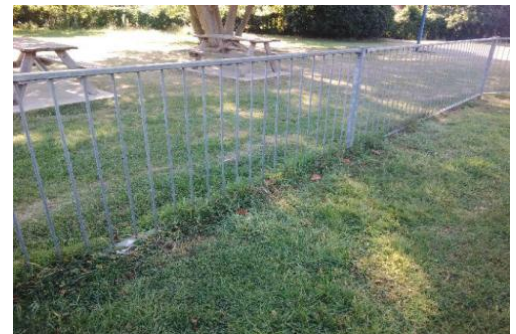
Item: Fencing - Flat Top
Manufacturer: Unknown
Surface Type: N/A
Item Quantity: 1
Equipment Compliance: N/A
Surface Area Compliance: N/A

There are a number of loose posts around the fence -
Monitor for any further deterioration and reset as required

There is some damage to the fence sections - Monitor for
any further deterioration and repair as required

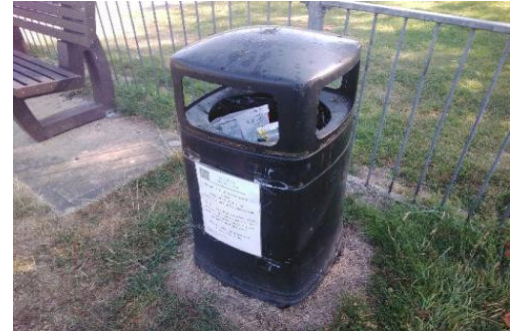
Item: Litter Bin
Manufacturer: Unknown
Surface Type: N/A
Item Quantity: 1
Equipment Compliance: N/A
Surface Area Compliance: N/A

The lid or door of the litter bin is not secured - Ensure the lid or door is kept locked

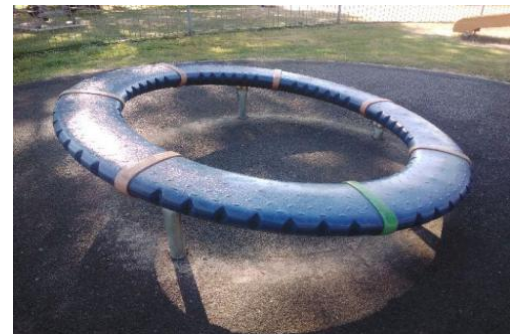
Item: Supernova
Manufacturer: Kompan Ltd
Surface Type: Wet Pour
Item Quantity: 1
Equipment Compliance: Yes
Surface Area Compliance: No

There is some minor damage to the surface - Monitor for any further deterioration and repair as required

There are gaps opening between the surfacing and the edging surround or between the joints in the surfacing - Monitor for any further deterioration and repair as required

The surfacing dimensions are short and do not meet with the requirements of the current applicable standard - Monitor - no remedial action recommended

The ring is damaged - Replace

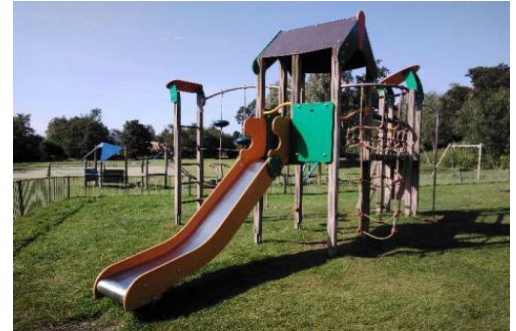
Item: Multi Play (Junior)
Manufacturer: Kompan Ltd
Surface Type: Grass Matrix Tiles
Item Quantity: 1
Equipment Compliance: No
Surface Area Compliance: Yes

The rope has worn and there are sharp wire strands protruding - Replace rope or net

The ropes/nets are worn/damaged in places - Monitor for any further deterioration and repair or replace as required

A number of fixing(s) have worked loose - Secure all loose fixings

There is/are finger entrapment/s in the framework and the item fails to meet the requirements of BS EN 1176 Part 1 4.2.7.6 Entrapment of fingers - Monitor - No remedial work recommended

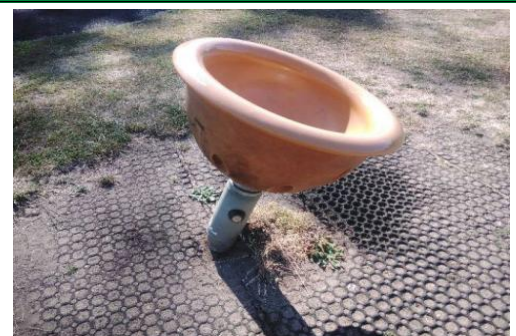
Item: Spinner Bowl
Manufacturer: Kompan Ltd
Surface Type: Grass Matrix Tiles
Item Quantity: 1
Equipment Compliance: Yes
Surface Area Compliance: Yes

There are gaps opening between the grass mat tiles - Provide additional ties or secure / reinstate surface

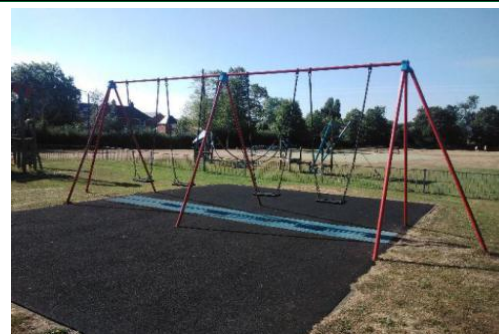
Item: 2 Bay 4 Seat (Flat)
Manufacturer: Wicksteed Playgrounds
Surface Type: Wet Pour
Item Quantity: 1
Equipment Compliance: No
Surface Area Compliance: Yes

There are significant gaps (over 30mm) between the surface and the edging or between the joints in the surface; these are large enough for a small foot to enter - Repair surfacing

The seats are too close to the frame as defined in BS EN 1176 Part 2; this is a low risk failure and no remedial action is required - Monitor - No remedial work recommended

The bushes are showing signs of wear - Monitor for any further deterioration and replace as required

The surface is lifting at the edges and creating trip points - Repair perimeter of surfacing to remove trip points

The seats are too close to each other as defined in BS EN 1176 Part 2; this is a low risk failure and no remedial action is required - Monitor - No remedial work recommended

There is some minor damage to the surface - Monitor for any further deterioration and repair as required

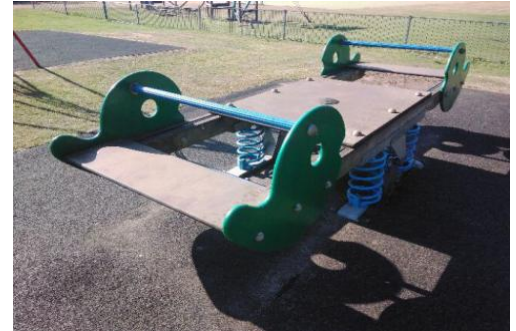
Item: See Saw
Manufacturer: Kompan Ltd
Surface Type: Wet Pour
Item Quantity: 1
Equipment Compliance: Yes
Surface Area Compliance: Yes

The surface is lifting at the edges and creating trip points - Repair perimeter of surfacing to remove trip points

There is/are bolt cap covers missing or damaged on the item - Replace missing or damaged bolt cap covers

There is some damage to the item - Monitor for any further deterioration and repair as required

There are gaps opening between the surfacing and the edging surround or between the joints in the surfacing - Monitor for any further deterioration and repair as required

The paintwork on this item has been damaged or worn exposing the metal underneath which is rusting - Treat any rusting components and repaint

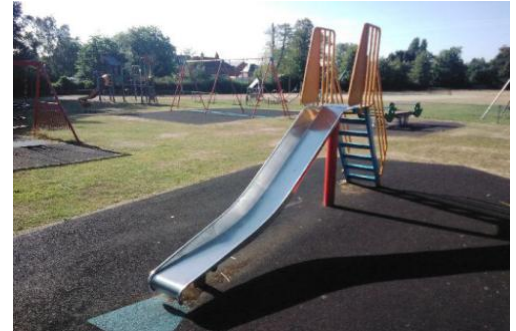
Item: Free Standing Slide
Manufacturer: Wicksteed Playgrounds
Surface Type: Wet Pour
Item Quantity: 1
Equipment Compliance: No
Surface Area Compliance: Yes

There are significant gaps (over 30mm) between the surface and the edging or between the joints in the surface; these are large enough for a small foot to enter - Repair surfacing

The item fails to meet the requirements of BS EN 1176 Part 1 4.2.7.2 head and neck entrapment in the barriers and/or steps - Monitor - No remedial work recommended

There are a number of dents in the slide surface - Monitor for any further deterioration and repair as required

There is algae, silt or moss growth on the surface resulting in slippery conditions - Clean and treat appropriately

The paintwork on this item has been damaged or worn exposing the metal underneath which is rusting - Treat any rusting components and repaint

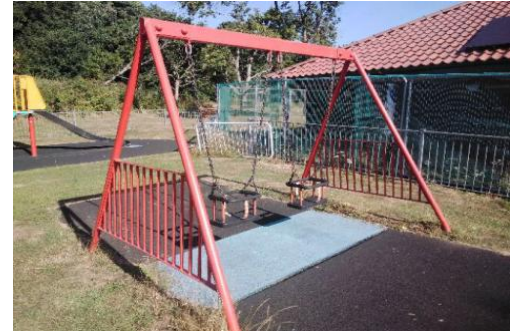
Item: 1 Bay 2 Seat (Cradle)
Manufacturer: Not Identified
Surface Type: Wet Pour
Item Quantity: 1
Equipment Compliance: No
Surface Area Compliance: No

There are significant gaps (over 30mm) between the surface and the edging or between the joints in the surface; these are large enough for a small foot to enter - Repair surfacing

The surfacing width under the seat/s is / are less than 875mm when measured from the centre of the seat outwards, and fails the requirements of BS EN 1176 Part 2 - Monitor - No remedial work recommended

There are gaps opening between the surfacing and the edging surround or between the joints in the surfacing - Monitor for any further deterioration and repair as required

The chain openings are in excess of the 8.6mm as recommended by BS EN 1176 - Monitor - No remedial work recommended

The seats are too close to each other as defined in BS EN 1176 Part 2; this is a low risk failure and no remedial action is required - Monitor - No remedial work recommended

The paintwork on this item has been damaged or worn exposing the metal underneath which is rusting - Treat any rusting components and repaint

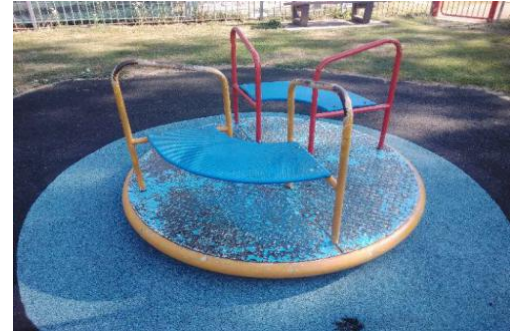
Item: Roundabout
Manufacturer: Unknown
Surface Type: Wet Pour
Item Quantity: 1
Equipment Compliance: Yes
Surface Area Compliance: Yes

There is some minor damage to the surface - Repair

The paintwork on this item has been damaged or worn exposing the metal underneath which is rusting - Treat any rusting components and repaint

The bearing is worn / damaged and the item is not operating correctly - Repair / replace

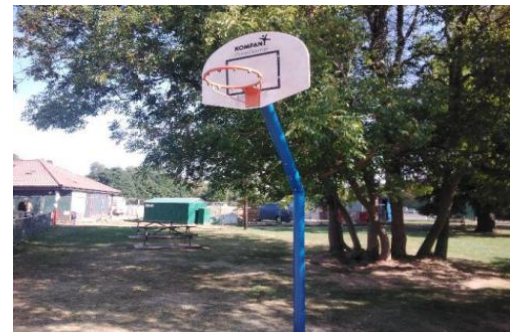
Item: Basketball Post
Manufacturer: Kompan Ltd
Surface Type: Bitmac
Item Quantity: 1
Equipment Compliance: Yes
Surface Area Compliance: N/A

There are trip hazards at the edges of the surface - Reinstate surrounding surface levels to remove the trip points

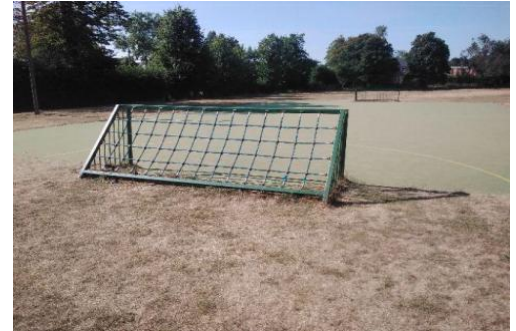
Item: 5 a side Goals
Manufacturer: Unknown
Surface Type: Carpet System
Item Quantity: 1
Equipment Compliance: Yes
Surface Area Compliance: N/A

The ropes/nets are worn/damaged in places - Monitor for any further deterioration and repair or replace as required

The paintwork on this item has been damaged or worn exposing the metal underneath which is rusting - Treat any rusting components and repaint

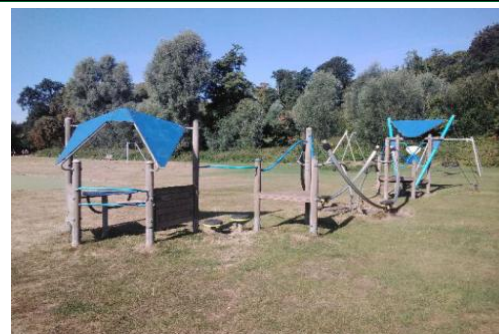
Item: Multi Play (Senior)
Manufacturer: Kompan Ltd
Surface Type: Grass Matrix Tiles
Item Quantity: 1
Equipment Compliance: Yes
Surface Area Compliance: Yes

There is algae or moss on the surface of the equipment - Clean and treat appropriately

There is some damage to the item - Monitor for any further deterioration and repair as required

The ropes/nets are worn/damaged in places - Monitor for any further deterioration and repair or replace as required

There is/are bolt cap covers missing or damaged on the item - Replace missing or damaged bolt cap covers

There is some damage to the traveller - Monitor for any further deterioration and repair as required

The spinning post is loose in the socket - Monitor for any further deterioration and repair as required

The traveller is damaged - Replace

A number of fixing(s) have worked loose - Secure all loose fixings

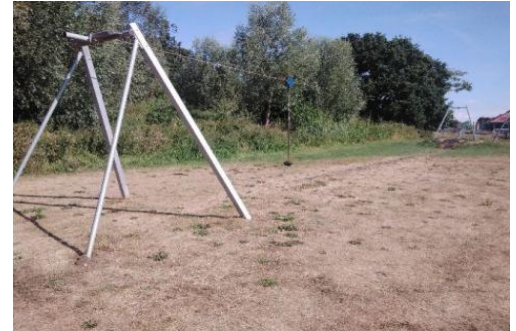
Item: Cable Runway
Manufacturer: Kompan Ltd
Surface Type: Grass Matrix Tiles
Item Quantity: 1
Equipment Compliance: No
Surface Area Compliance: Yes

We have completed a visual inspection of the cable and fixing points from ground level, however it is not possible to fully inspect the cable and fixings without either hiring equipment to gain access or removing the cable and inspecting at ground level. We recommend that the main cable and fixing security is thoroughly inspected at least in accordance with the manufacturers recommendations to check for damage, security or internal rusting, this will help to ensure the continued safe use of the equipment - Inspect in accordance with the manufacturers recommendations

There is moderate damage to the surface - Repair the damaged areas of surfacing

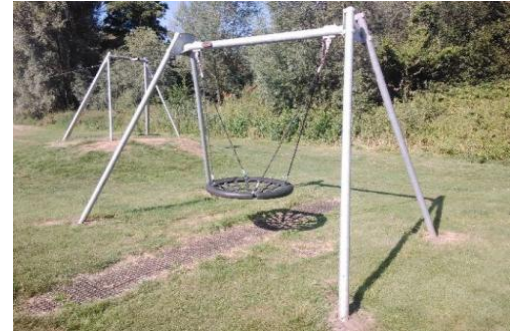
Item: Basket Swing - Type 1
Manufacturer: Kompan Ltd
Surface Type: Grass Matrix Tiles
Item Quantity: 1
Equipment Compliance: Yes
Surface Area Compliance: Yes

The seat has minor damage or wear - Monitor for any further deterioration and replace as required

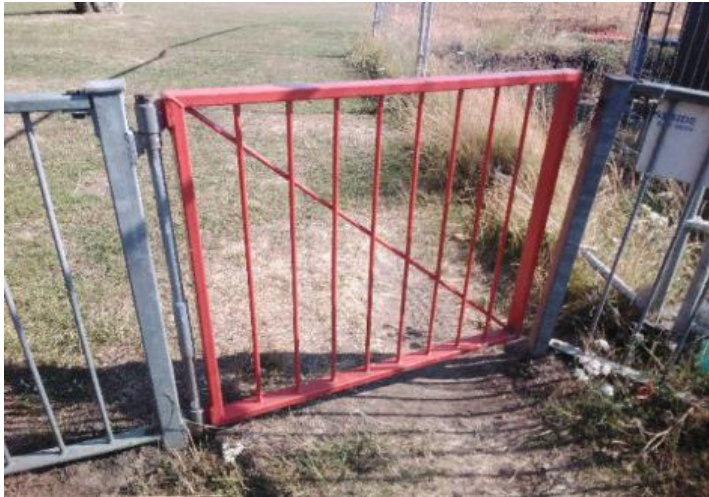
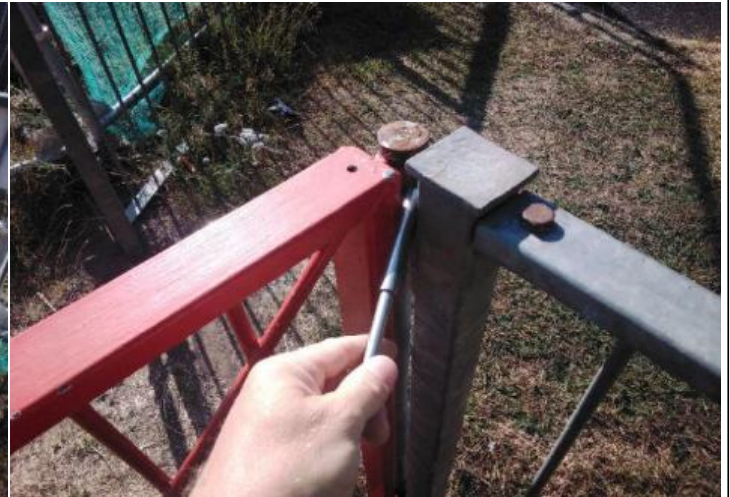
Item: Gates - Gate
Manufacturer: Unknown

Risk Level: L - Low Risk
Surface: N/A

Finding: There are openings that are less than 12mm that could trap or crush fingers

Action: Where possible a 12mm gap should be maintained on both sides or between the gate leaves

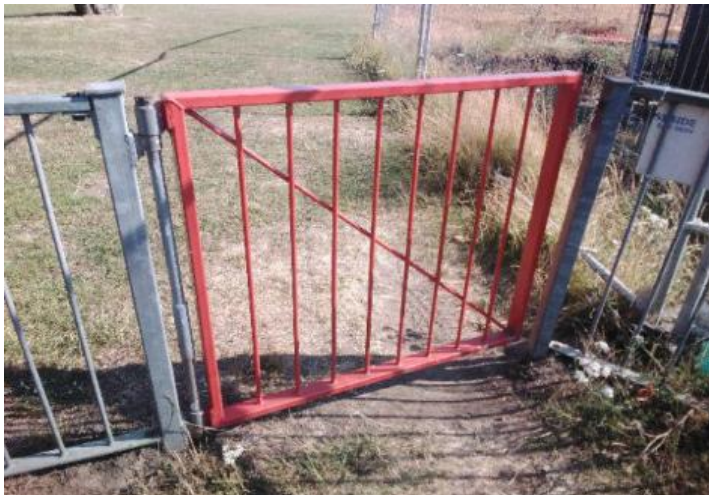
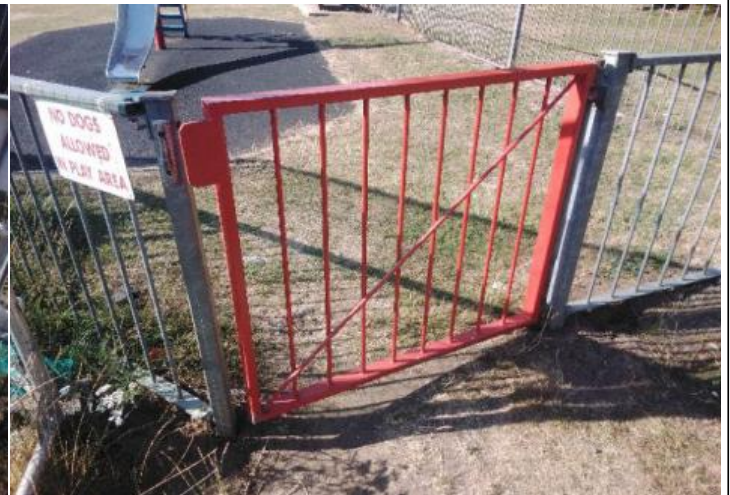
Item: Gates - Gate
Manufacturer: Unknown

Risk Level: L - Low Risk
Surface: N/A

Finding: The gate is closing too quickly (less than 4 seconds)

Action: Take corrective action to ensure that the gate closes in 4-8 seconds

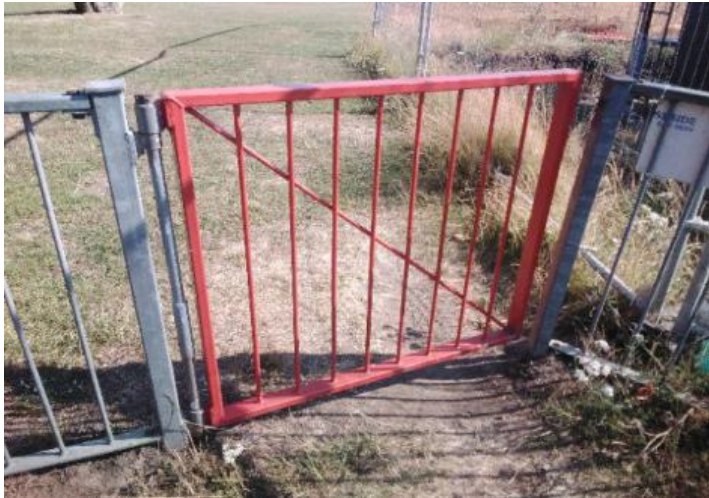
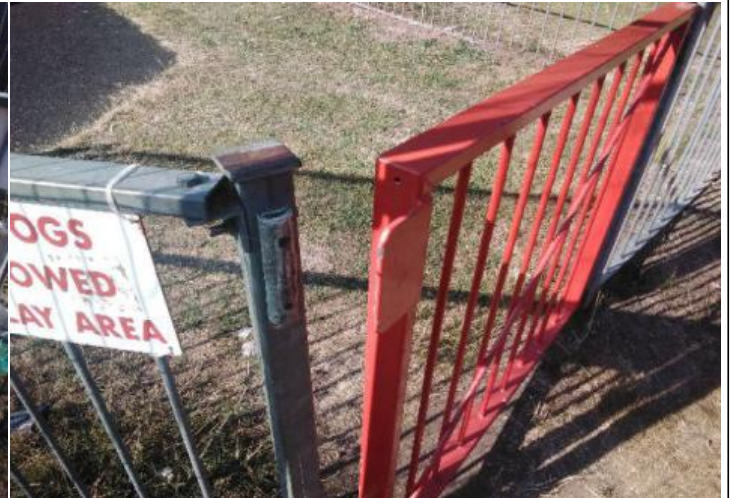
Item: Gates - Gate
Manufacturer: Unknown

Risk Level: V - Very Low Risk
Surface: N/A

Finding: The gate is not operating correctly

Action: Take effective action to ensure the gate closes between 4 and 8 seconds

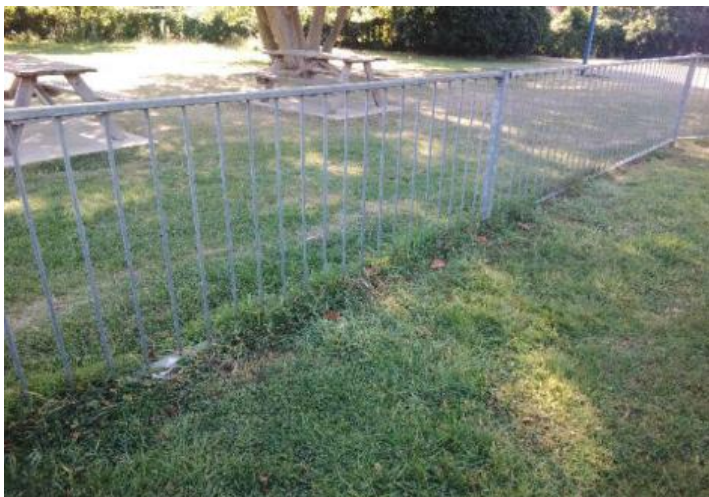
Item: Fences - Fencing - Flat Top
Manufacturer: Unknown

Risk Level: L - Low Risk
Surface: N/A

Finding: There are a number of loose posts around the fence

Action: Monitor for any further deterioration and reset as required

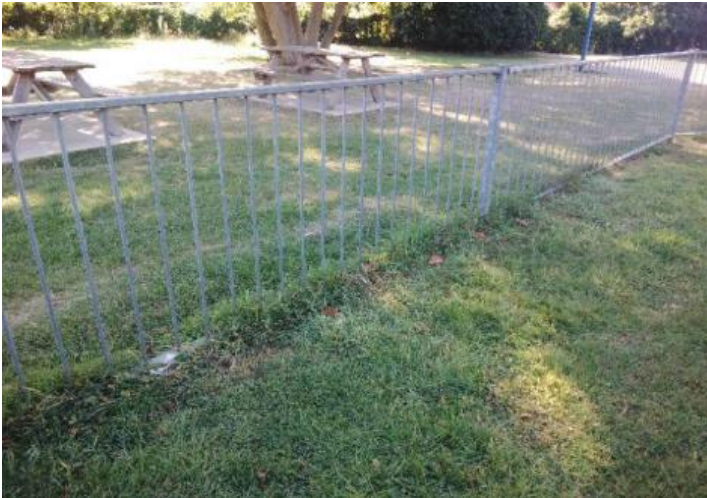
Item: Fences - Fencing - Flat Top
Manufacturer: Unknown

Risk Level: L - Low Risk
Surface: N/A

Finding: There is some damage to the fence sections

Action: Monitor for any further deterioration and repair as required

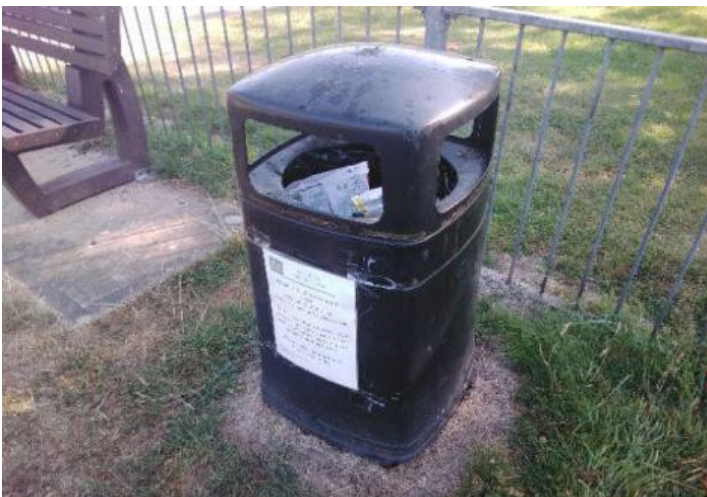
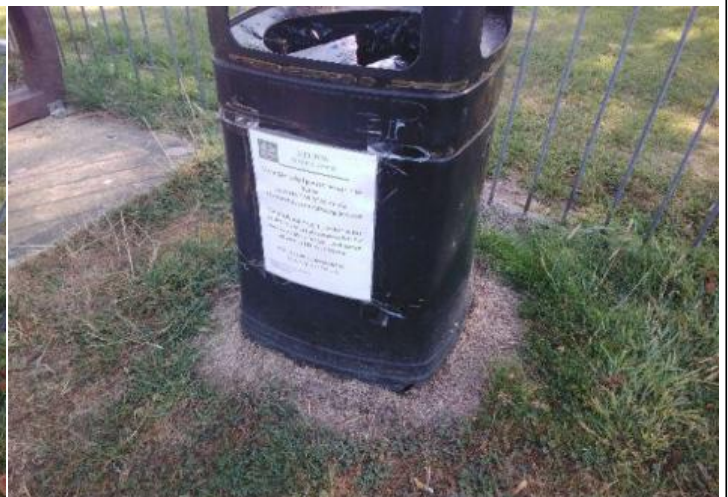
Item: Ancillary Items - Litter Bin
Manufacturer: Unknown

Risk Level: L - Low Risk
Surface: N/A

Finding: The lid or door of the litter bin is not secured

Action: Ensure the lid or door is kept locked

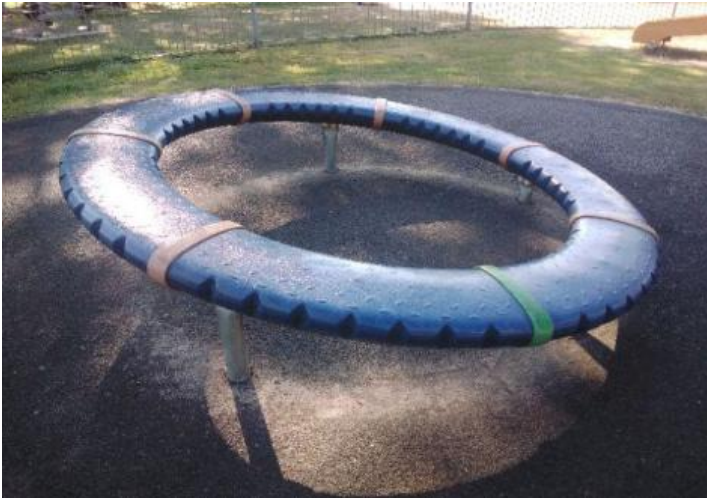
Item: Rotor Play - Supernova
Manufacturer: Kompan Ltd

Risk Level: V - Very Low Risk
Surface: Wet Pour

Finding: There is some minor damage to the surface

Action: Monitor for any further deterioration and repair as required

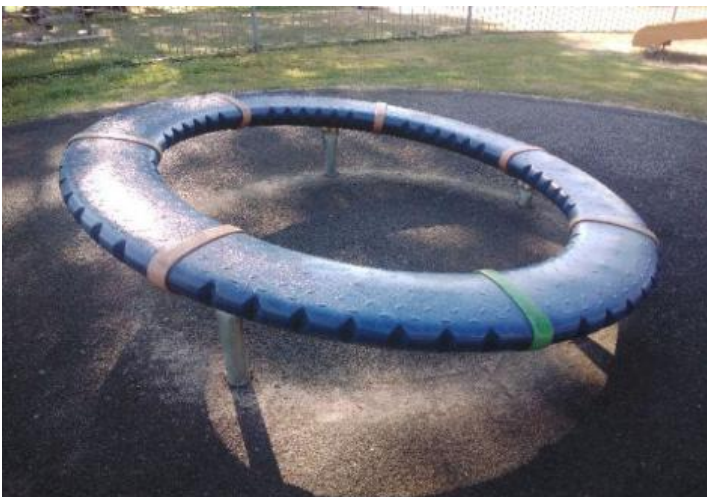
Item: Rotor Play - Supernova
Manufacturer: Kompan Ltd

Risk Level: V - Very Low Risk
Surface: Wet Pour

Finding: The surfacing dimensions are short and do not meet with the requirements of the current applicable standard

Action: Monitor - no remedial action recommended

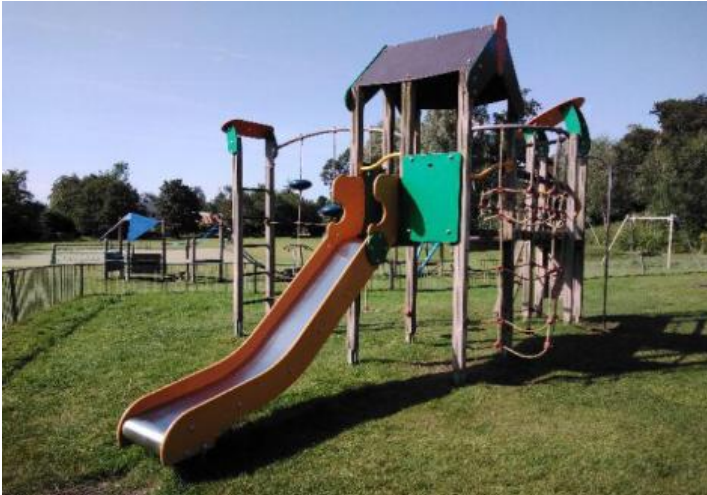
Item: Activity Equipment - Multi Play (Junior)
Manufacturer: Kompan Ltd

Risk Level: M - Moderate Risk
Surface: Grass Matrix Tiles

Finding: The rope has worn and there are sharp wire strands protruding

Action: Replace rope or net

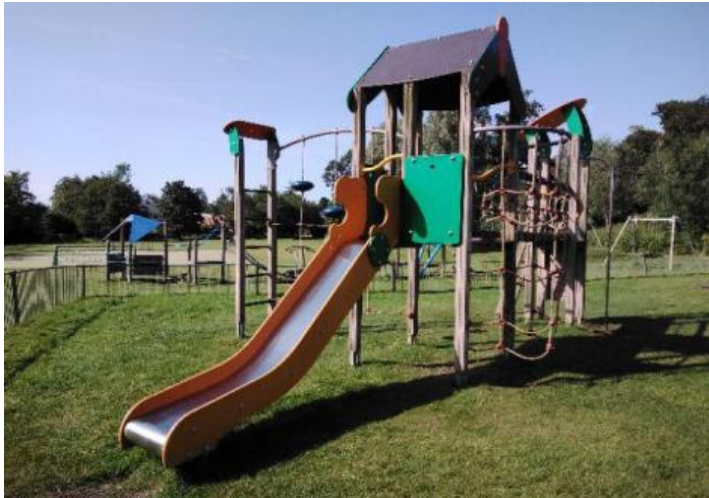
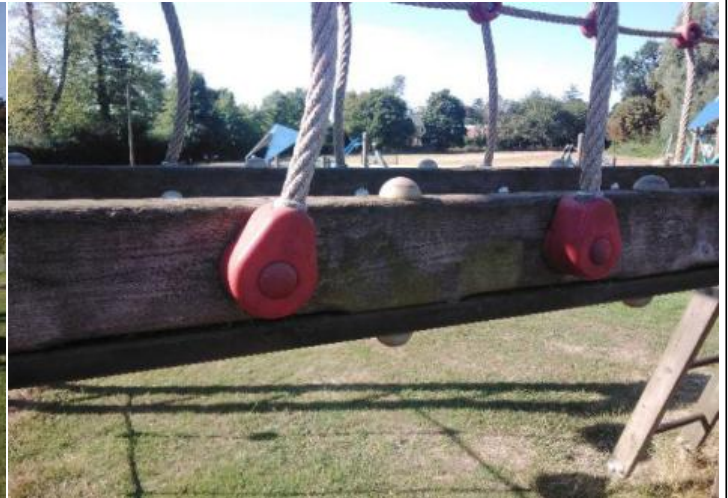
Item: Activity Equipment - Multi Play (Junior)
Manufacturer: Kompan Ltd

Risk Level: L - Low Risk
Surface: Grass Matrix Tiles

Finding: There is algae or moss on the surface of the equipment

Action: Clean and treat appropriately

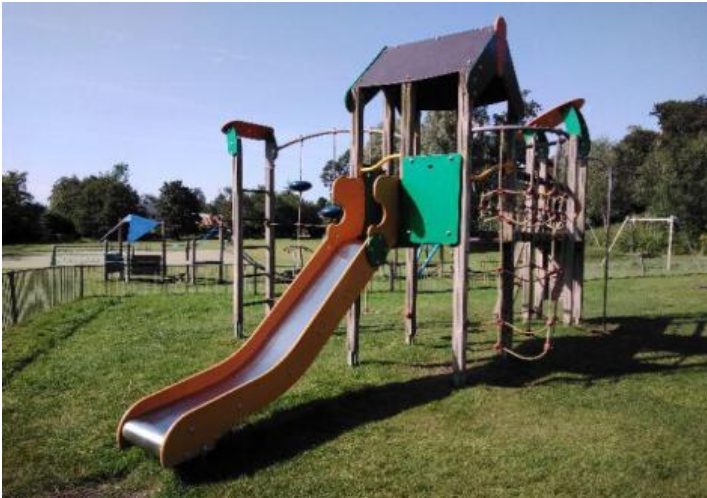
Item: Activity Equipment - Multi Play (Junior)
Manufacturer: Kompan Ltd

Risk Level: L - Low Risk
Surface: Grass Matrix Tiles

Finding: A number of fixing(s) have worked loose

Action: Secure all loose fixings

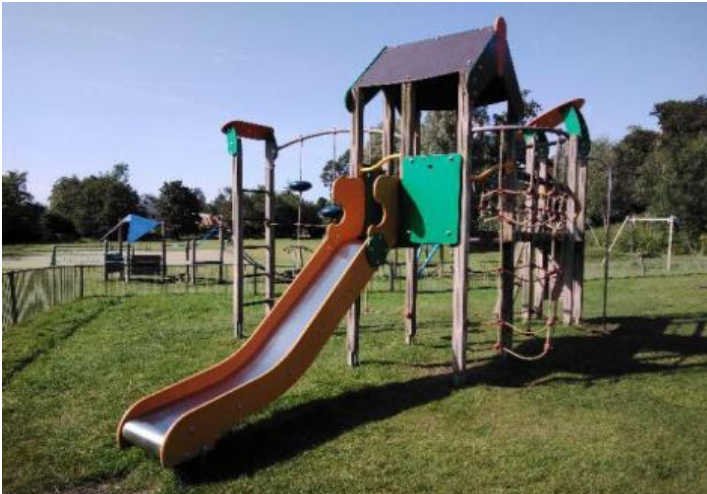
Item: Activity Equipment - Multi Play (Junior)
Manufacturer: Kompan Ltd

Risk Level: L - Low Risk
Surface: Grass Matrix Tiles

Finding: A number of fixing(s) have worked loose

Action: Secure all loose fixings

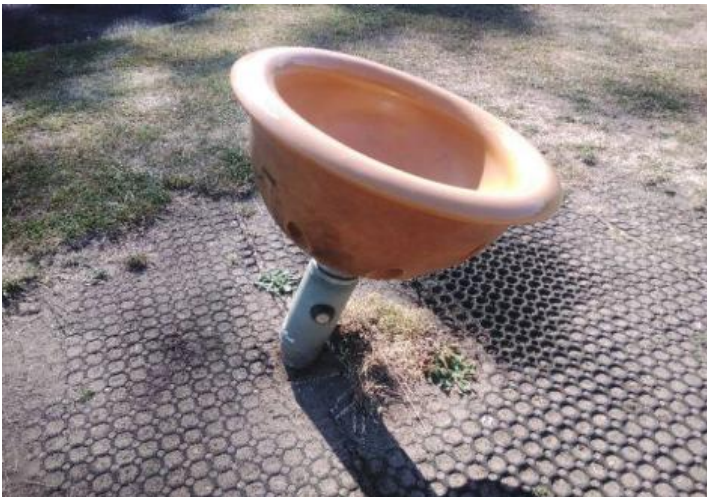
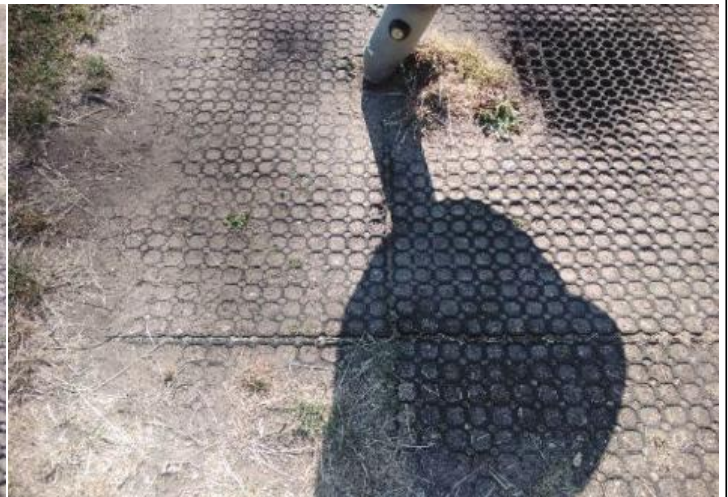
Finding: There are gaps opening between the grass mat tiles

Action: Provide additional ties or secure / reinstate surface

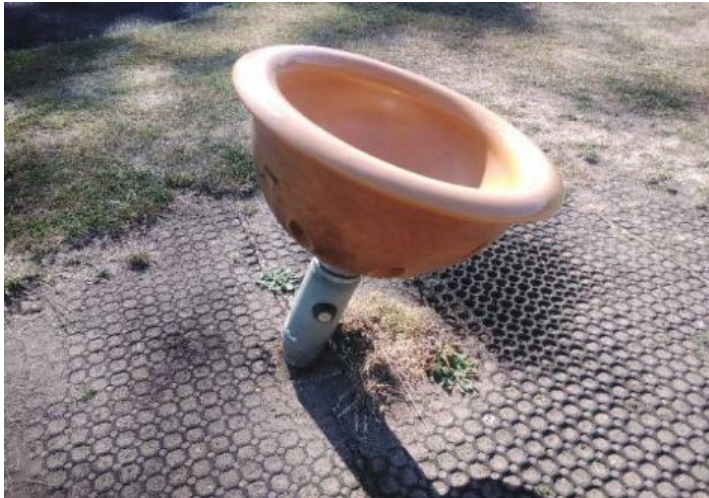
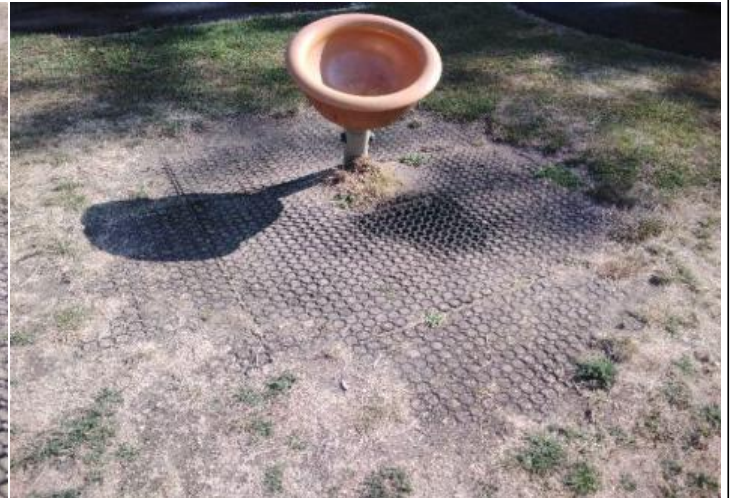
Finding: The grass mats are silted up, the soil is compacted and the area will become very slippery when the soil is wet. **Action:** Reinstatement as required

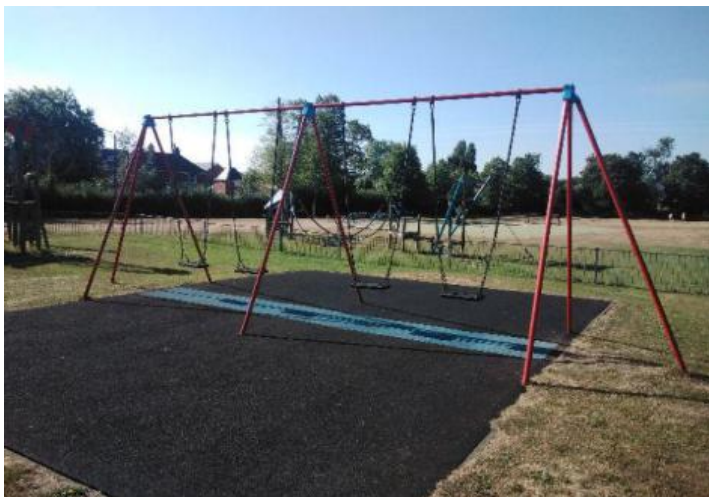
Finding: There are significant gaps (over 30mm) between the surface and the edging or between the joints in the surface; these are large enough for a small foot to enter. **Action:** Repair surfacing

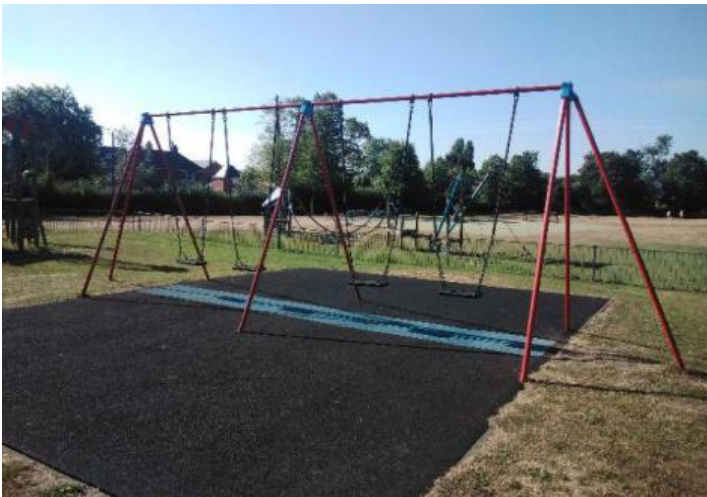
Finding: The bushes are showing signs of wear

Action: Monitor for any further deterioration and replace as required

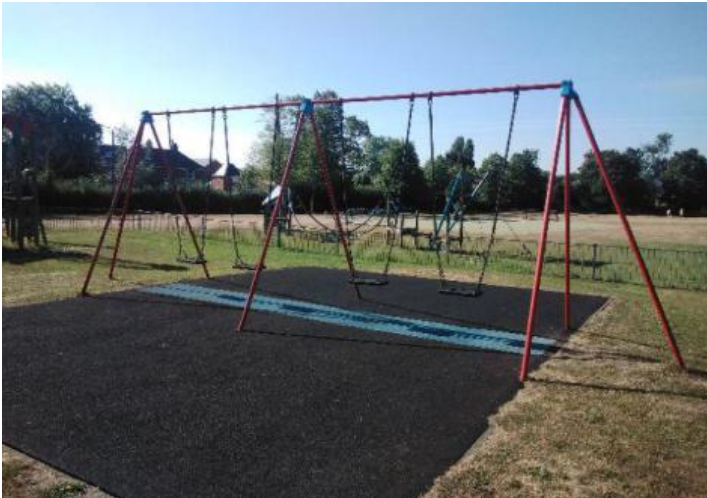
Finding: There is some minor damage to the surface

Action: Monitor for any further deterioration and repair as required

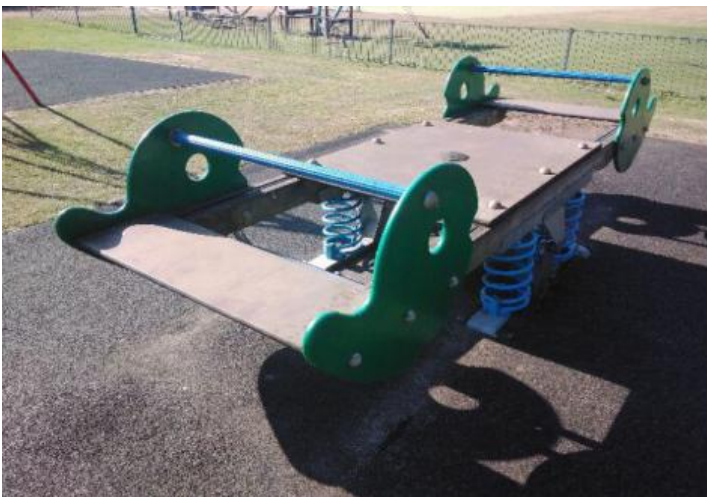
Finding: The surface is lifting at the edges and creating trip points

Action: Repair perimeter of surfacing to remove trip points

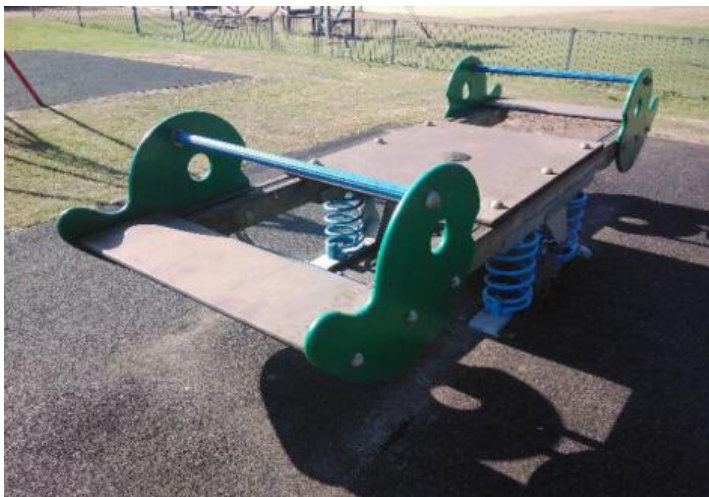
Finding: There is/are bolt cap covers missing or damaged on the item
Action: Replace missing or damaged bolt cap covers

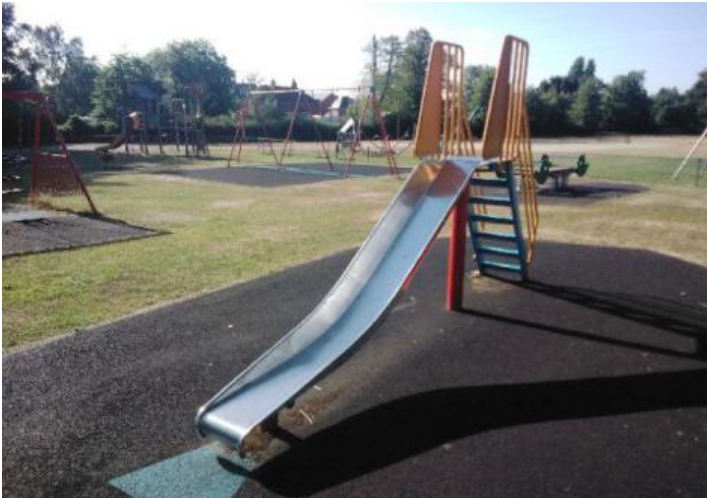
Finding: There are significant gaps (over 30mm) between the surface and the edging or between the joints in the surface; these are large enough for a small foot to enter

Action: Repair surfacing

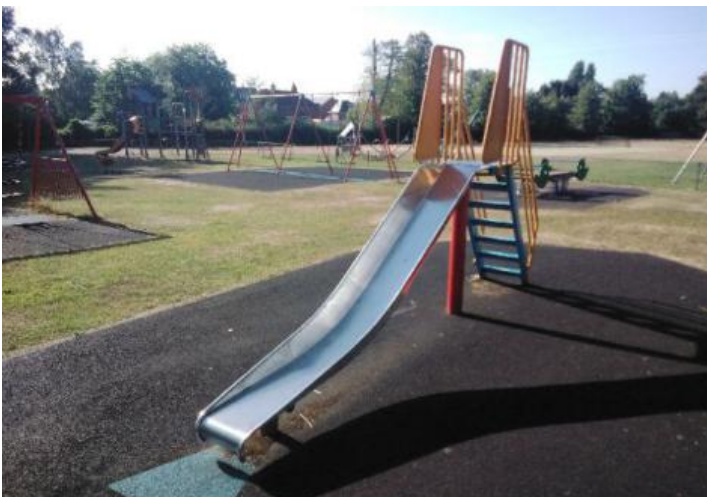
Finding: The item fails to meet the requirements of BS EN 1176 Part 1 4.2.7.2 head and neck entrapment in the barriers and/or steps

Action: Monitor - No remedial work recommended

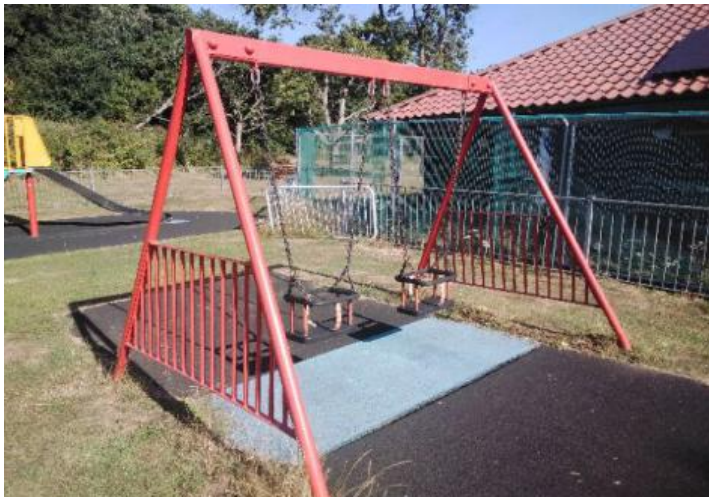
Finding: The chain openings are in excess of the 8.6mm as recommended by BS EN 1176

Action: Monitor - No remedial work recommended

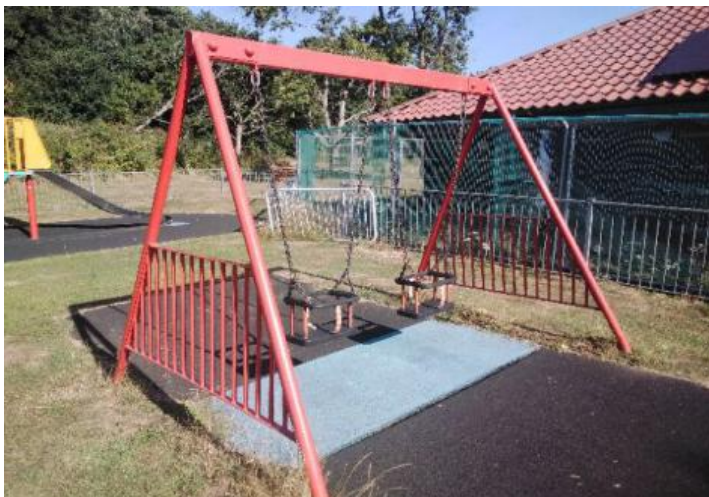
Finding: The paintwork on this item has been damaged or worn exposing the metal underneath which is rusting
Action: Treat any rusting components and repaint

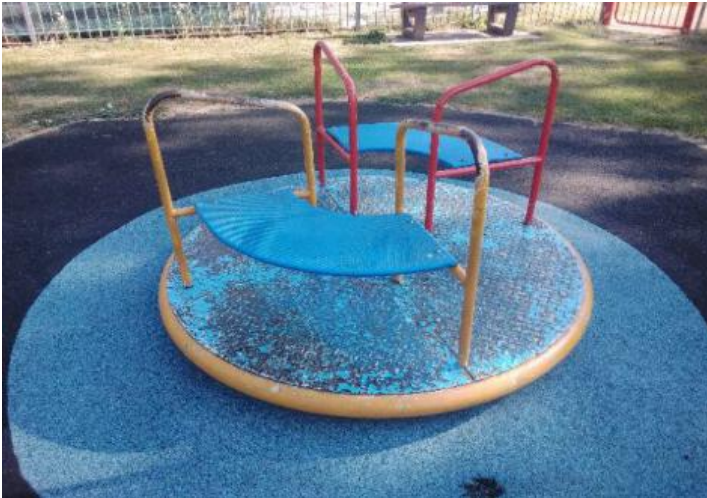
Finding: There is some minor damage to the surface

Action: Repair

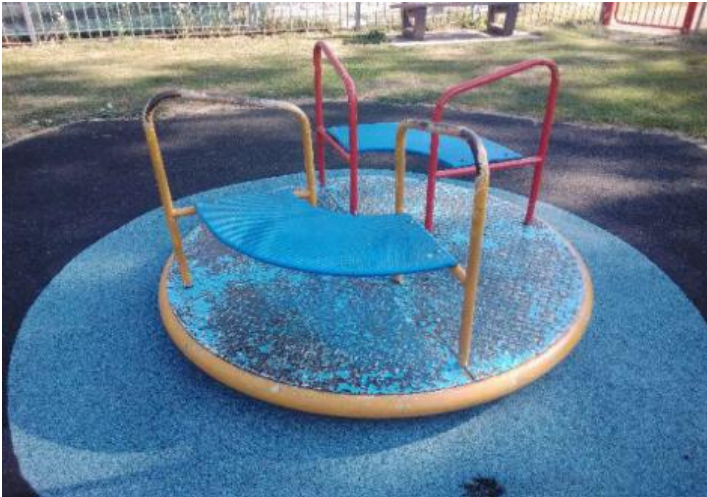
Finding: The bearing is worn / damaged and the item is not operating correctly

Action: Repair / replace

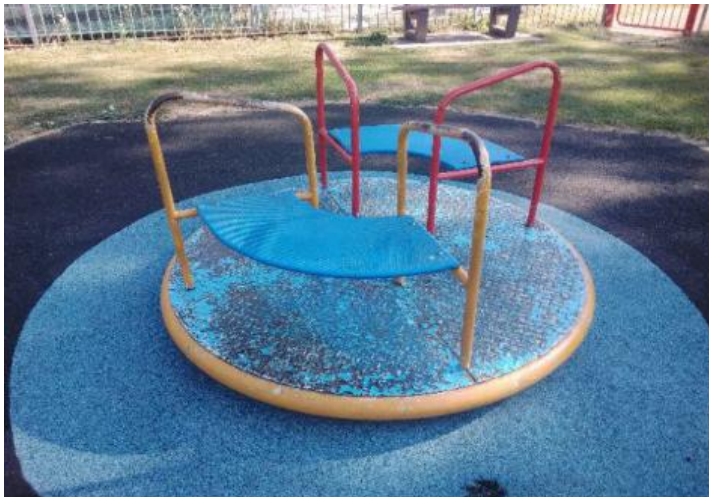
Finding: The paintwork on this item has been damaged or worn exposing the metal underneath which is rusting

Action: Treat any rusting components and repaint

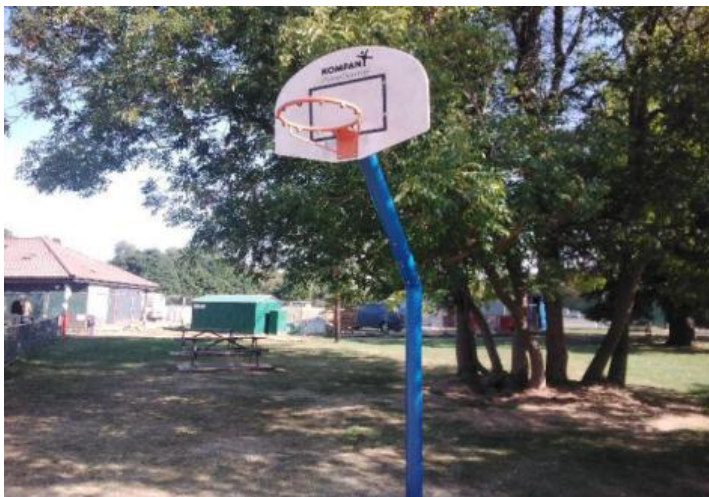
Finding: There are trip hazards at the edges of the surface

Action: Reinstate surrounding surface levels to remove the trip points

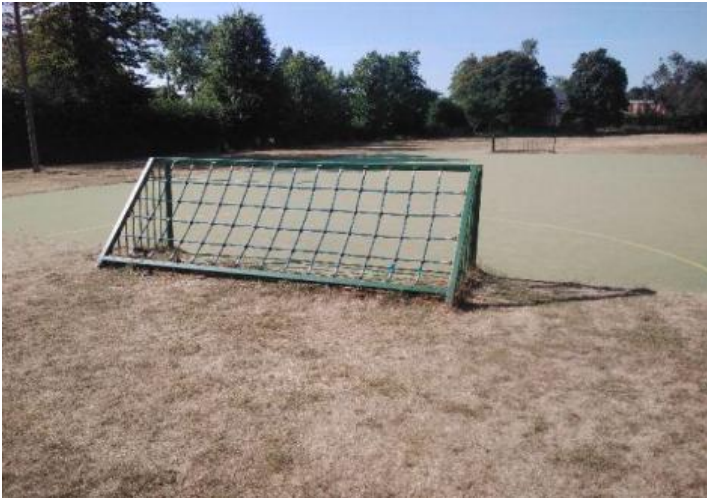
Finding: The ropes/nets are worn/damaged in places

Action: Monitor for any further deterioration and repair or replace as required

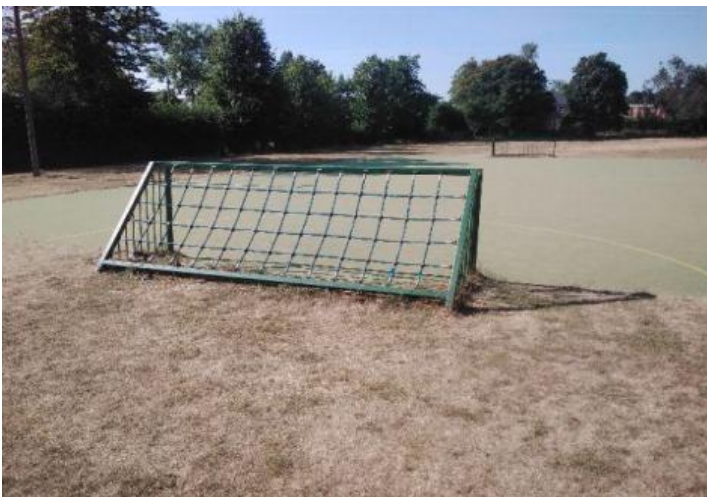
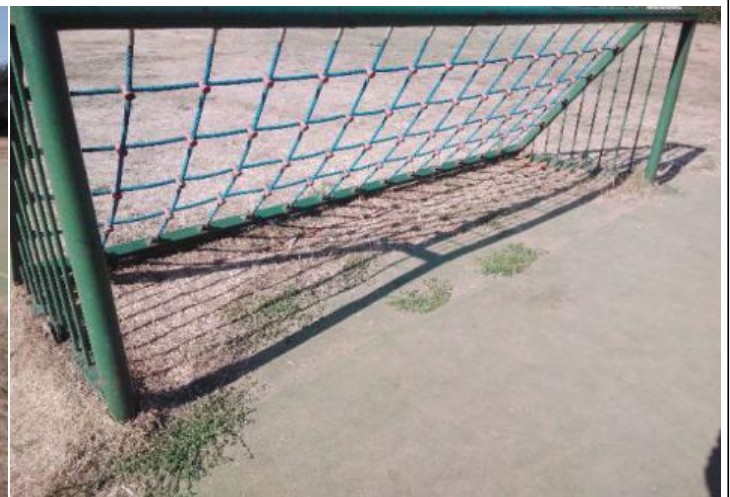
Finding: There is weed / vegetation growth on, between, or around the edges of the surfacing

Action: Remove weed / vegetation growth

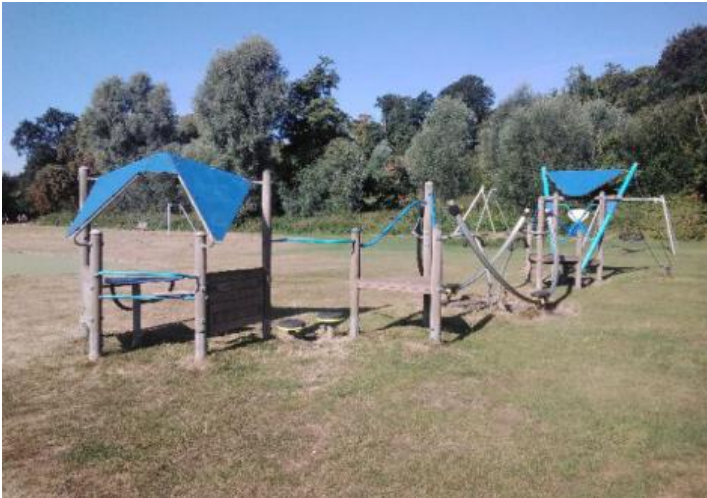
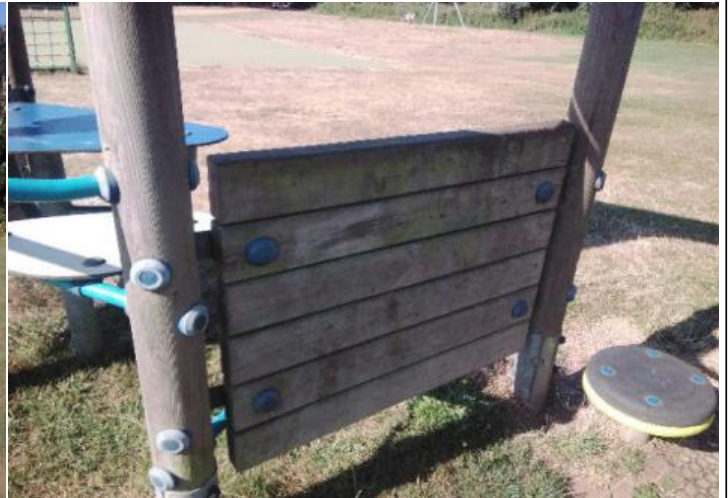
Finding: There is algae or moss on the surface of the equipment

Action: Clean and treat appropriately

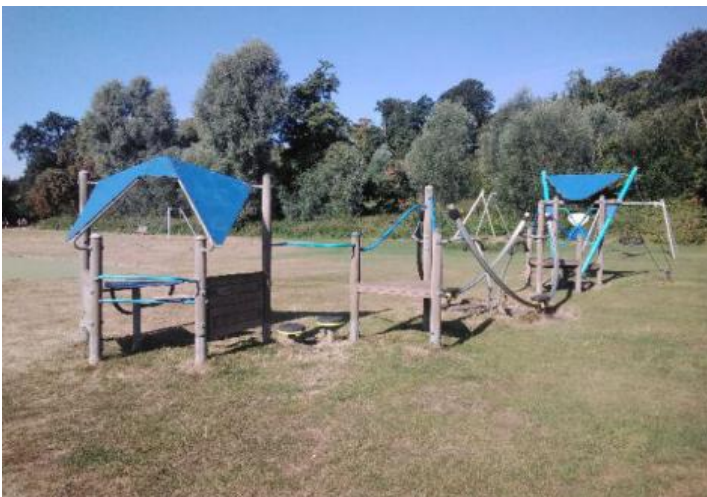
Finding: There is/are bolt cap covers missing or damaged on the item

Action: Replace missing or damaged bolt cap covers

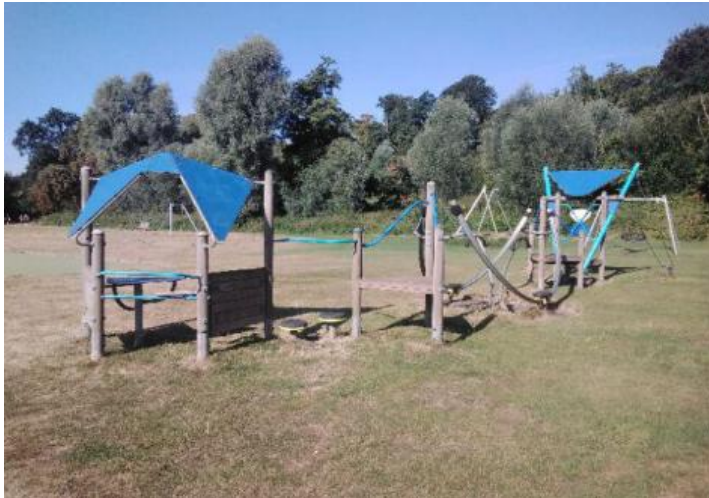
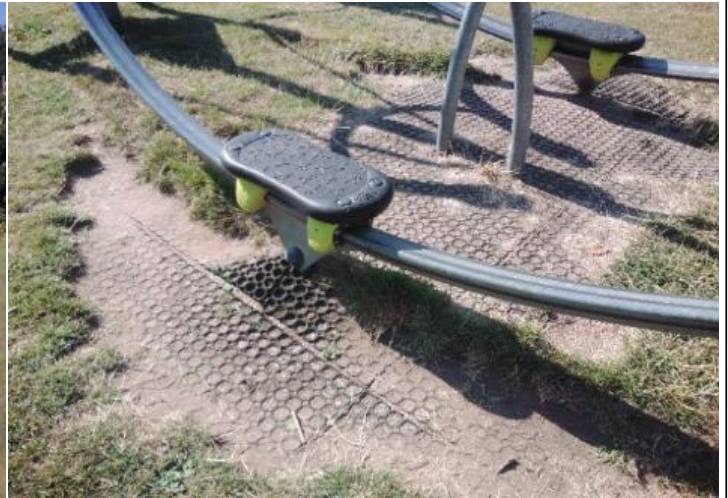
Finding: There are gaps opening between the grass mat tiles

Action: Provide additional ties or secure / reinstate surface tiles

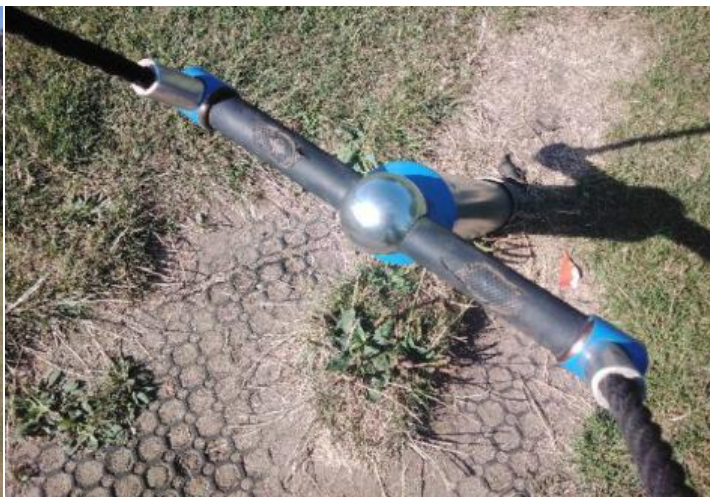
Finding: There is some damage to the item

Action: Monitor for any further deterioration and repair as required

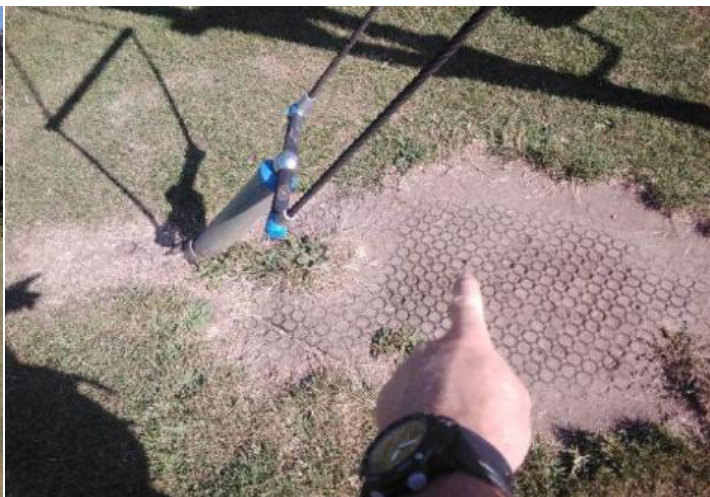
Finding: Fixing Pins have been installed in the impact areas of the grass mats

Action: Remove pins from impact areas

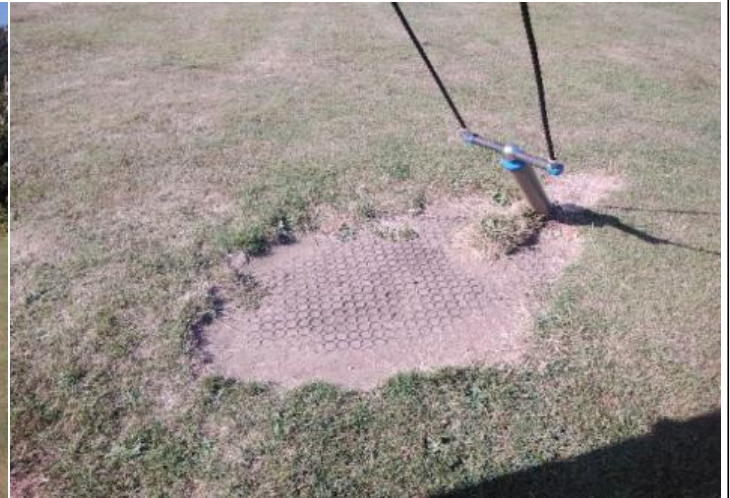
Finding: The grass mats are silted up, the soil is compacted and the area will become very slippery when the soil is wet. **Action:** Reinststate as required
