the play inspection company

Annual Inspection

Melton Parish Council

Melton Road

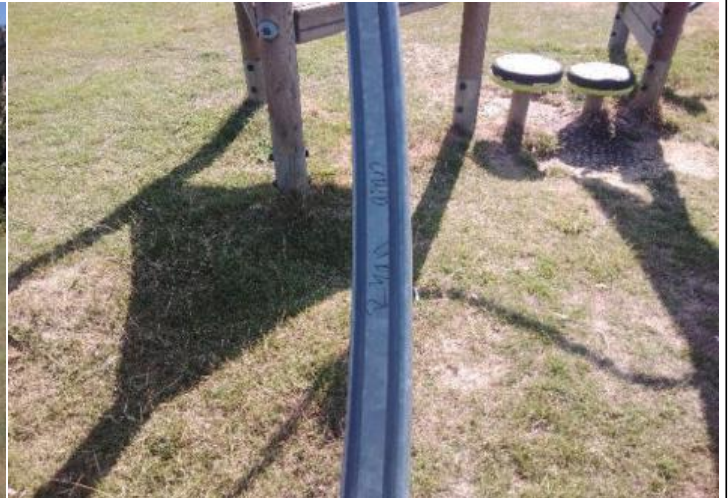
Finding: There is some graffiti present

Action: Remove the graffiti

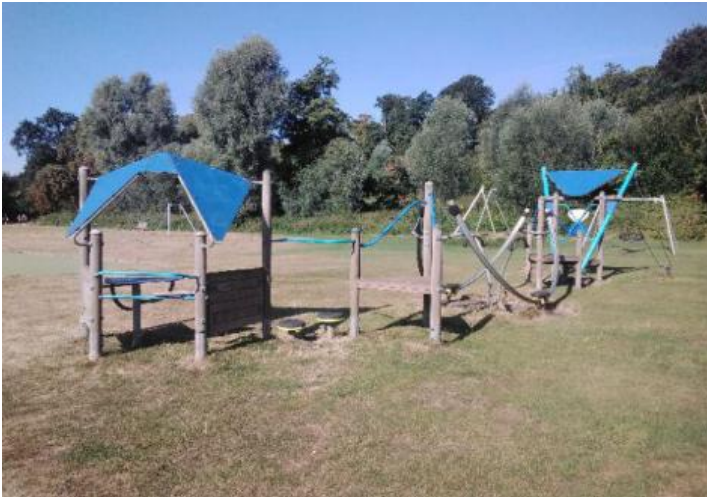
Finding: A number of fixing(s) have worked loose

Action: Secure all loose fixings

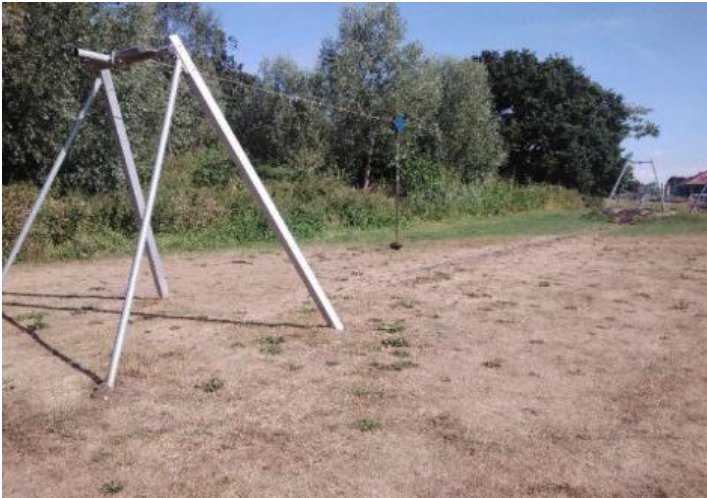
We have completed a visual inspection of the cable and fixing points from ground level, however it is not possible to fully inspect the cable and fixings without either hiring equipment to gain access or removing the cable and inspecting at ground level. We recommend that the main cable and fixing security is thoroughly inspected at least in accordance with the manufacturers recommendations to check for damage, security or internal rusting, this will help to ensure the continued safe use of the equipment - Inspect in accordance with the manufacturers recommendations

Finding: We have completed a visual inspection of the cable and fixing points from ground level, however it is not possible to fully inspect the cable and fixings without either hiring equipment to gain access or removing the cable and inspecting at ground level. We recommend that the main cable and fixing security is thoroughly inspected at least in accordance with the manufacturers recommendations to check for damage, security or internal rusting, this will help to ensure the continued safe use of the equipment

Action: Inspect in accordance with the manufacturers recommendations

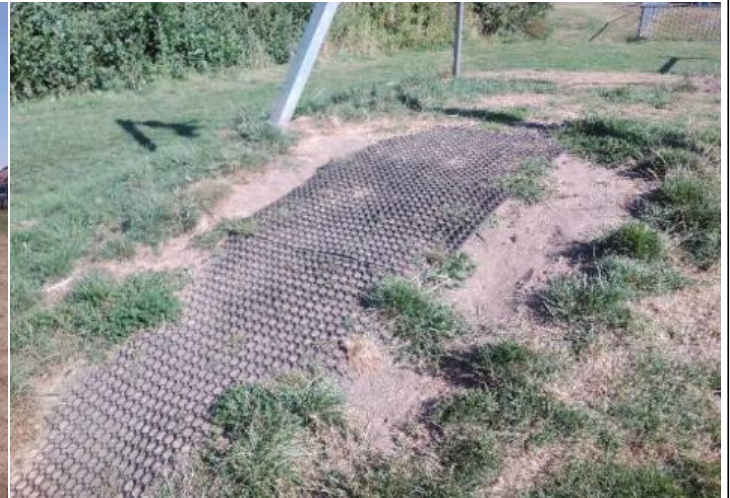
Finding: The grass has eroded within the impact area of the equipment and may not provide the necessary impact attenuating properties for the equipment fall height; the surface may also be slippery in wet weather
Action: Reinststate the grass or provide an all weather surface

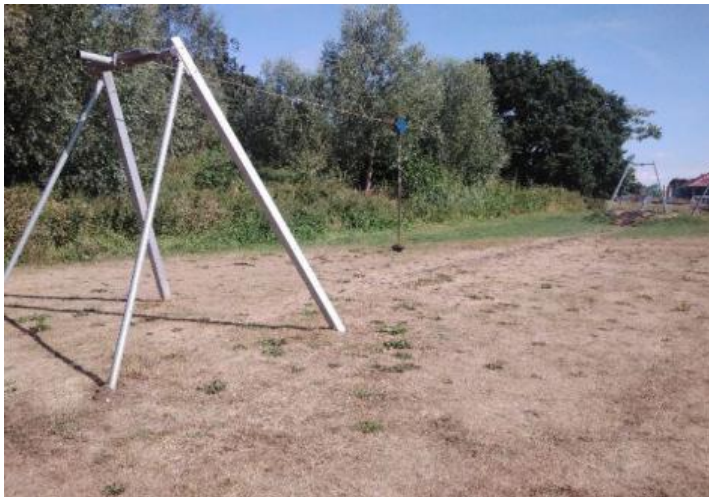
The edges of the grass mat surface have not been installed in accordance with the API Code of Practice - Tuck in edges of grass mat to remove trip hazards

Finding: The edges of the grass mat surface have not been installed in accordance with the API Code of Practice
Action: Tuck in edges of grass mat to remove trip hazards

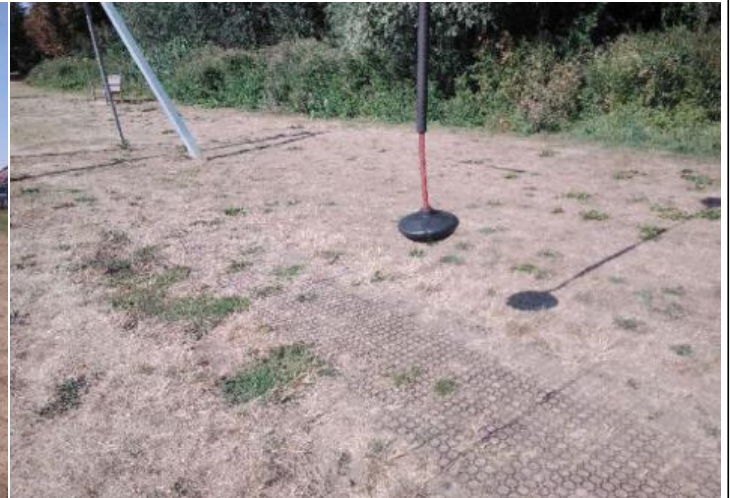
Finding: The height of the seat is less than 350mm when loaded and does not meet the requirements of BS EN 1176 Part 4

Action: Ensure the seat is a minimum of 350mm above ground level when loaded with 69.5kg

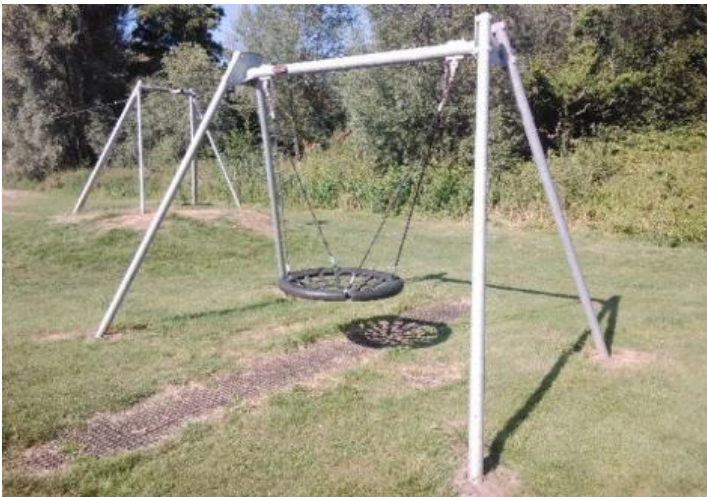
The seat has minor damage or wear - Monitor for any further deterioration and replace as required

Finding: The seat has minor damage or wear

Action: Monitor for any further deterioration and replace as required
