## Annual Inspection

Melton Parish Council

Beresford Drive Play Area

Beresford Drive, Woodbridge, Suffolk, IP12 1JJ

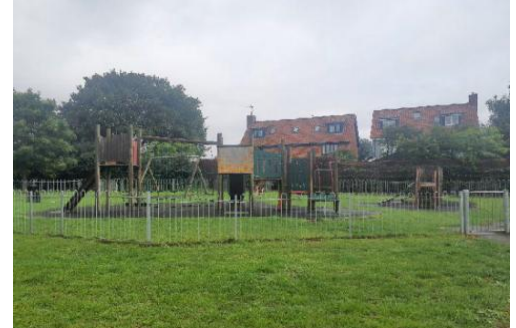
**Item:** Site General  
**Manufacturer:** Owner/Operator  
**Surface Type:** N/A  
**Item Quantity:** 1  
**Equipment Compliance:** N/A  
**Surface Area Compliance:** N/A

There is algae, silt or moss growth on the surface resulting in slippery conditions - Clean and treat appropriately

There is a loose cone on site - Remove

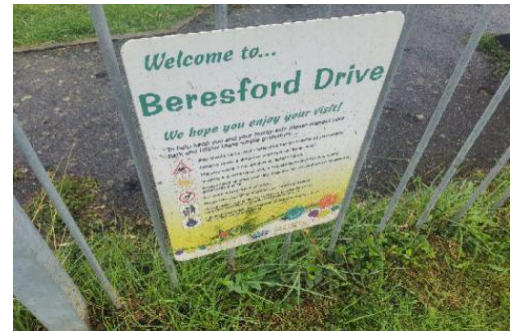
**Item:** Sign  
**Manufacturer:** Owner/Operator  
**Surface Type:** N/A  
**Item Quantity:** 1  
**Equipment Compliance:** N/A  
**Surface Area Compliance:** N/A

A sign is damaged - Replace

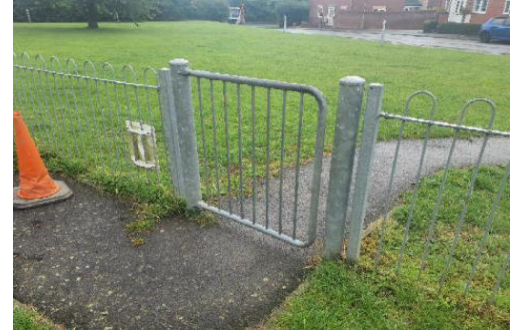
**Item:** Gate - Self Closing  
**Manufacturer:** Medway Gate Co.  
**Surface Type:** Bitmac  
**Item Quantity:** 1  
**Equipment Compliance:** N/A  
**Surface Area Compliance:** N/A

There are trip hazards at the edges of the surface - Reinstate surrounding surface levels to remove the trip points

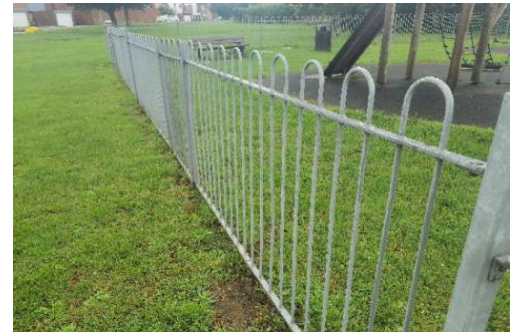
**Item:** Fence - Bow Top  
**Manufacturer:** Not Identified  
**Surface Type:** Grass  
**Item Quantity:** 1  
**Equipment Compliance:** N/A  
**Surface Area Compliance:** N/A

There is some damage to the fence sections - Monitor for any further deterioration and repair as required

There are a number of loose posts around the fence - Monitor for any further deterioration and reset as required

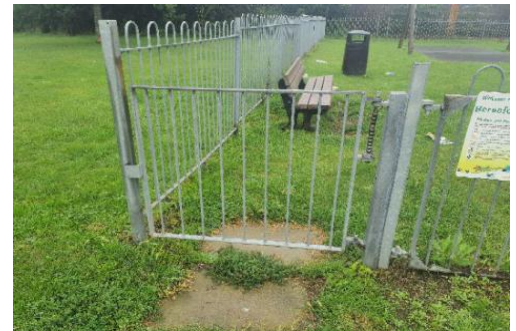
**Item:** Gate - Self Closing  
**Manufacturer:** Not Identified  
**Surface Type:** Paving Slabs  
**Item Quantity:** 1  
**Equipment Compliance:** N/A  
**Surface Area Compliance:** N/A

A number of fixing(s) have worked loose - Secure all loose fixings

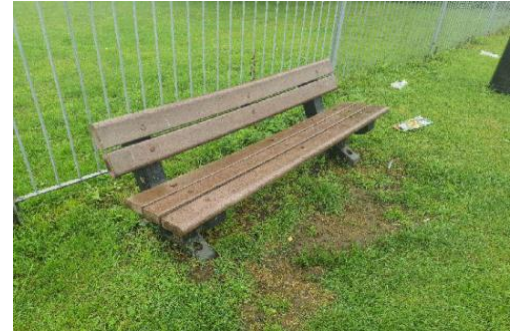
**Item:** Bench  
**Manufacturer:** Broxap  
**Surface Type:** Grass  
**Item Quantity:** 1  
**Equipment Compliance:** N/A  
**Surface Area Compliance:** N/A

There is some evidence of fire damage to the item - Monitor for any further deterioration and repair as required

The surface has eroded in some areas and may be slippery in wet conditions - Reinstate the surface

The fixings have corroded excessively - Replace all corroded fixings

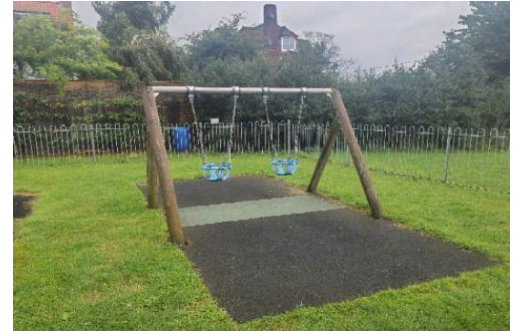
**Item:** 1 Bay 2 Seat (Cradle)  
**Manufacturer:** Playdale Playgrounds Ltd  
**Surface Type:** Wet Pour  
**Item Quantity:** 1  
**Equipment Compliance:** Yes  
**Surface Area Compliance:** Yes

There is some strimmer / machinery damage apparent on the posts, this can penetrate the preservative applied to the timber and accelerate the rotting process - Monitor for any deterioration (rot) and replace as required

The timber has a number of splits/shakes or air cracks and this may affect the stability or allow water ingress which will accelerate the rotting process - Monitor to ensure the splits do not cross through fixing points of the structure and/or cause any instability

There is some evidence of rot in the timber - Monitor for any further deterioration and replace as required

The surface is lifting at the edges and creating trip points - Repair perimeter of surfacing to remove trip points

There is algae or moss on the surface of the equipment which can lead to the onset of rot - Monitor condition of the timber (rot) Clean and treat appropriately

There is some notable evidence of chain wear - Monitor for any further deterioration and replace when 40% worn

There are caps missing from the underside of the seats - Replace missing caps under the seats

There are gaps opening between the surfacing and the edging surround or between the joints in the surfacing - Monitor for any further deterioration and repair as required

The swivel joint is becoming worn - Monitor for any further deterioration and replace

There is/are bolt cap covers missing or damaged on the item - Replace missing or damaged bolt cap covers

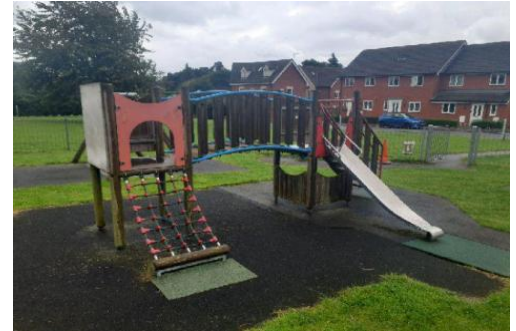
**Item:** Multi Play (Toddler)  
**Manufacturer:** Playdale Playgrounds Ltd  
**Surface Type:** Wet Pour  
**Item Quantity:** 1  
**Equipment Compliance:** No  
**Surface Area Compliance:** Yes

The surface is lifting at the edges and creating trip points - Repair perimeter of surfacing to remove trip points

There are significant gaps (over 30mm) between the surface and the edging or between the joints in the surface; these are large enough for a small foot to enter - Repair surfacing

There is some evidence of rot in the timber - Monitor for any further deterioration and replace as required

There are a number of dents in the slide surface - Monitor for any further deterioration and repair as required

The side of the slide is damaged - Monitor for any further deterioration and repair as required

There is/are finger entrapment/s in the slide starting section due to missing inserts and the item fails to meet the requirements of BS EN 1176 Part 1 4.2.7.6 Entrapment of fingers - Provide inserts to remove entrapment

There is/are bolt cap covers missing or damaged on the item - Replace missing or damaged bolt cap covers

The timber has a number of splits/shakes or air cracks and this may affect the stability or allow water ingress which will accelerate the rotting process - Monitor to ensure the splits do not cross through fixing points of the structure and/or cause any instability

There are falls in excess of 600mm between adjacent components on the structure, in contravention of the recommendations set out in BS EN 1176 Part 1; 4.2.8.4 - Monitor - No remedial work recommended

The connecting links are in excess of 8.6mm and less than 12mm and fail the requirements of BS EN 1176 Part 1; clause 4.2.13, Chains - Monitor use and replace with compliant links at the next maintenance cycle

There are areas or parts of the timber on the structure that have rotted - Replace all affected timbers

A number of fixing(s) have worked loose - Secure all loose fixings

There are gaps in excess of 30mm in the direction of travel creating foot entrapment/s in contravention of BS EN 1176 Part 1 in the bridge - Monitor - no remedial action recommended

A barrier has been replaced and there are metal brackets remaining creating sharp edges - Remove brackets

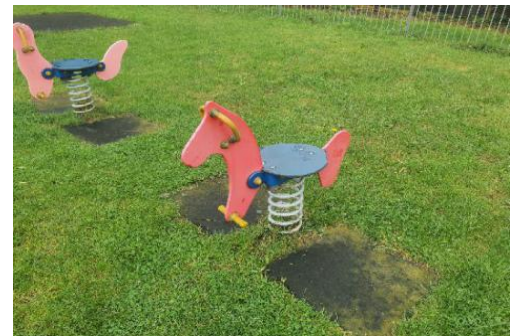
**Item:** Spring Horse  
**Manufacturer:** Ledon  
**Surface Type:** Rubber Tiles  
**Item Quantity:** 1  
**Equipment Compliance:** No  
**Surface Area Compliance:** Yes

The end of handgrips and/or footrests have a cross section of less than 15cm<sup>2</sup> and fail to meet the requirements of BS EN 1176 Part 6 - Monitor - No remedial work recommended

The paintwork on the spring has been damaged or worn exposing the metal underneath which is rusting - Treat any rusting components and repaint

The end caps are missing on the Handgrips/Footrests - Replace missing end caps

There is some minor damage to the surface - Monitor for any further deterioration and repair as required

The U bolts clamping the spring are worn - Replace

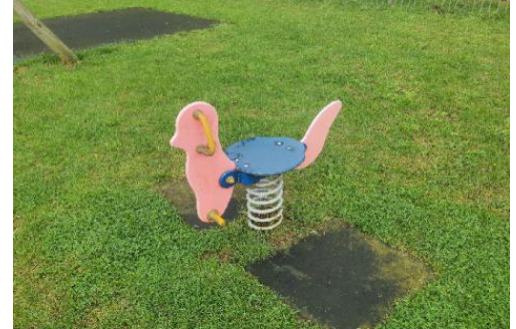
**Item:** Spring Bird  
**Manufacturer:** Ledon  
**Surface Type:** Rubber Tiles  
**Item Quantity:** 1  
**Equipment Compliance:** No  
**Surface Area Compliance:** Yes

The end of handgrips and/or footrests have a cross section of less than 15cm<sup>2</sup> and fail to meet the requirements of BS EN 1176 Part 6 - Monitor - No remedial work recommended

The U bolts clamping the spring are worn - Monitor for any further deterioration and replace as required

The paintwork on the spring has been damaged or worn exposing the metal underneath which is rusting - Treat any rusting components and repaint

There is some damage to the item - Monitor for any further deterioration and repair as required

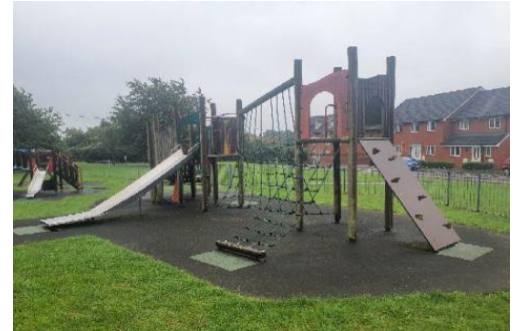
**Item:** Multi Play (Junior)  
**Manufacturer:** Playdale Playgrounds Ltd  
**Surface Type:** Wet Pour  
**Item Quantity:** 1  
**Equipment Compliance:** No  
**Surface Area Compliance:** Yes

A number of net connector fixing(s) have worked loose - Secure all loose fixings

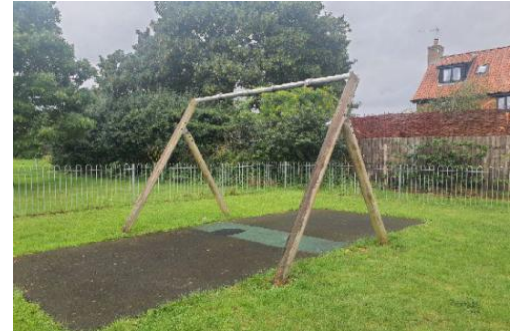
**Item:** 1 Bay 2 Seat (Flat)  
**Manufacturer:** Playdale Playgrounds Ltd  
**Surface Type:** Wet Pour  
**Item Quantity:** 1  
**Equipment Compliance:** N/A  
**Surface Area Compliance:** N/A

There are areas or parts of the timber on the structure that have rotted (Risk assessment has been lowered due to there being no swings attached) - Replace all affected timbers before re hanging swings

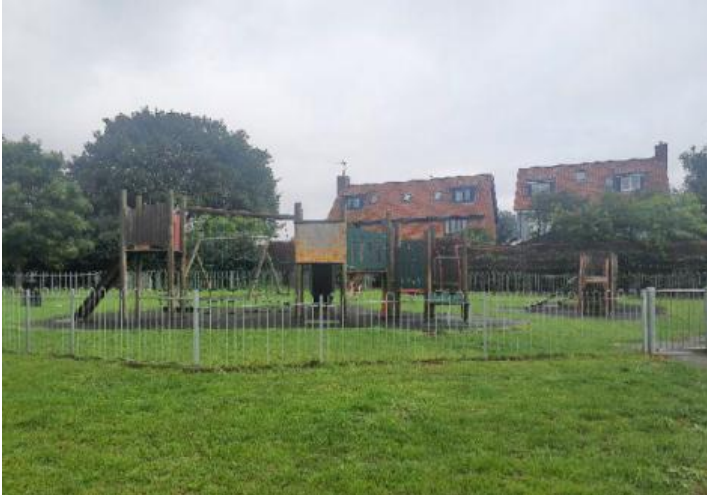
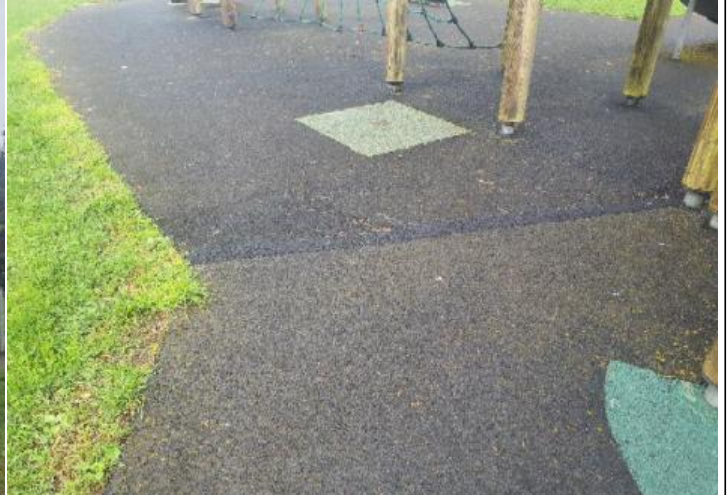
**Item:** Ancillary Items - Site General  
**Manufacturer:** Owner/Operator

**Finding:** There is algae, silt or moss growth on the surface resulting in slippery conditions

**Action:** Clean and treat appropriately

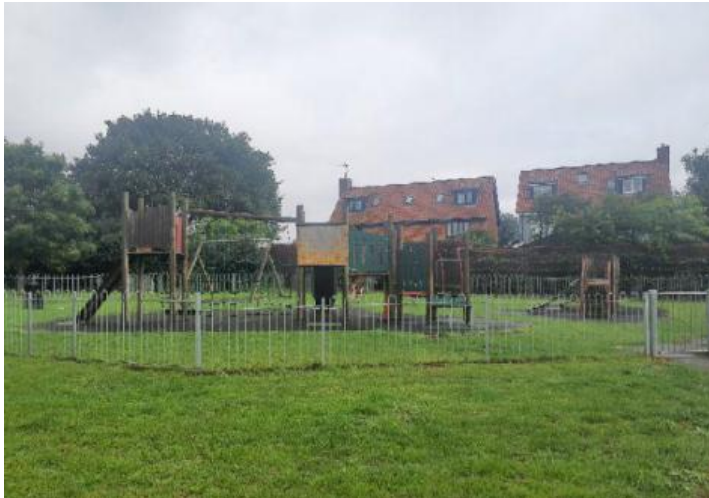
**Item:** Ancillary Items - Site General  
**Manufacturer:** Owner/Operator

**Finding:** There is a loose cone on site

**Action:** Remove

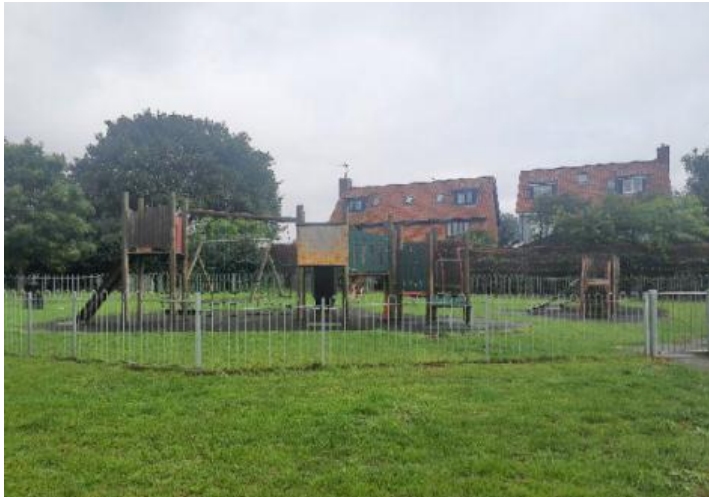
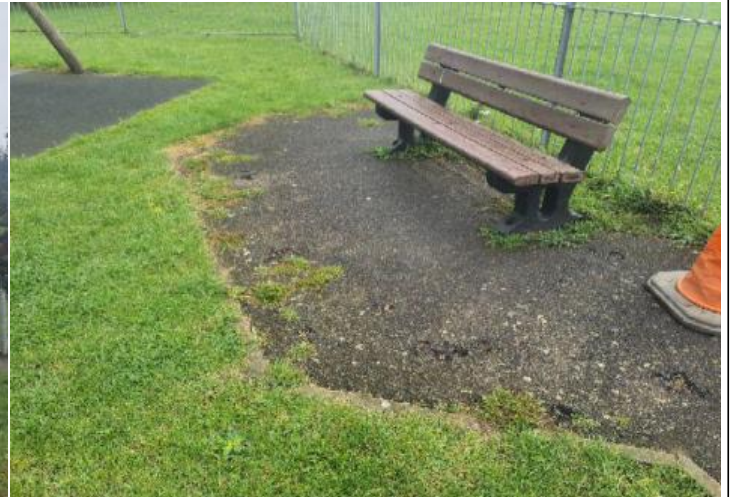
**Item:** Ancillary Items - Site General  
**Manufacturer:** Owner/Operator

**Finding:** There is weed / vegetation growth on, between, or around the edges of the surfacing

**Action:** Remove weed / vegetation growth

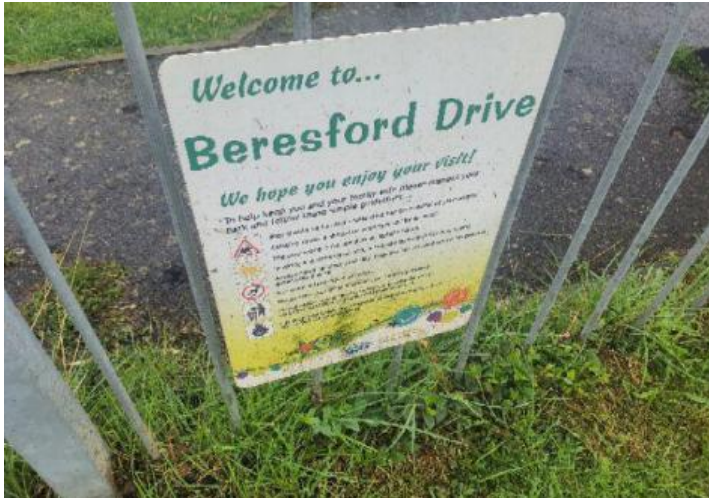
**Item:** Ancillary Items - Sign  
**Manufacturer:** Owner/Operator

**Finding:** A sign is damaged

**Action:** Replace

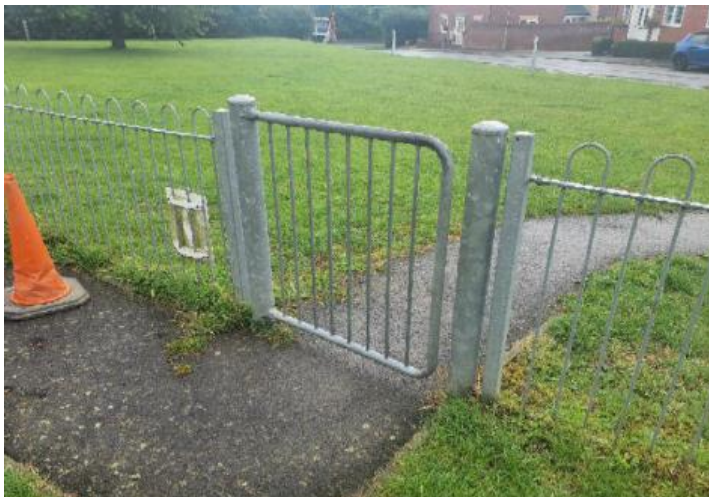
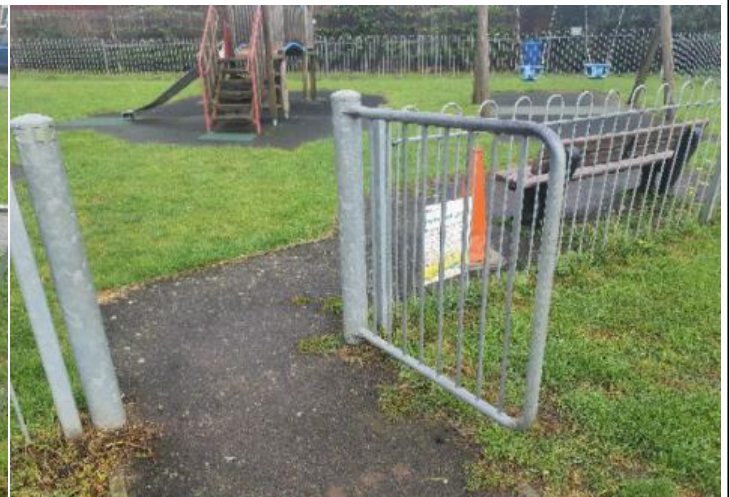
**Item:** Gates - Gate - Self Closing  
**Manufacturer:** Medway Gate Co.

**Finding:** The gate is not operating correctly

**Action:** Take effective action to ensure the gate closes between 4 and 8 seconds

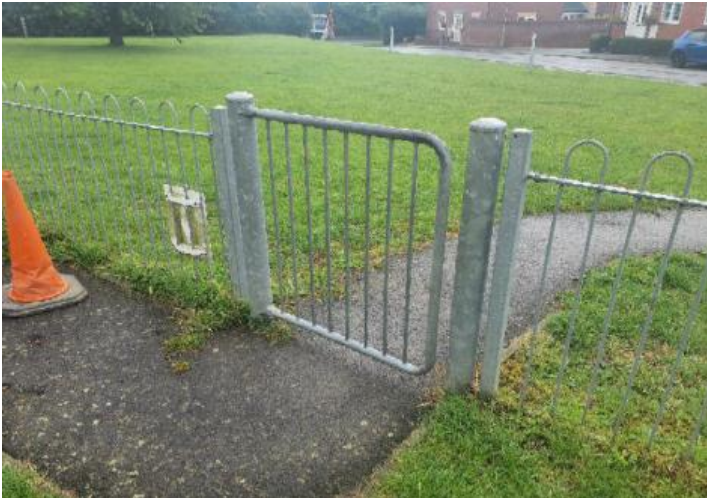
**Item:** Gates - Gate - Self Closing  
**Manufacturer:** Medway Gate Co.

**Finding:** There are trip hazards at the edges of the surface

**Action:** Reinstate surrounding surface levels to remove the trip points

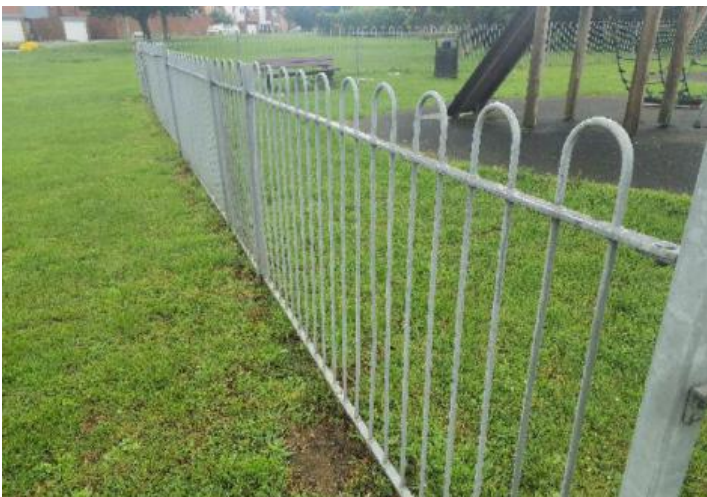
**Item:** Fences - Fence - Bow Top  
**Manufacturer:** Not Identified

**Finding:** There is some damage to the fence sections

**Action:** Monitor for any further deterioration and repair as required

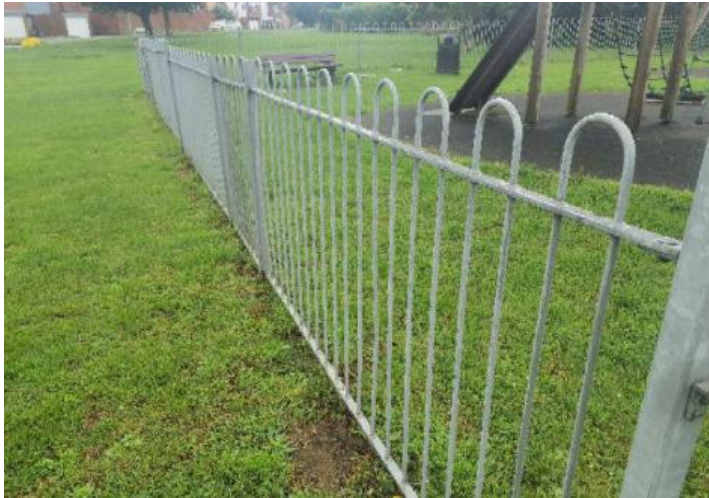
**Item:** Fences - Fence - Bow Top  
**Manufacturer:** Not Identified

**Finding:** There are a number of loose posts around the fence

**Action:** Monitor for any further deterioration and reset as required

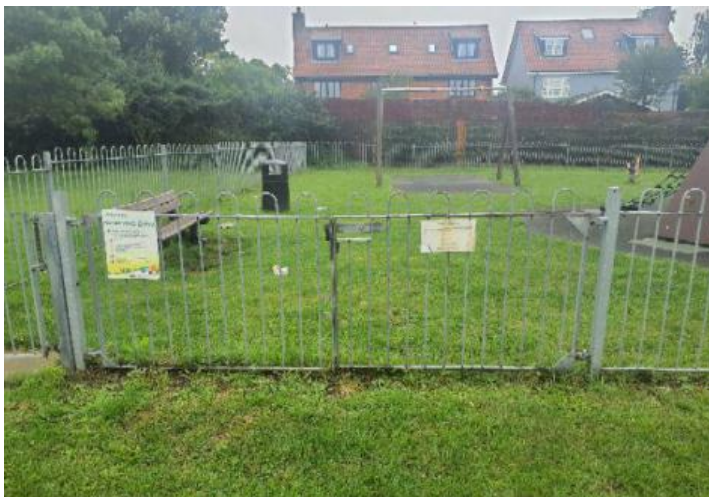
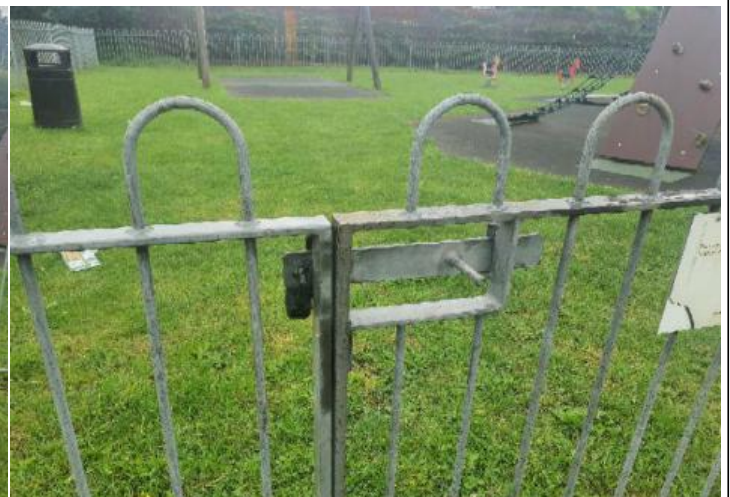
**Item:** Gates - Gate - Maintenance  
**Manufacturer:** Not Identified

**Finding:** The maintenance gate was correctly padlocked at the time of inspection, however this means that the inspector was unable to fully assess the gate

**Action:** Ensure that there are 12mm gaps throughout the full range of motion on gate/s and between leaves where relevant

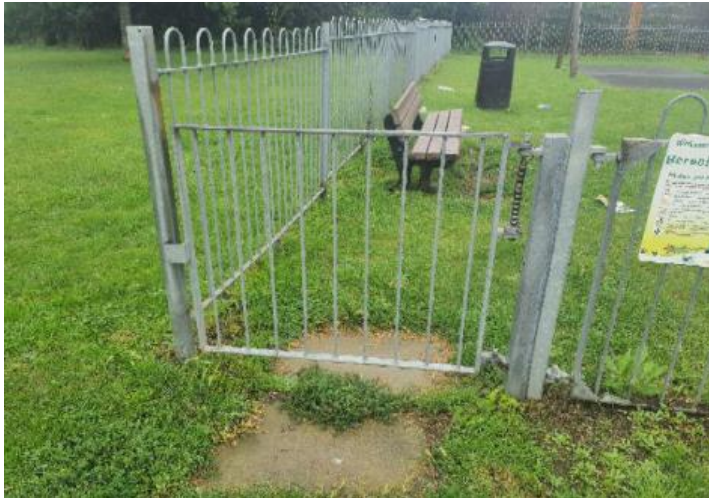
**Item:** Gates - Gate - Self Closing  
**Manufacturer:** Not Identified

**Finding:** A number of fixing(s) have worked loose

**Action:** Secure all loose fixings

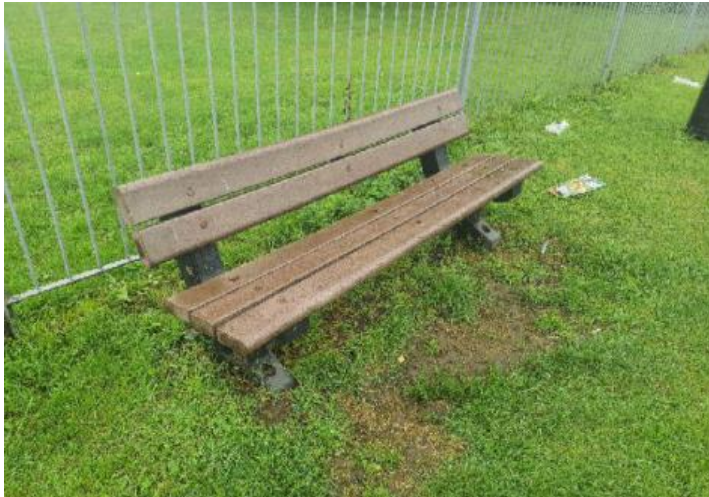
**Item:** Ancillary Items - Bench  
**Manufacturer:** Broxap

**Finding:** There is some evidence of fire damage to the item

**Action:** Monitor for any further deterioration and repair as required

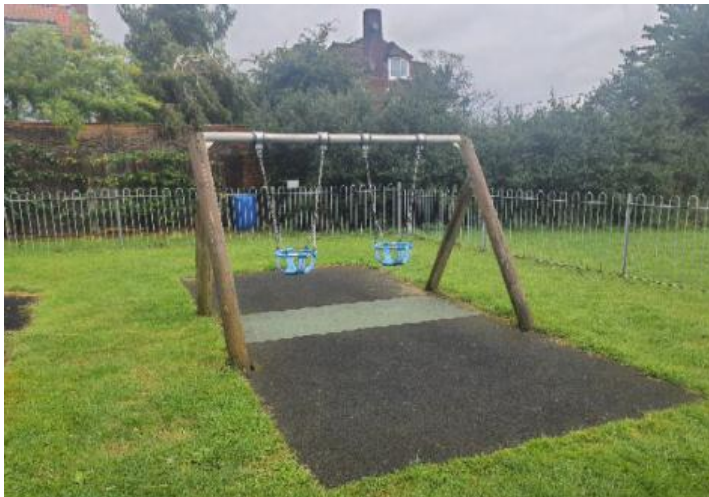
<b>Item:</b>	Swings - 1 Bay 2 Seat (Cradle)	<b>Risk Level:</b>	L - Low Risk
<b>Manufacturer:</b>	Playdale Playgrounds Ltd	<b>Surface:</b>	Wet Pour

<b>Finding:</b> There is some strimmer / machinery damage apparent on the posts, this can penetrate the preservative applied to the timber and accelerate the rotting process	<b>Action:</b> Monitor for any deterioration (rot) and replace as required
---	--

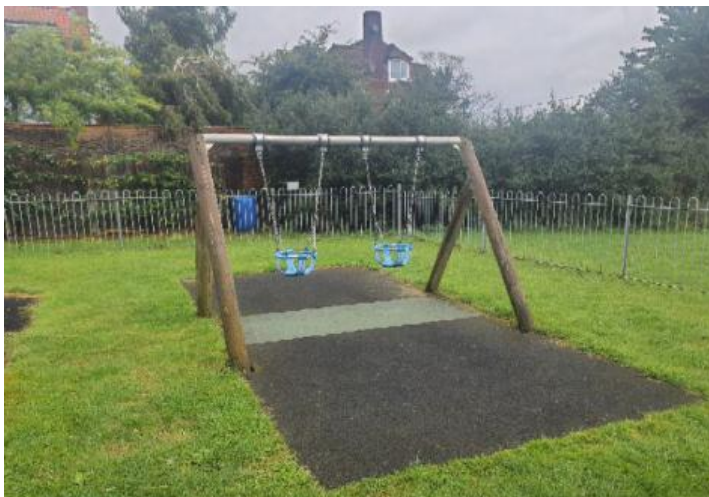
<b>Item:</b>	Swings - 1 Bay 2 Seat (Cradle)	<b>Risk Level:</b>	L - Low Risk
<b>Manufacturer:</b>	Playdale Playgrounds Ltd	<b>Surface:</b>	Wet Pour

<b>Finding:</b> The timber has a number of splits/shakes or air cracks and this may affect the stability or allow water ingress which will accelerate the rotting process	<b>Action:</b> Monitor to ensure the splits do not cross through fixing points of the structure and/or cause any instability
---	--

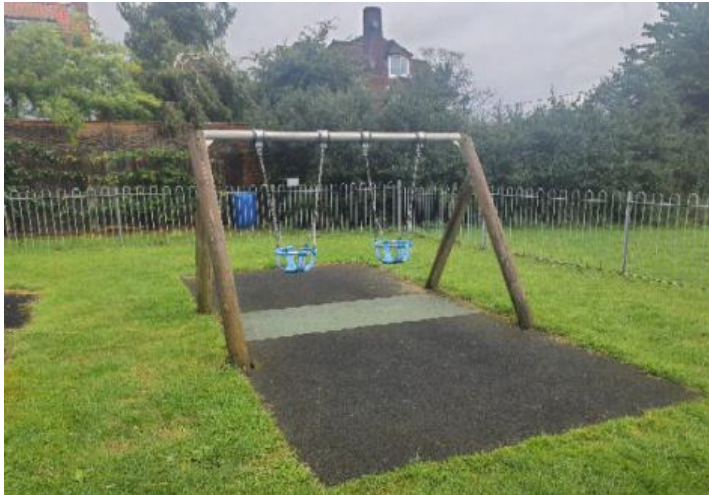
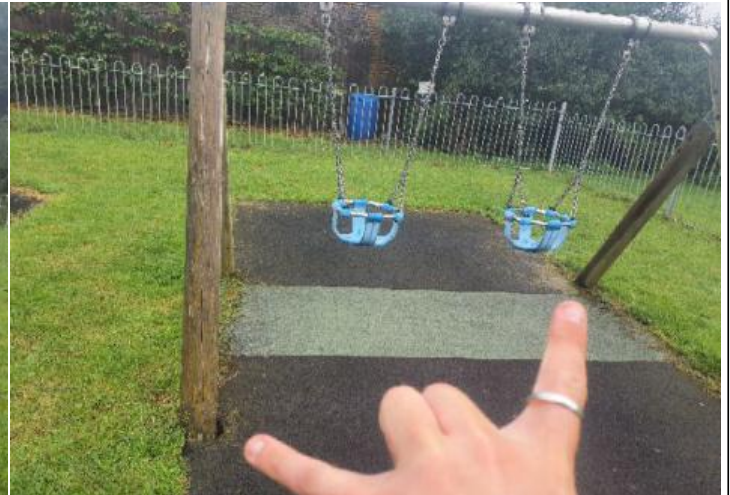
**Item:** Swings - 1 Bay 2 Seat (Cradle)  
**Manufacturer:** Playdale Playgrounds Ltd

**Finding:** There is some evidence of rot in the timber

**Action:** Monitor for any further deterioration and replace as required

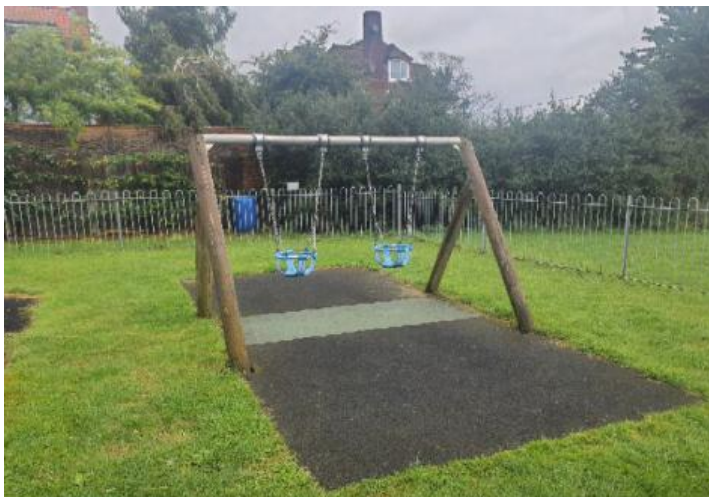
**Item:** Swings - 1 Bay 2 Seat (Cradle)  
**Manufacturer:** Playdale Playgrounds Ltd

**Finding:** The surface is lifting at the edges and creating trip points

**Action:** Repair perimeter of surfacing to remove trip points

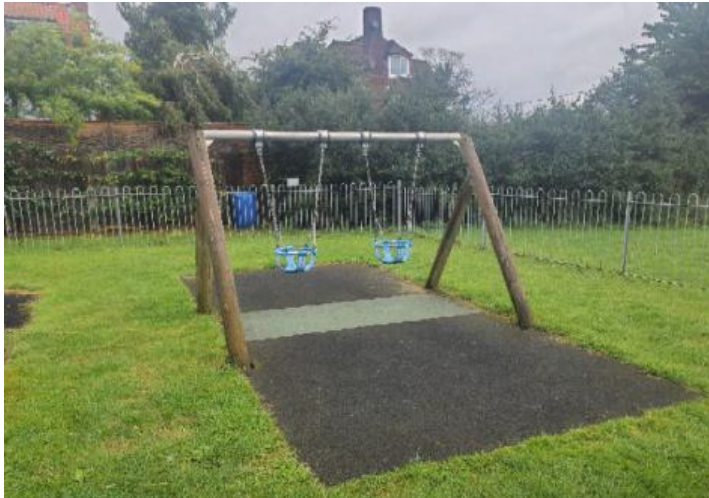
**Item:** Swings - 1 Bay 2 Seat (Cradle)  
**Manufacturer:** Playdale Playgrounds Ltd

**Finding:** There is algae or moss on the surface of the equipment which can lead to the onset of rot

**Action:** Monitor condition of the timber (rot) Clean and treat appropriately

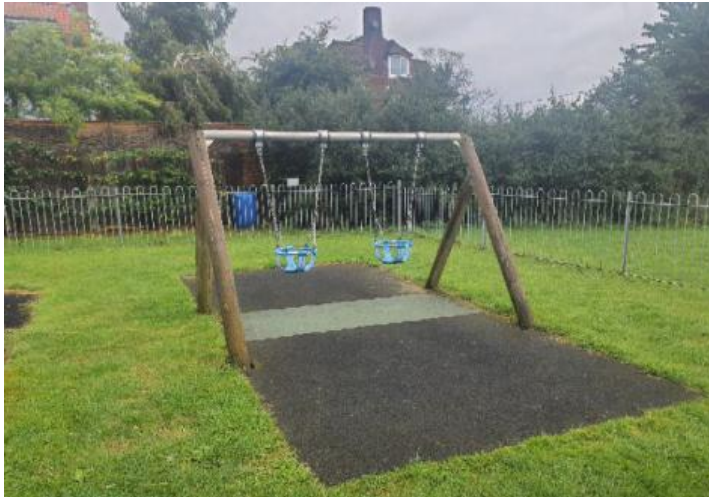
**Item:** Swings - 1 Bay 2 Seat (Cradle)  
**Manufacturer:** Playdale Playgrounds Ltd

**Finding:** There is/are bolt cap covers missing or damaged on the item

**Action:** Replace missing or damaged bolt cap covers

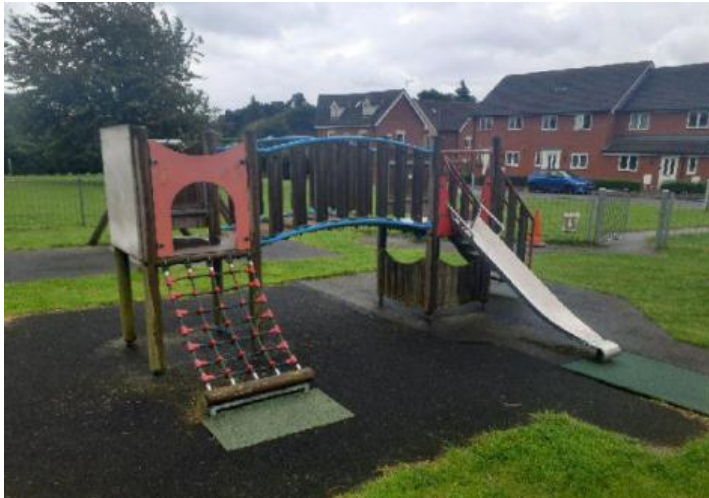
**Item:** Activity Equipment - Multi Play (Toddler)  
**Manufacturer:** Playdale Playgrounds Ltd

**Finding:** The surface is lifting at the edges and creating trip points

**Action:** Repair perimeter of surfacing to remove trip points

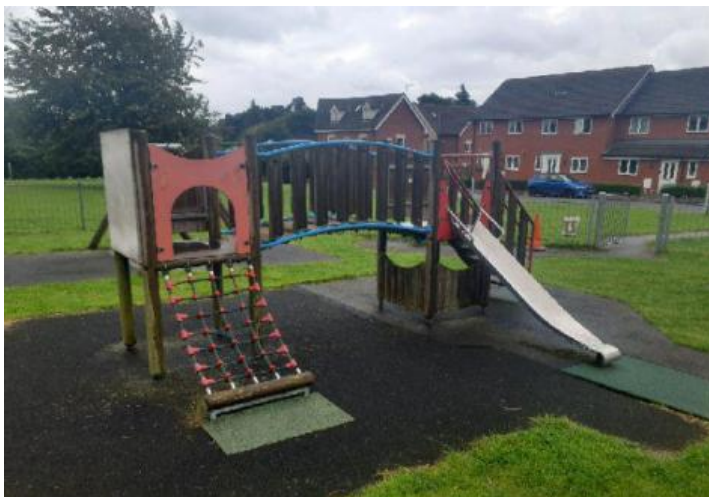
**Item:** Activity Equipment - Multi Play (Toddler)  
**Manufacturer:** Playdale Playgrounds Ltd

**Finding:** There are significant gaps (over 30mm) between the surface and the edging or between the joints in the surface; these are large enough for a small foot to enter

**Action:** Repair surfacing

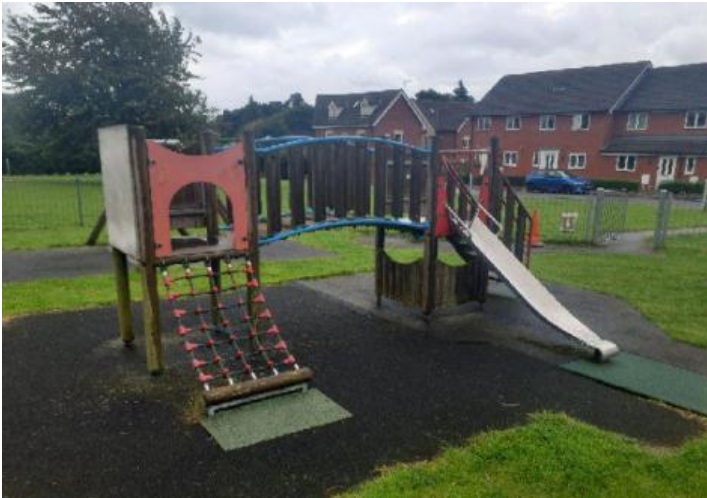
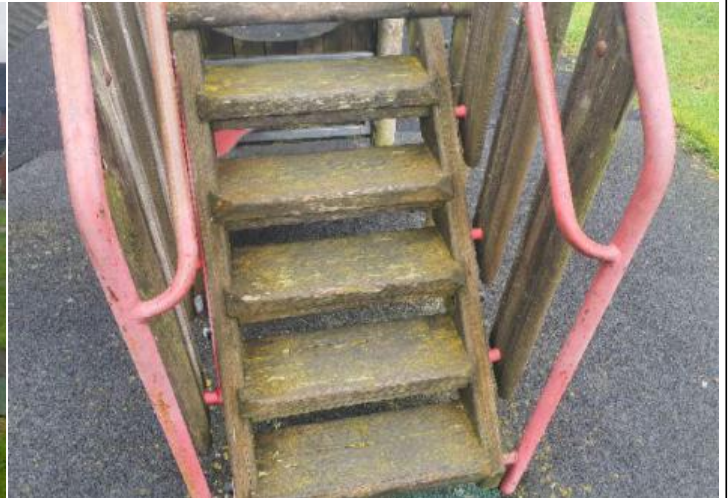
**Finding:** There is algae or moss on the surface of the equipment

**Action:** Clean and treat appropriately

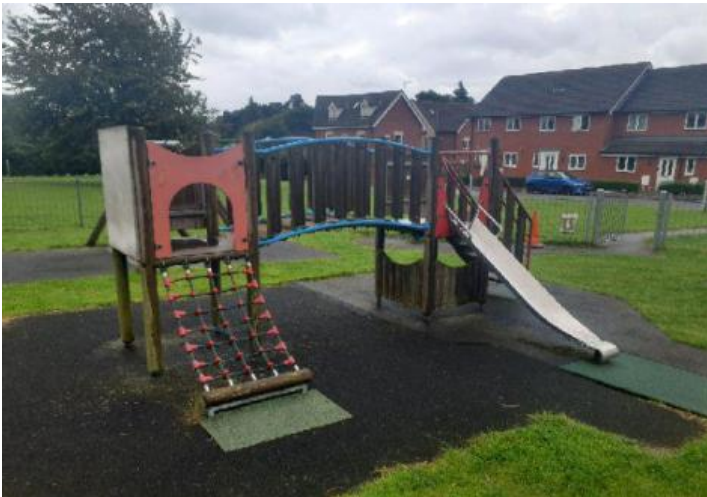
**Finding:** There is some evidence of rot in the timber

**Action:** Monitor for any further deterioration and replace as required

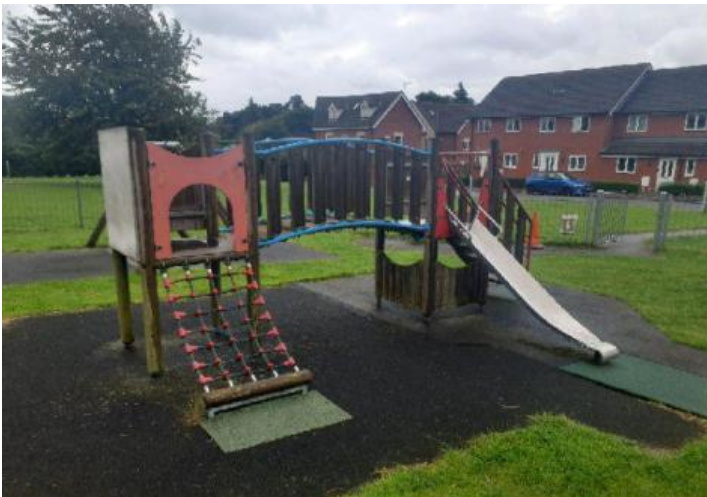
**Finding:** There is/are bolt cap covers missing or damaged on the item

**Action:** Replace missing or damaged bolt cap covers

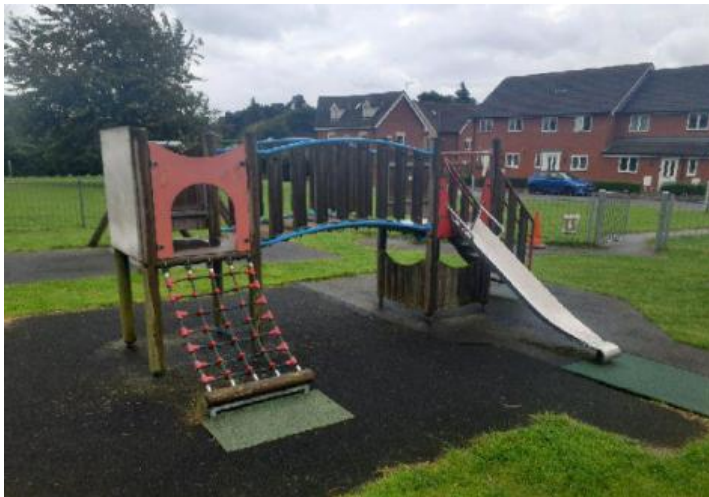
**Finding:** There are falls in excess of 600mm between adjacent components on the structure, in contravention of the recommendations set out in BS EN 1176 Part 1; 4.2.8.4  
**Action:** Monitor - No remedial work recommended

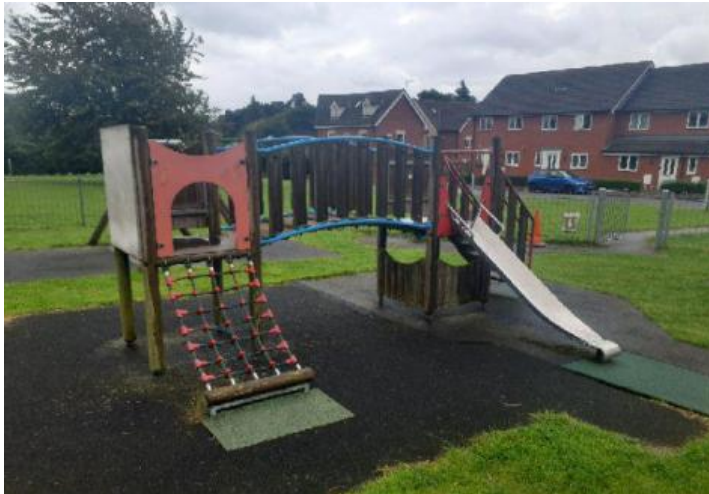
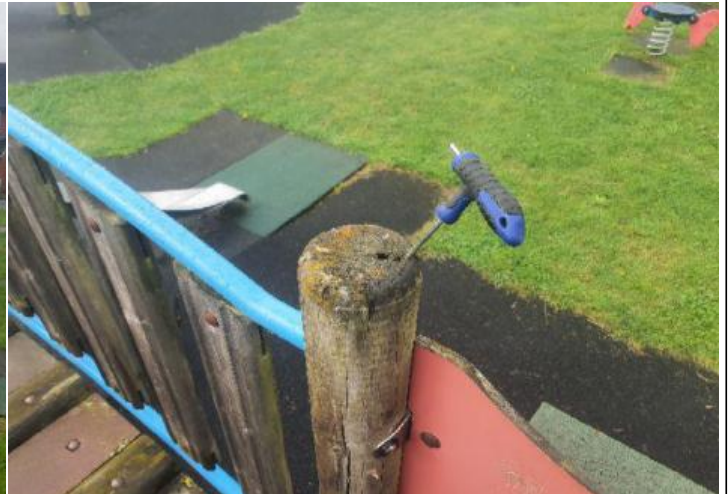
**Finding:** There is some evidence of rot in the timber

**Action:** Monitor for any further deterioration and replace as required

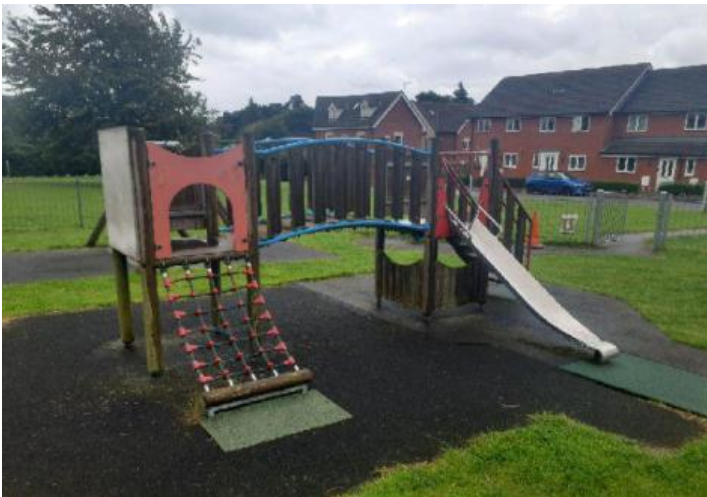
**Finding:** A number of fixing(s) have worked loose  
**Action:** Secure all loose fixings

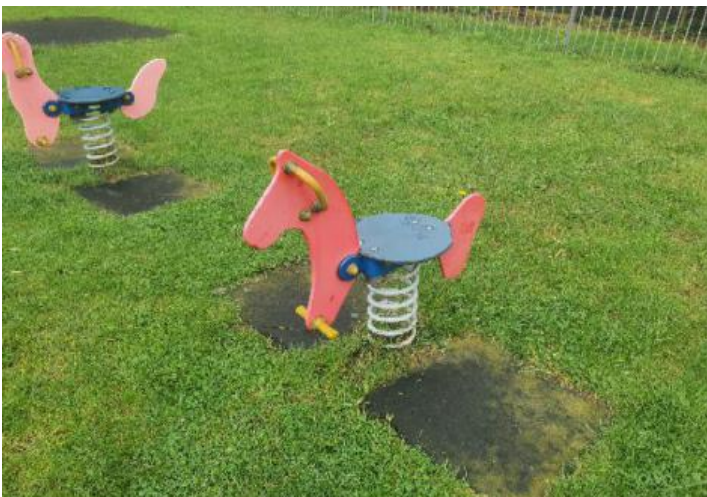
**Finding:** The end of handgrips and/or footrests have a cross section of less than 15cm<sup>2</sup> and fail to meet the requirements of BS EN 1176 Part 6

**Action:** Monitor - No remedial work recommended

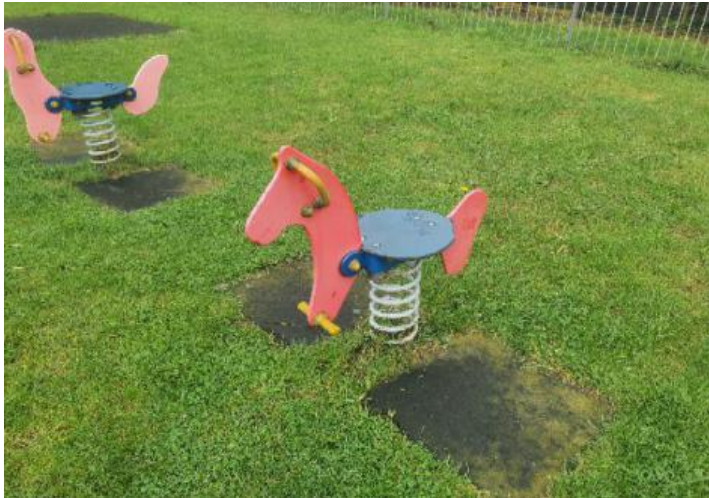
**Finding:** The U bolts clamping the spring are worn

**Action:** Replace

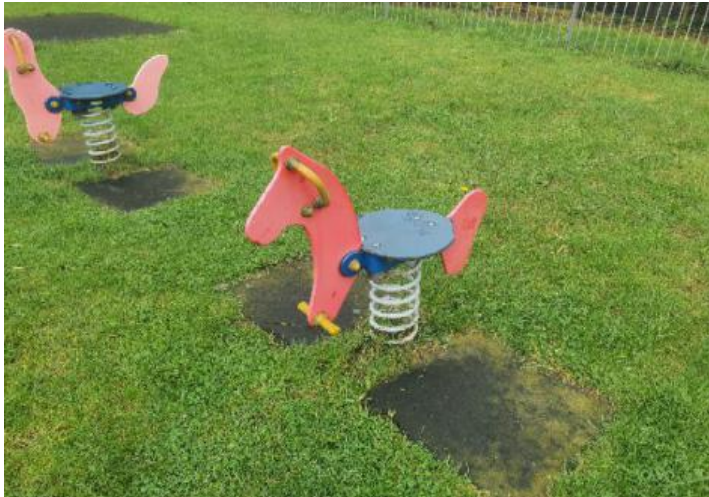
**Finding:** The end caps are missing on the Handgrips/Footrests

**Action:** Replace missing end caps

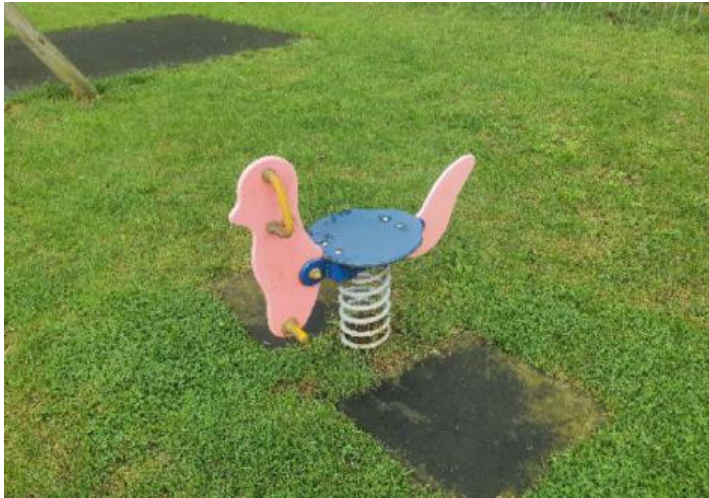
**Finding:** The end of handgrips and/or footrests have a cross section of less than 15cm<sup>2</sup> and fail to meet the requirements of BS EN 1176 Part 6  
**Action:** Monitor - No remedial work recommended

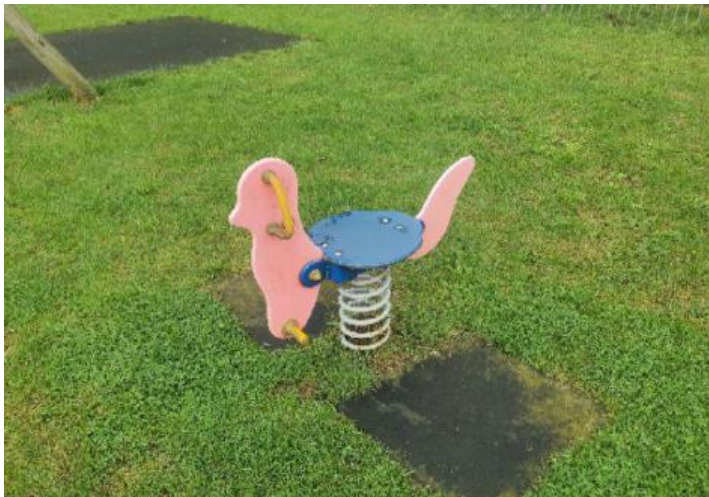
**Finding:** The U bolts clamping the spring are worn

**Action:** Monitor for any further deterioration and replace as required

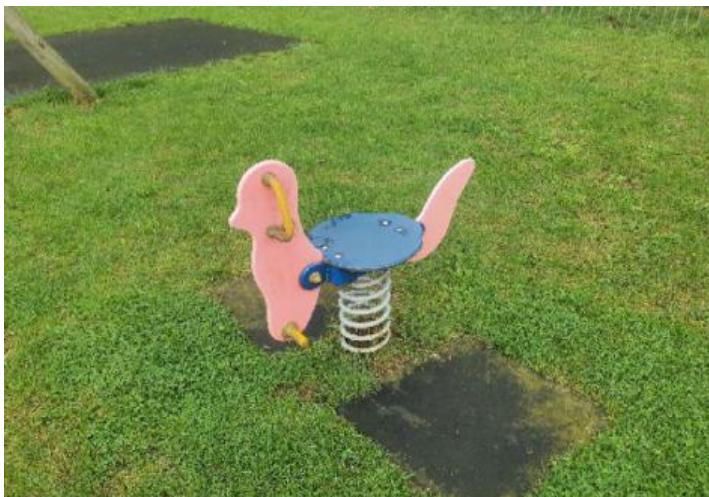
**Finding:** There is some damage to the item

**Action:** Monitor for any further deterioration and repair as required

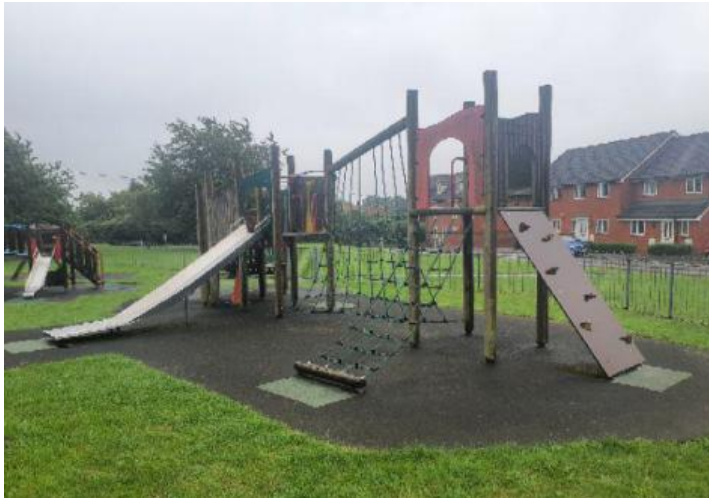
**Finding:** The timber has a number of splits/shakes or air cracks and this may affect the stability or allow water ingress which will accelerate the rotting process

**Action:** Monitor to ensure the splits do not cross through fixing points of the structure and/or cause any instability

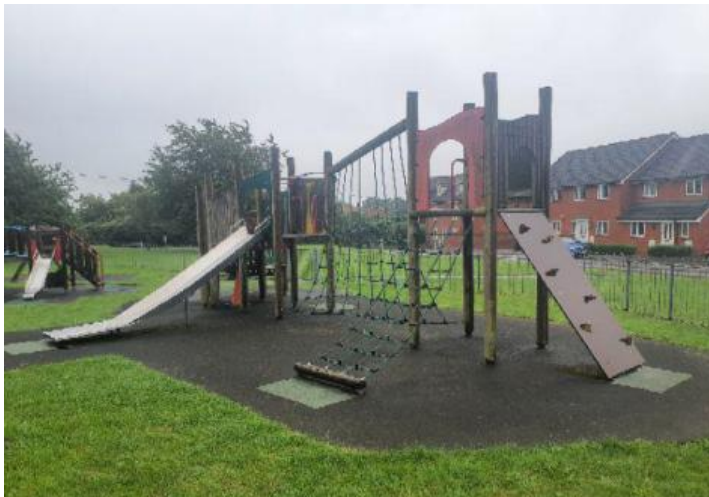
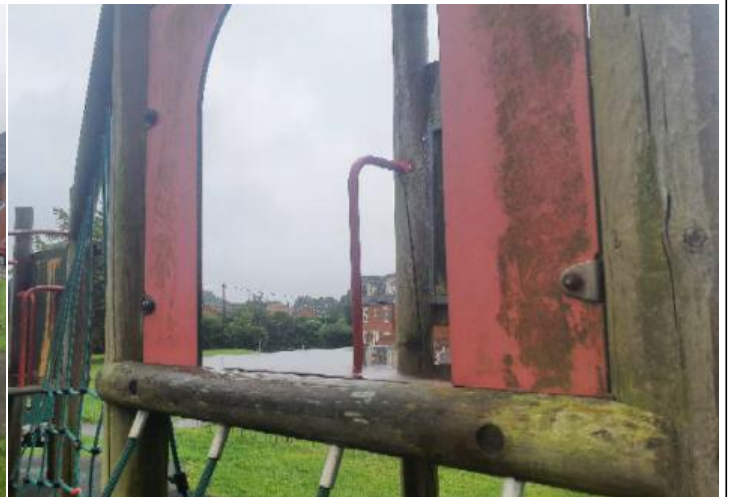
**Finding:** There is algae or moss on the surface of the equipment

**Action:** Clean and treat appropriately

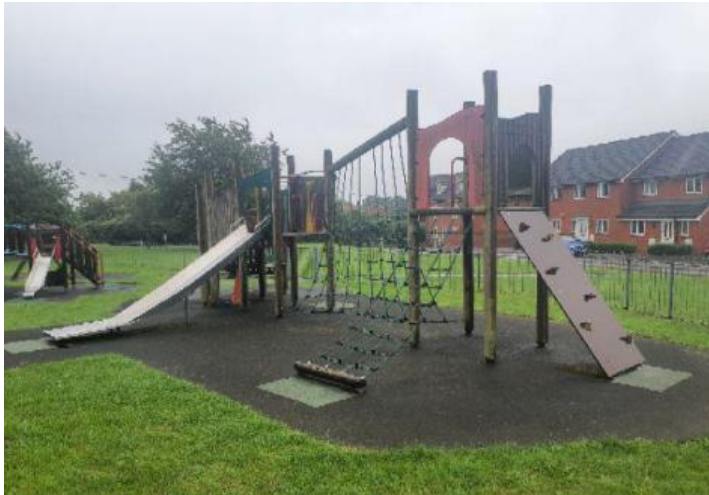
**Finding:** A number of fixing(s) have worked loose

**Action:** Secure all loose fixings

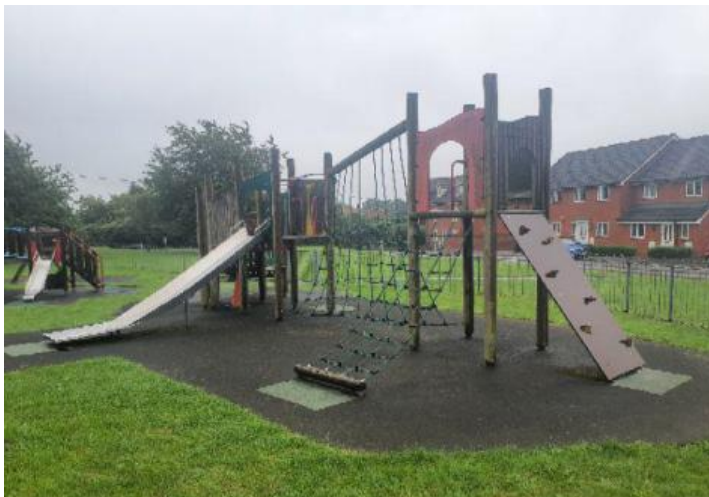
**Finding:** The wet pour has been repaired with bitmac which forms a hard object within the impact area

**Action:** Replace with a appropriate safer surface

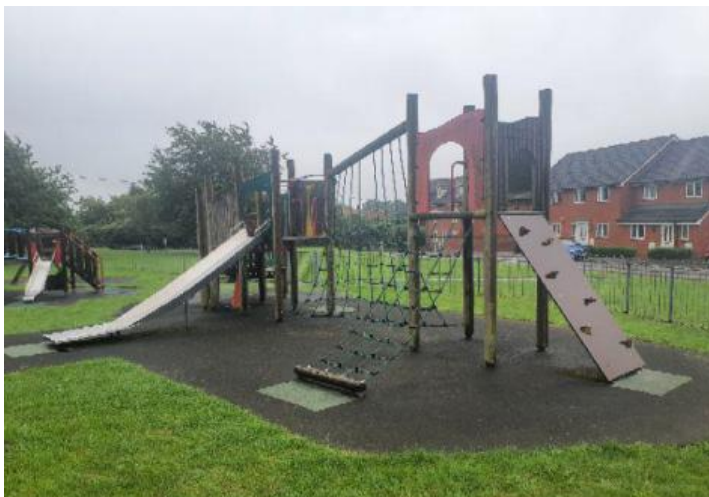
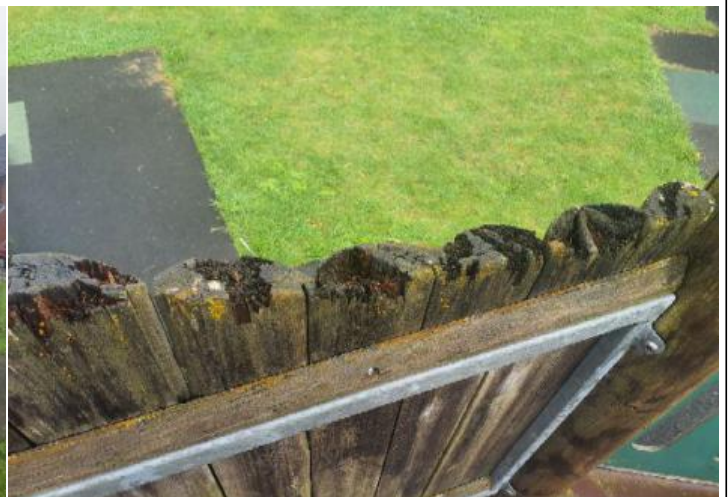
**Finding:** There are areas or parts of the timber on the structure that have rotted

**Action:** Replace all affected timbers

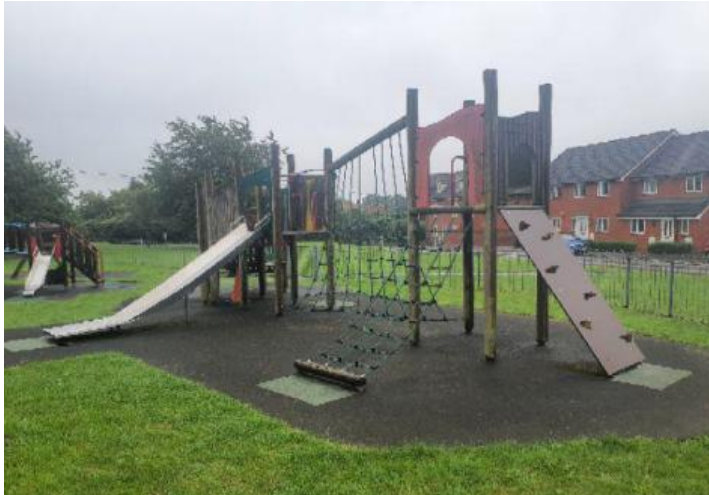
**Finding:** There are areas or parts of the timber on the structure that have rotted

**Action:** Replace all affected timbers

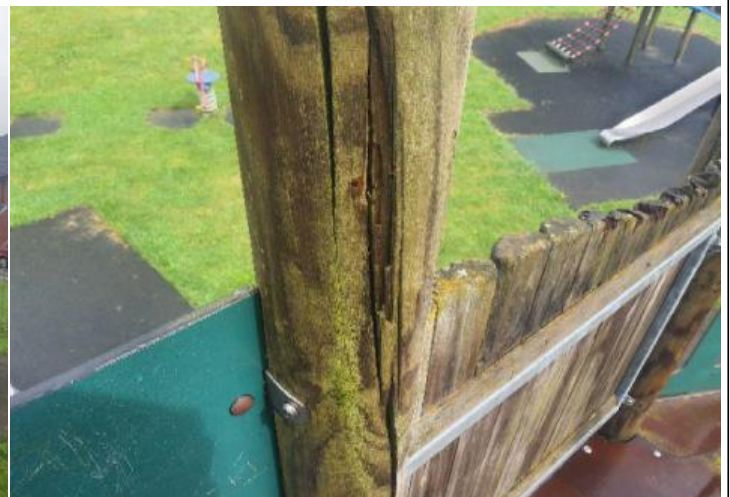
**Finding:** Parts of the timber are rough or splintered

**Action:** Remove all rough or sharp edges
