## Annual Inspection

Melton Parish Council

Beresford Drive Play Area

Beresford Drive, Woodbridge, Suffolk, IP12 1JJ

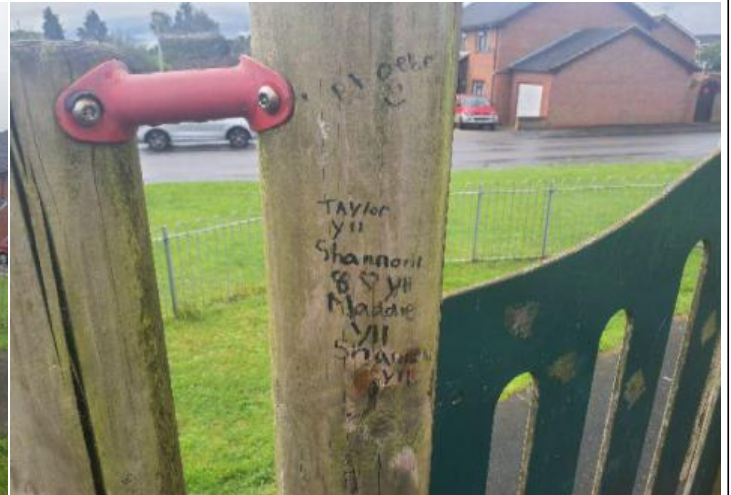
**Finding:** There is offensive graffiti present

**Action:** Remove as soon as practicable

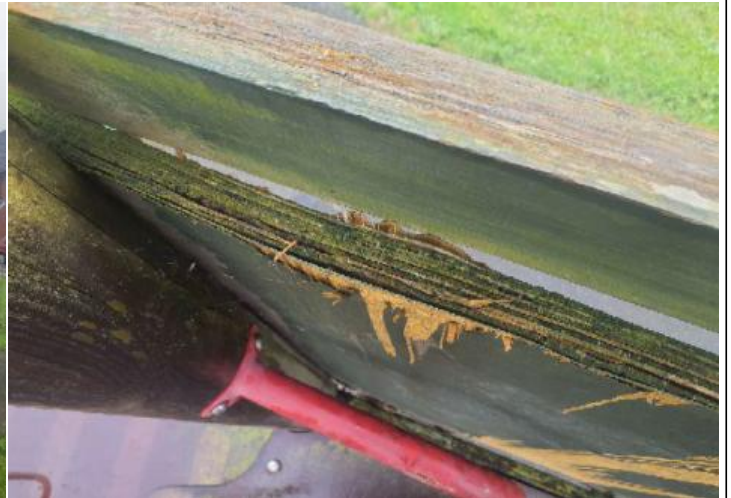
**Finding:** The plywood has delaminated in some places

**Action:** Remove all rough or splintered edges.

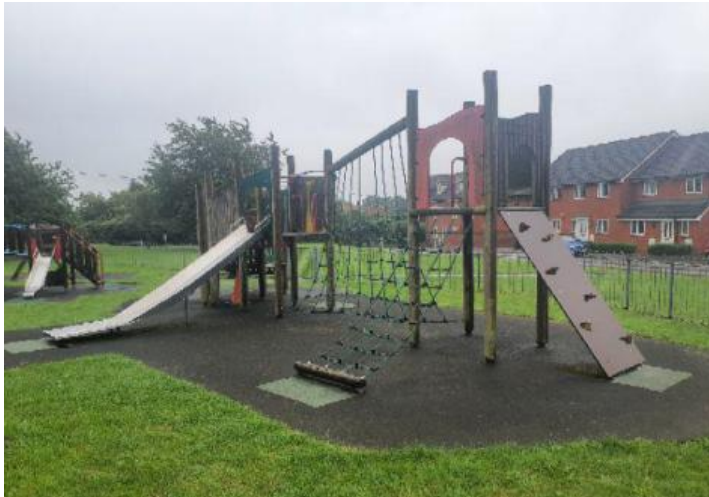
**Finding:** There are gaps opening between the surfacing and the edging surround or between the joints in the surfacing

**Action:** Monitor for any further deterioration and repair as required

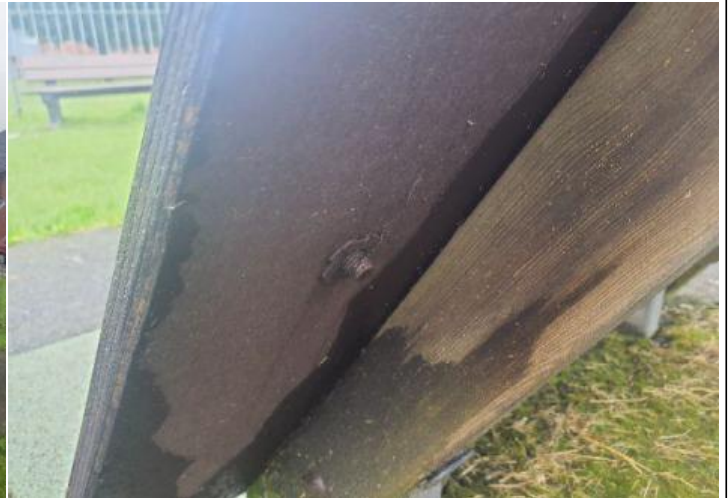
**Finding:** There are projecting bolt thread(s) present

**Action:** Remove excess thread length and deburr or provide cap

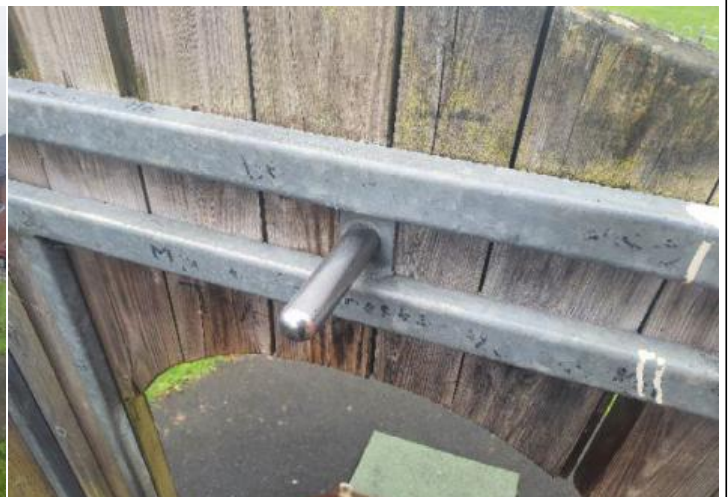
**Finding:** There is/are finger entrapment/s in the barrier due to missing fixings and the item fails to meet the requirements of BS EN 1176 Part 1 4.2.7.6 Entrapment of fingers

**Action:** Provide missing fixings to remove entrapment

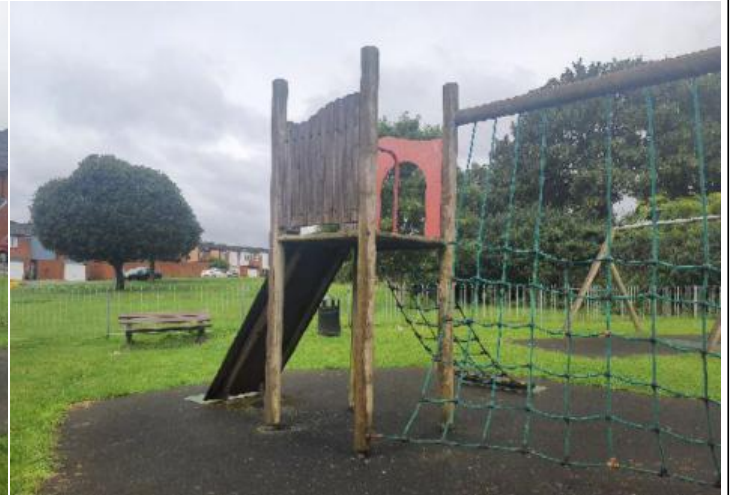
**Finding:** The tower is becoming unstable

**Action:** Repair or replace as required

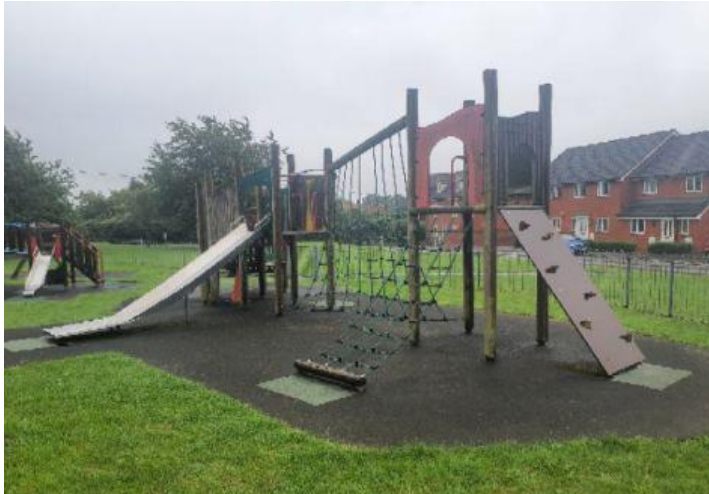
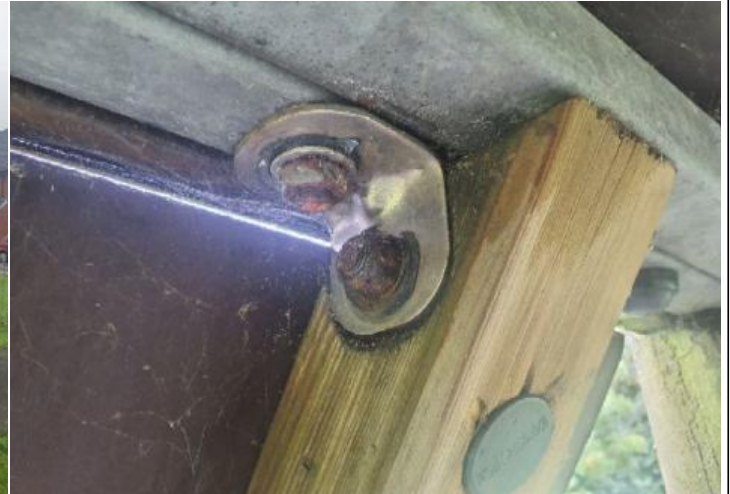
**Finding:** The fixings have corroded excessively

**Action:** Replace all corroded fixings

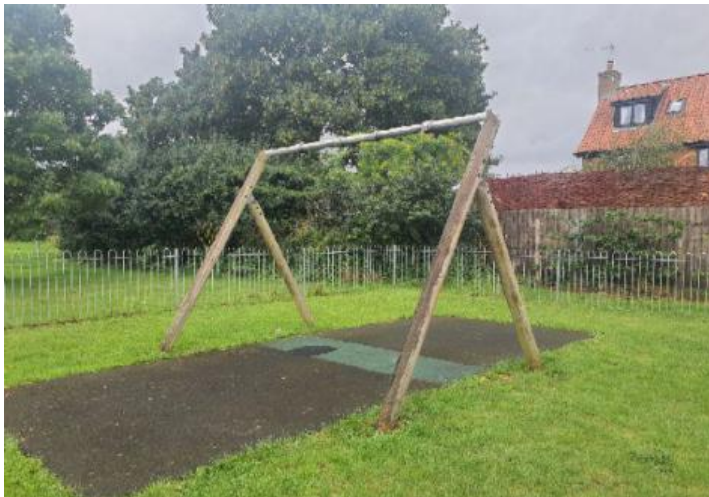
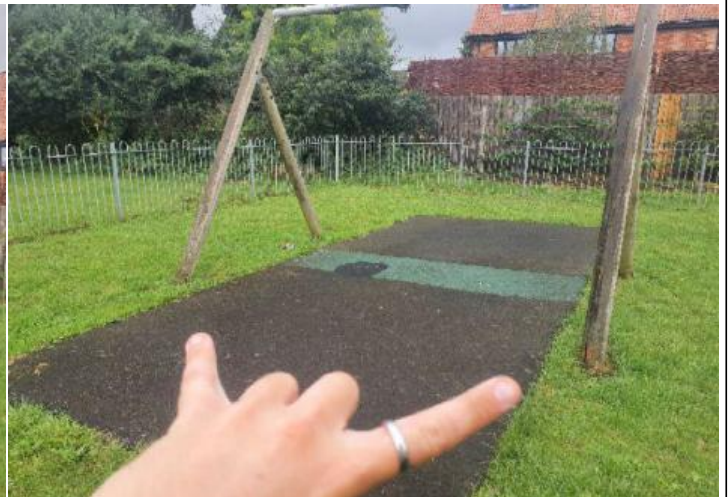
There are areas or parts of the timber on the structure that have rotted (Risk assessment has been lowered due to there being no swings attached) - Replace all affected timbers before re hanging swings

**Finding:** There are areas or parts of the timber on the structure that have rotted (Risk assessment has been lowered due to there being no swings attached)

**Action:** Replace all affected timbers before re hanging swings

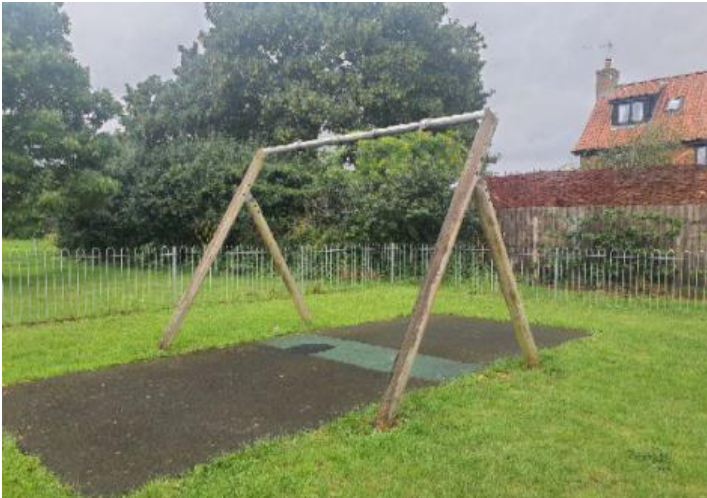
There is some strimmer / machinery damage apparent on the posts, this can penetrate the preservative applied to the timber and accelerate the rotting process - Monitor for any deterioration (rot) and replace as required

**Finding:** There is some strimmer / machinery damage apparent on the posts, this can penetrate the preservative applied to the timber and accelerate the rotting process

**Action:** Monitor for any deterioration (rot) and replace as required

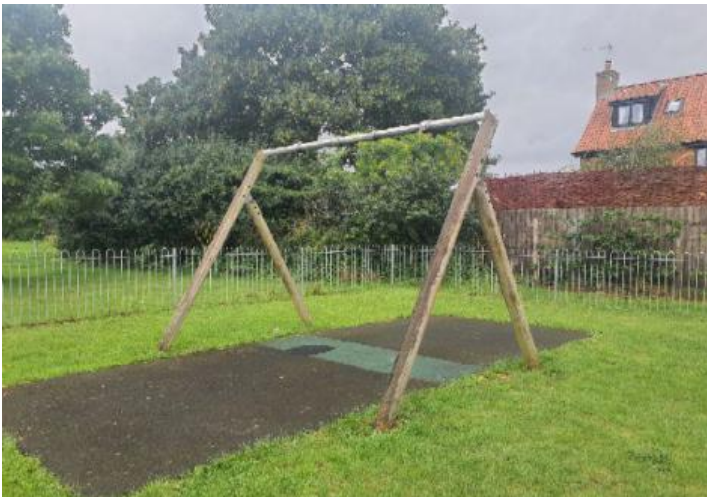
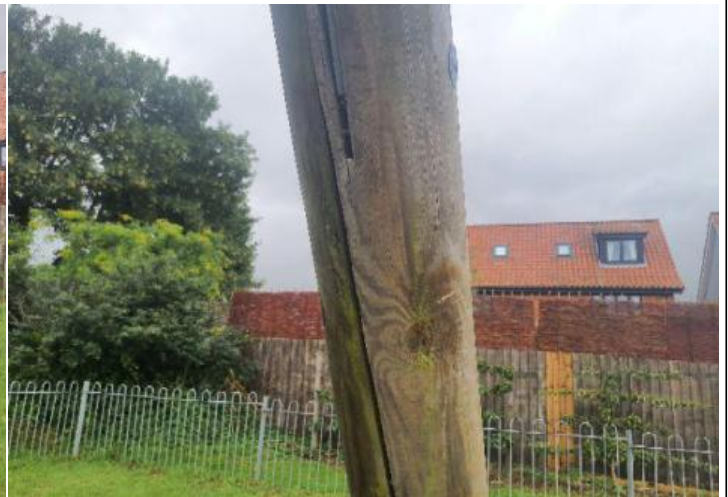
The timber has a number of splits/shakes or air cracks and this may affect the stability or allow water ingress which will accelerate the rotting process - Monitor to ensure the splits do not cross through fixing points of the structure and/or cause any instability

**Finding:** The timber has a number of splits/shakes or air cracks and this may affect the stability or allow water ingress which will accelerate the rotting process

**Action:** Monitor to ensure the splits do not cross through fixing points of the structure and/or cause any instability

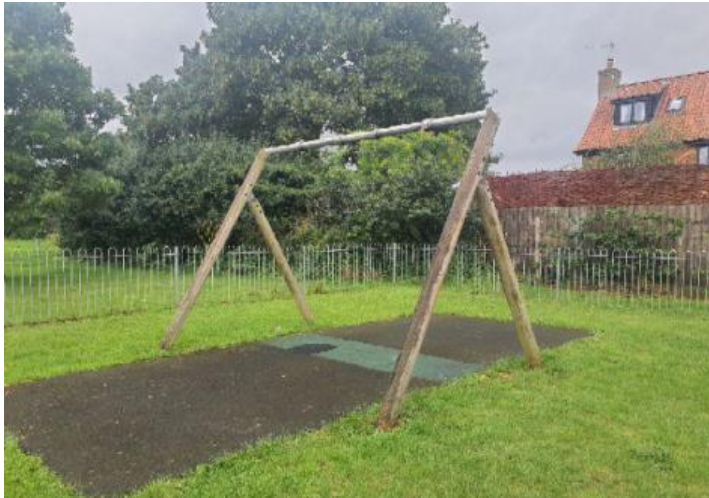
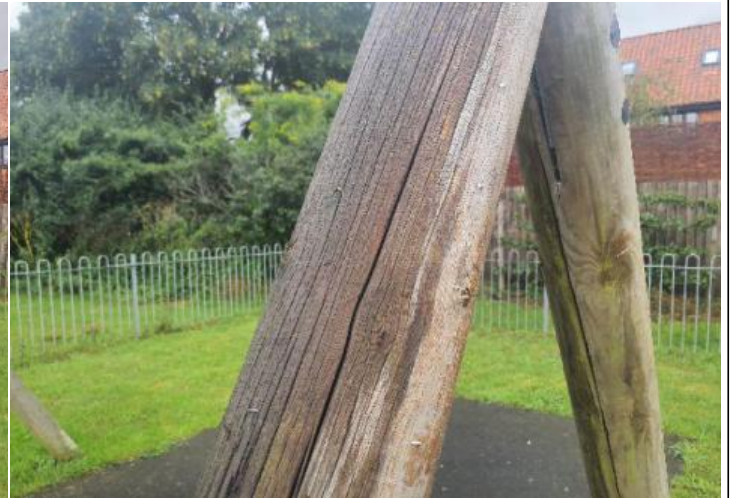
**Finding:** There are a number of redundant staples attached to the equipment  
**Action:** Remove redundant staples

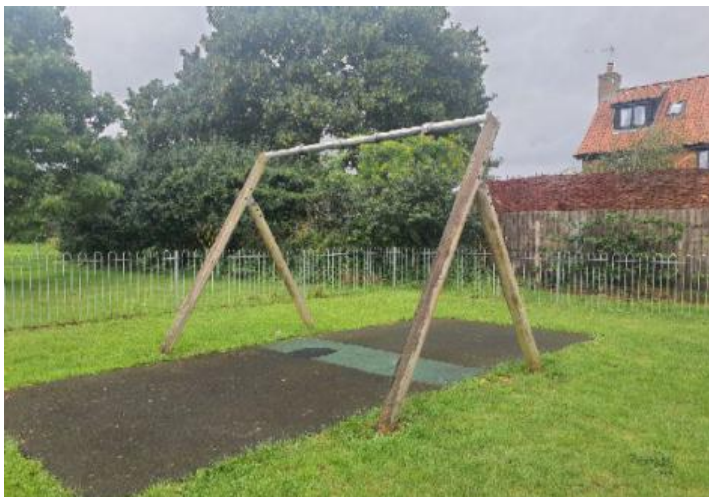
The surface is lifting at the edges and creating trip points - Repair perimeter of surfacing to remove trip points

**Finding:** The surface is lifting at the edges and creating trip points  
**Action:** Repair perimeter of surfacing to remove trip points

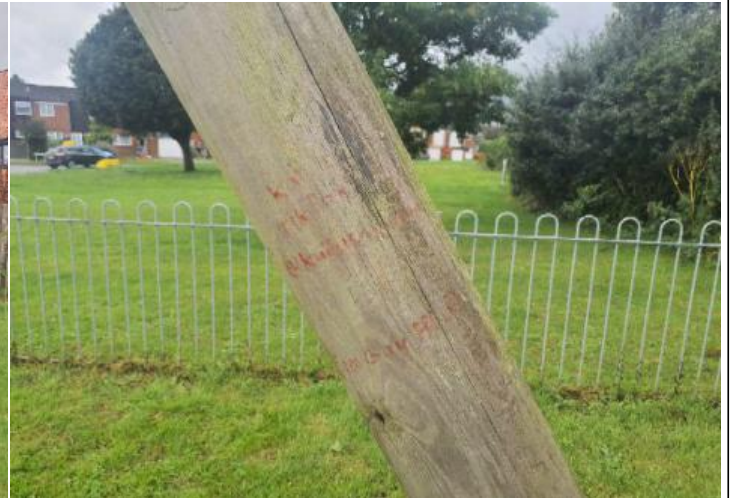
**Finding:** There is some graffiti present

**Action:** Remove the graffiti

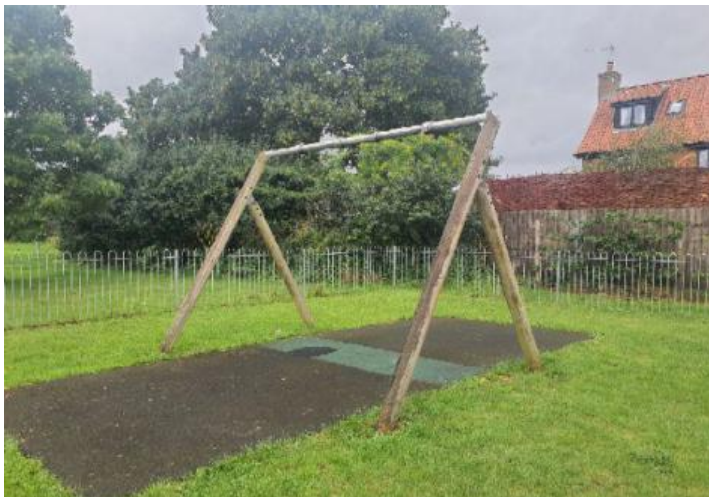
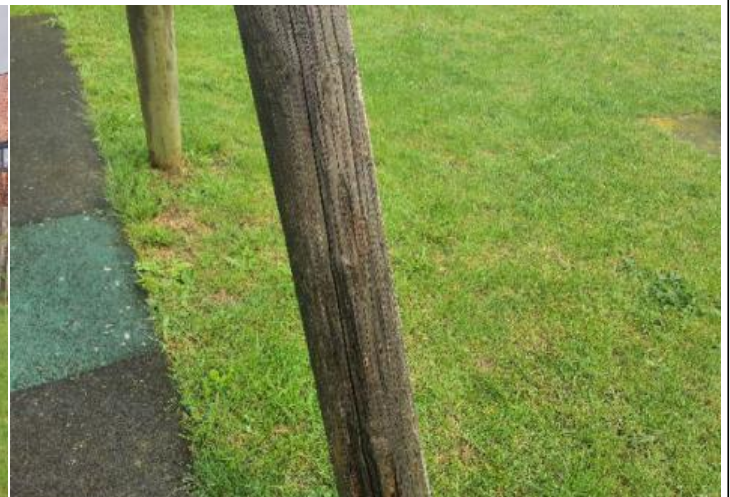
**i** 6 - Low Risk (Finding 7)

<b>Item:</b>	Swings - 1 Bay 2 Seat (Flat)	<b>Risk Level:</b>	L - Low Risk
<b>Manufacturer:</b>	Playdale Playgrounds Ltd	<b>Surface:</b>	Wet Pour

**Finding:** Parts of the timber are rough or splintered

**Action:** Remove all rough or sharp edges
