## Operational Inspection

Melton Parish Council

Melton Recreation Ground  
Melton Road , IP12 1PF

Operational Inspection - 1-September-2023 - 07:37 Inspector Dan Carr

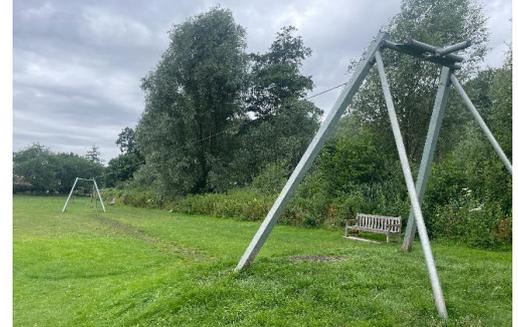
**Item:** Cable Runway  
**Manufacturer:** Kompan Ltd  
**Surface Type:** Grass  
**Item Quantity:** 1  
**Equipment Compliance:** N/A  
**Surface Area Compliance:** N/A

The cableway seat has been damaged - Monitor for any further deterioration and replace as required

There is surface corrosion / rust present on the item - Consider treating the item

The ropes/nets are worn/damaged in places - Monitor for any further deterioration and repair or replace as required

**Finding:** The cableway seat has been damaged

**Finding:** The ropes/nets are worn/damaged in places

**Finding:** There is surface corrosion / rust present on the item

**Action:** Monitor for any further deterioration and replace as required

**Action:** Monitor for any further deterioration and repair or replace as required
